Monitoring WRV Projects – What We Learned During 2015  
September 28, 2015  
Laura Backus, Alan Carpenter, Todd Sanford

## **Background and Purpose**

## WRV QUICK MONITOR D R A F T

**Project Name:** Berthoud Pass Restoration

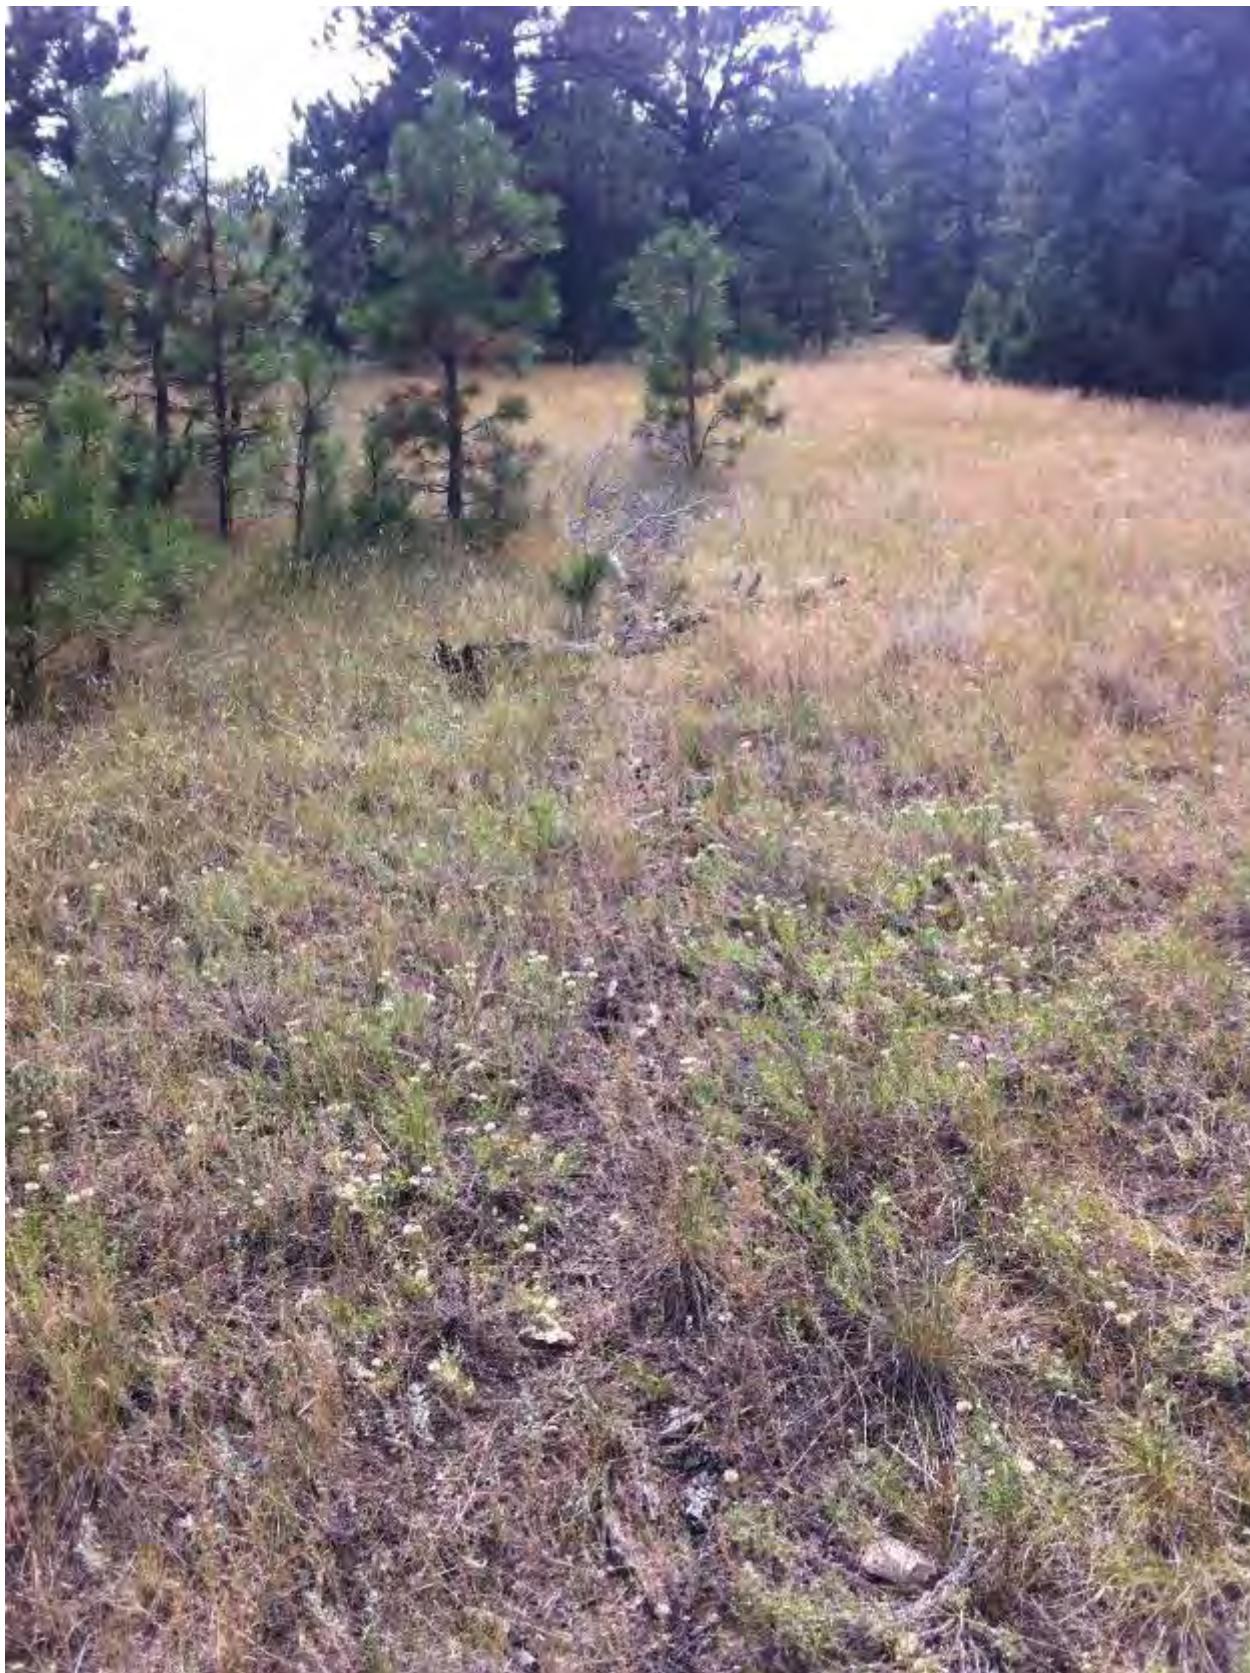
Start of Section C off of Canyon Loop Trail, looking north.

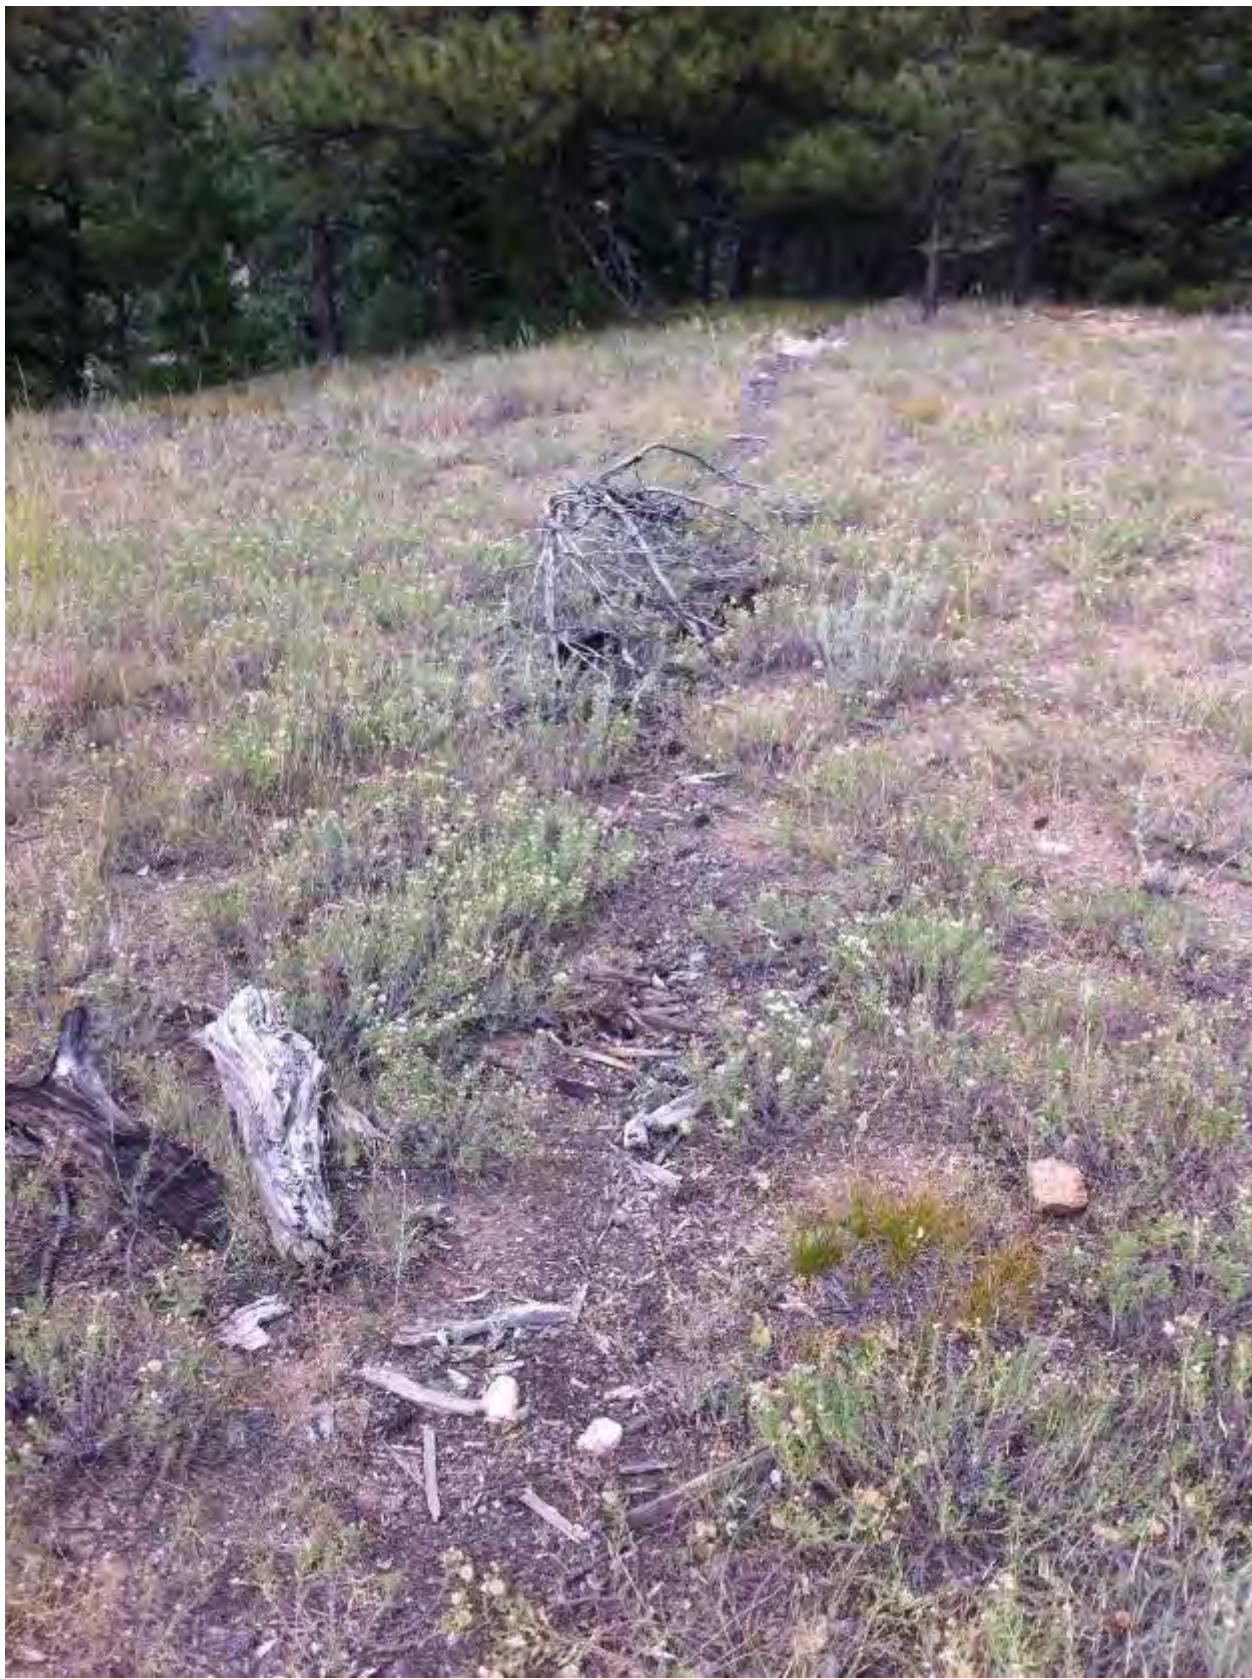
Section C us really hard to see. View is looking south, toward Canyon Loop Trail, about half way to the Loop Link Trail.

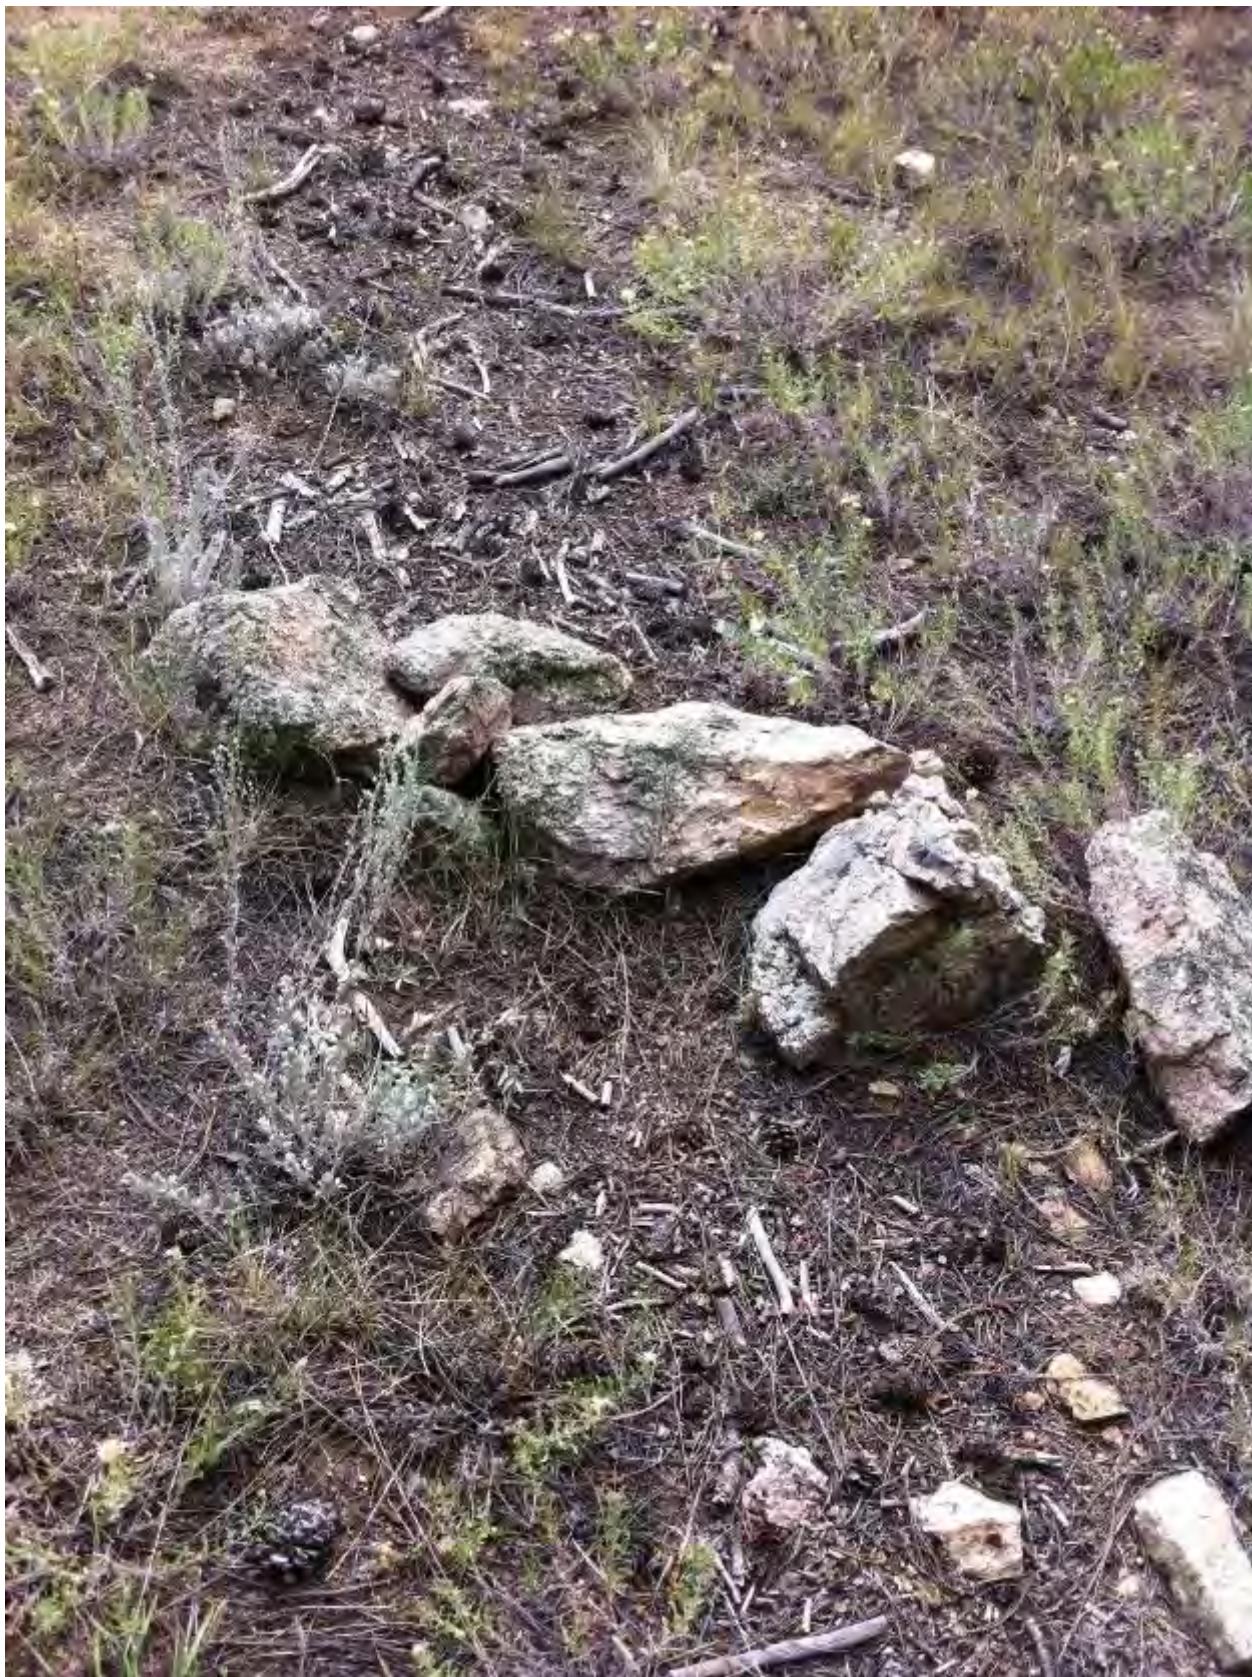
Section B is more obvious from Loop Link trail, but it appears un-used by humans

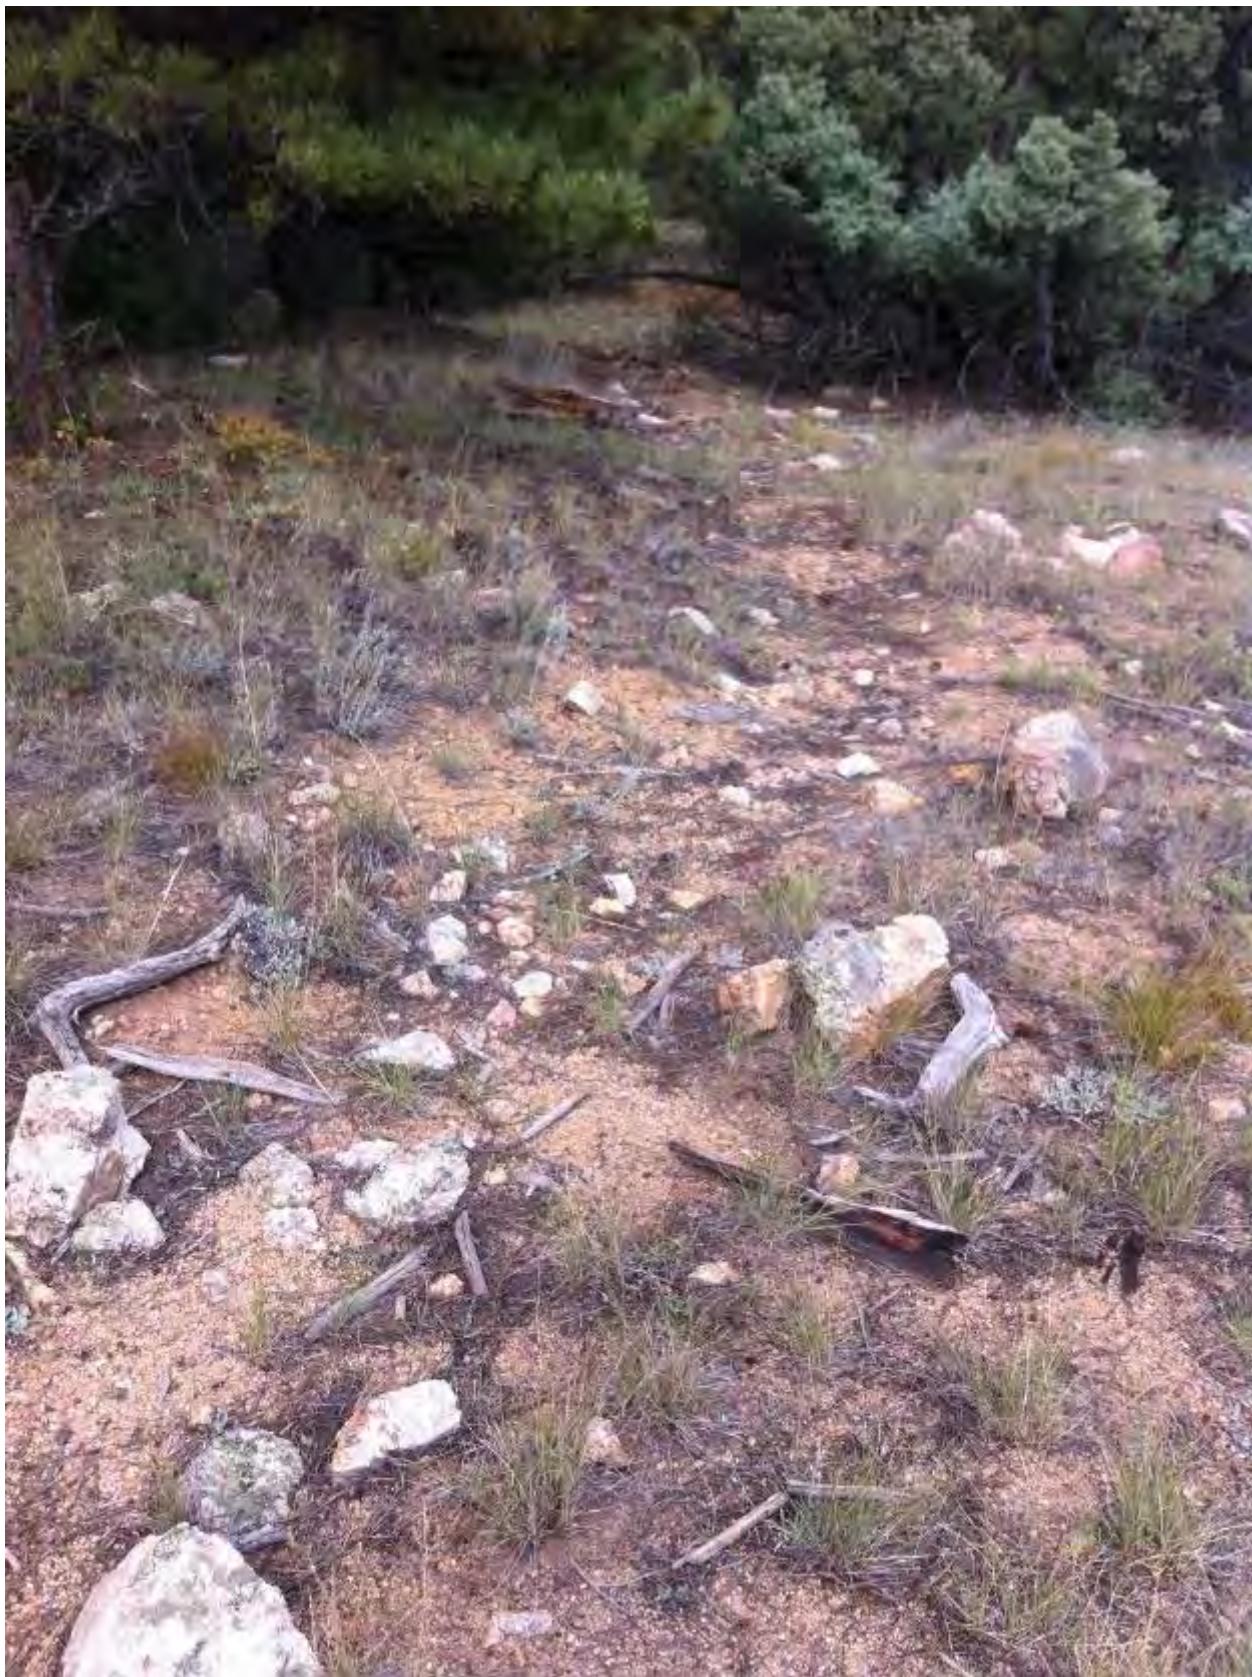
Water bar on Section B holding well.

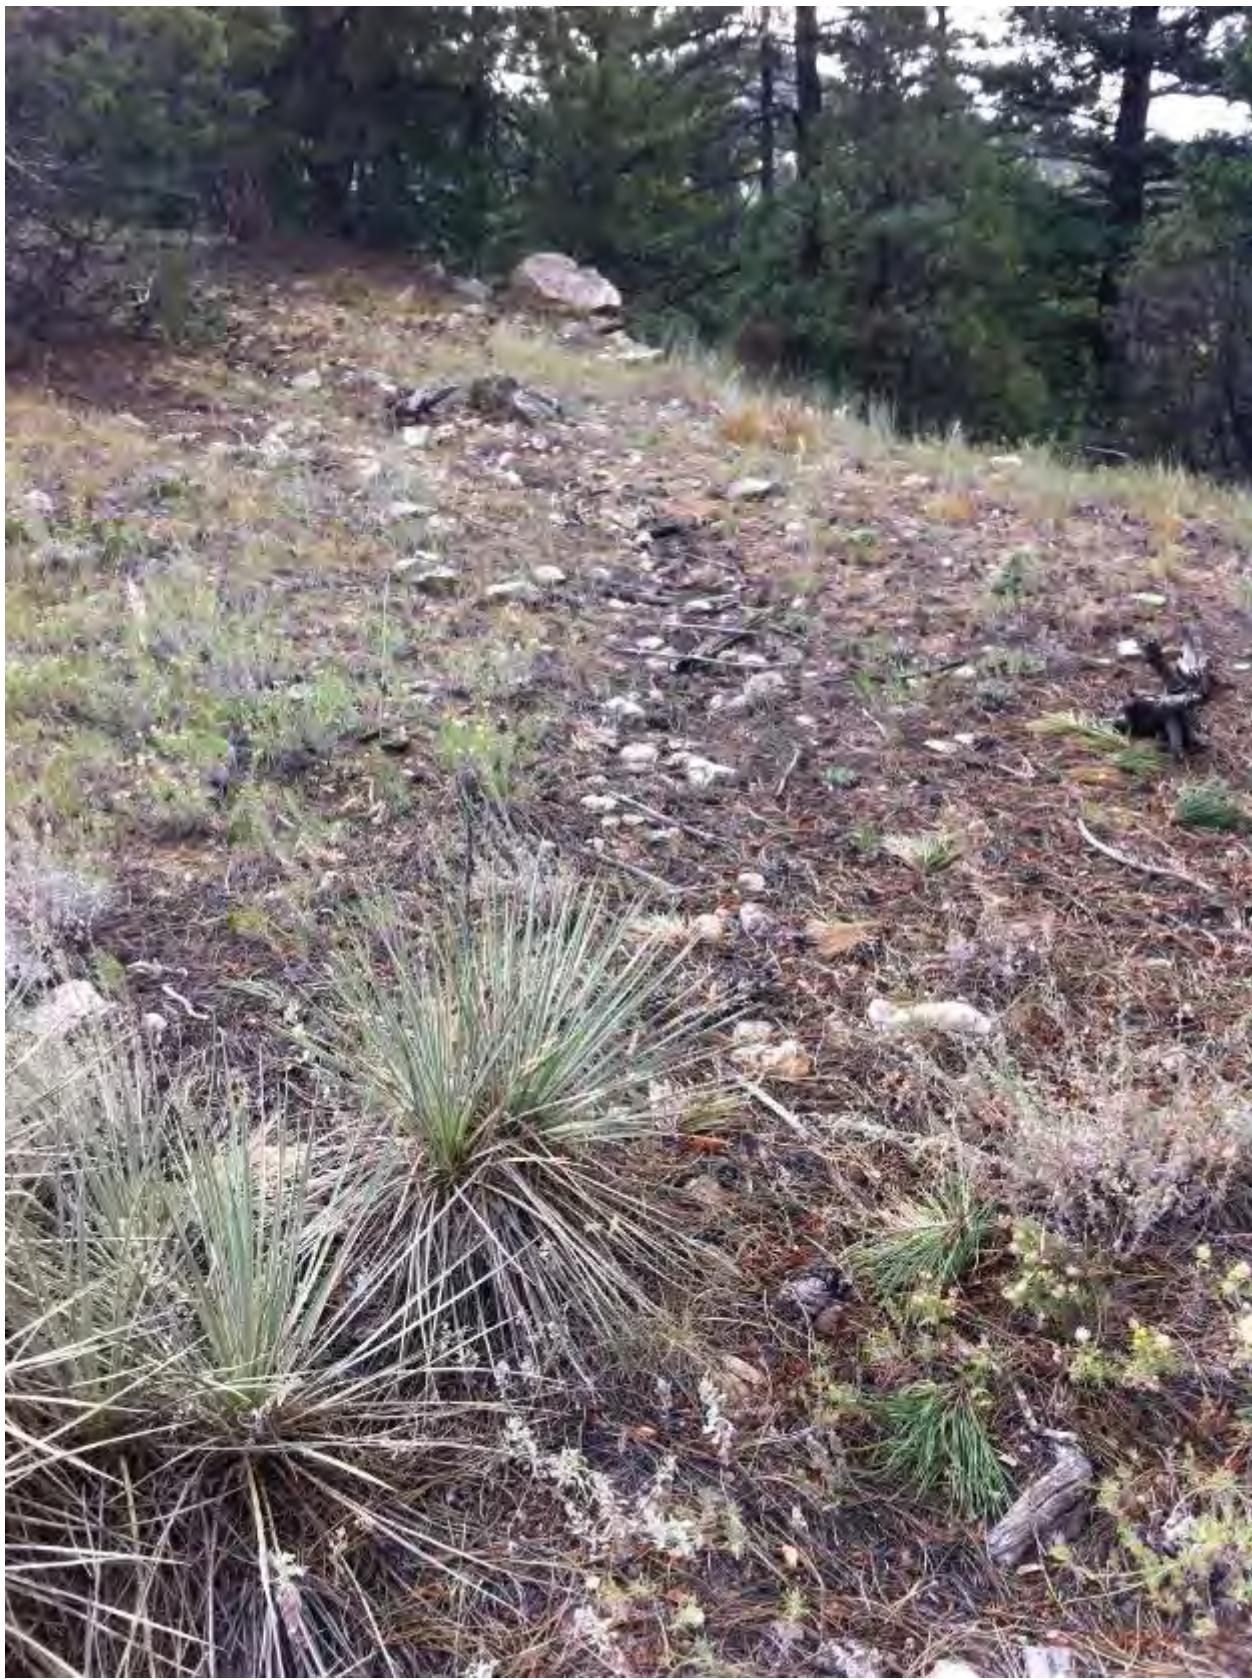
Grass seeding may not have worked, but trail is still quite obscure...

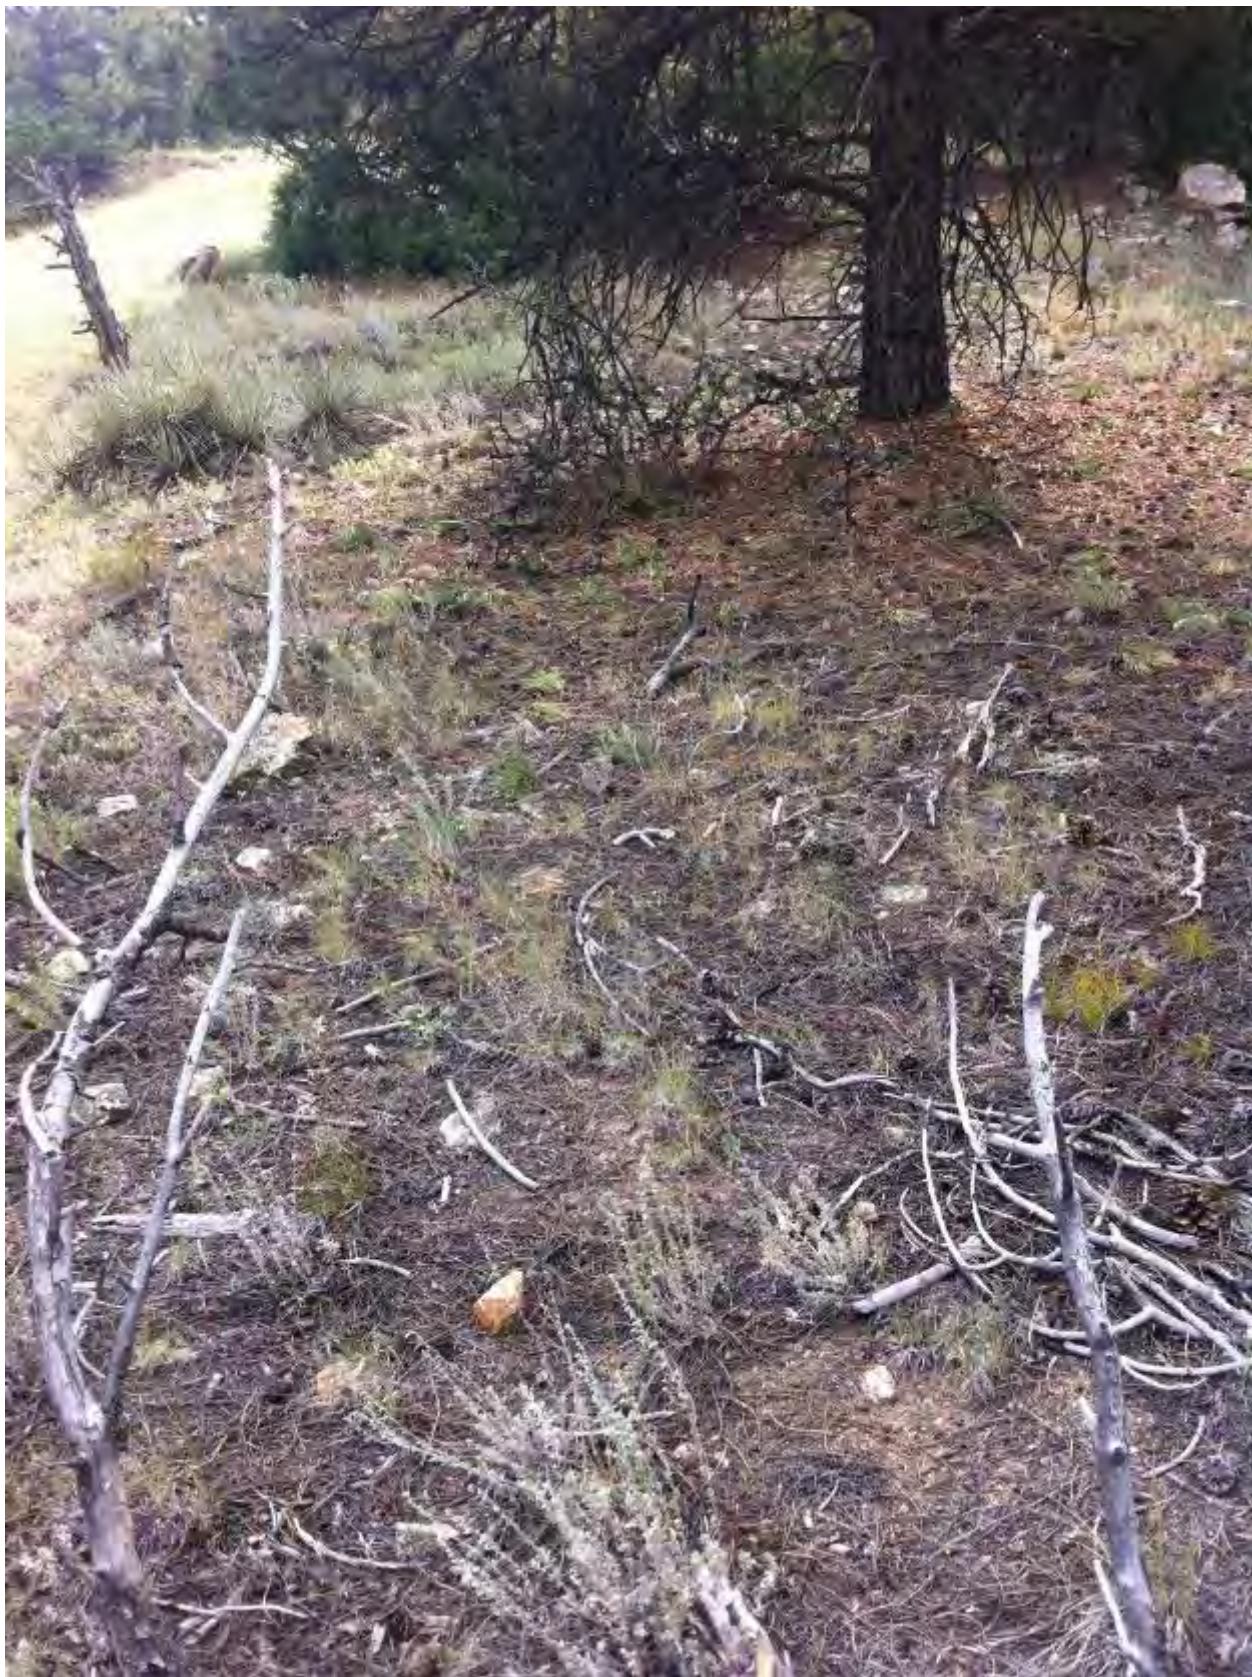
Section B. Woody Debris is working well to obscure the trail

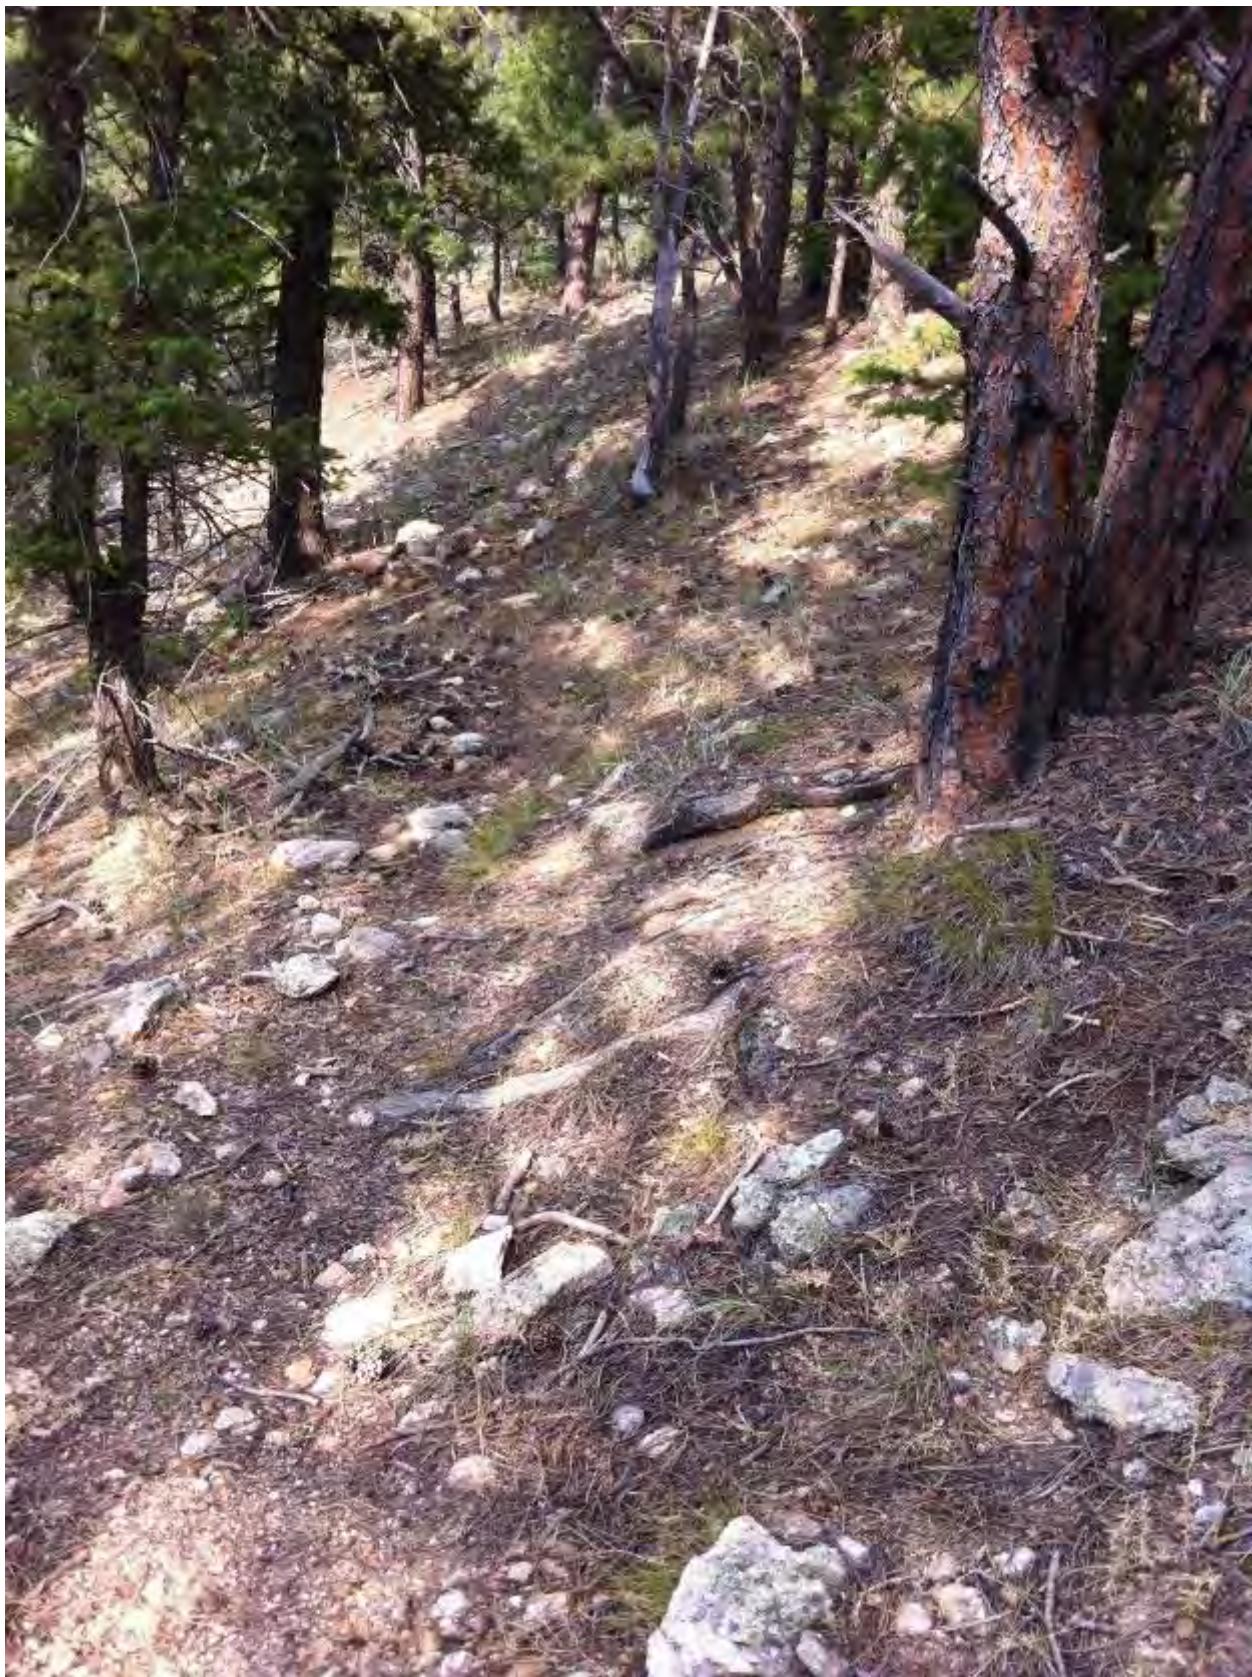
Section B very well obscured.

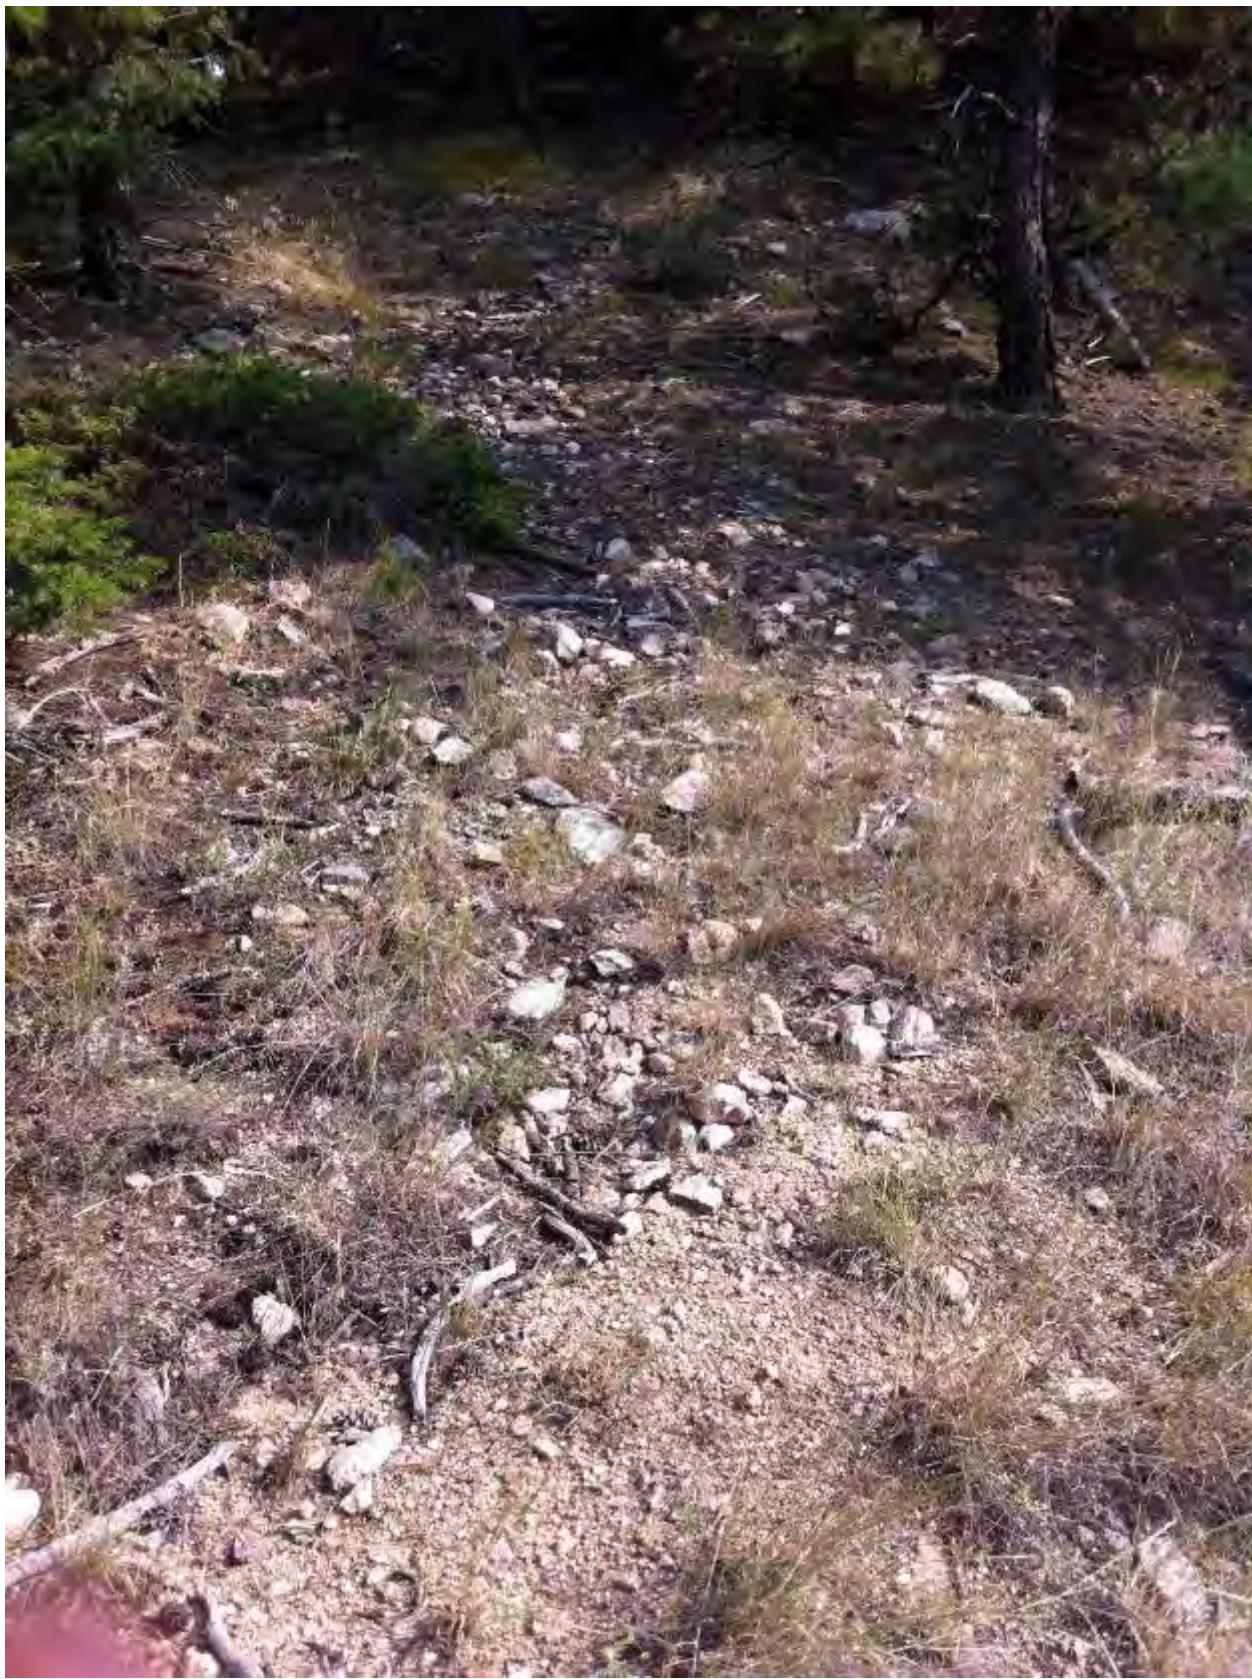
Section A was a little easier to follow as it is pretty steep in sections.

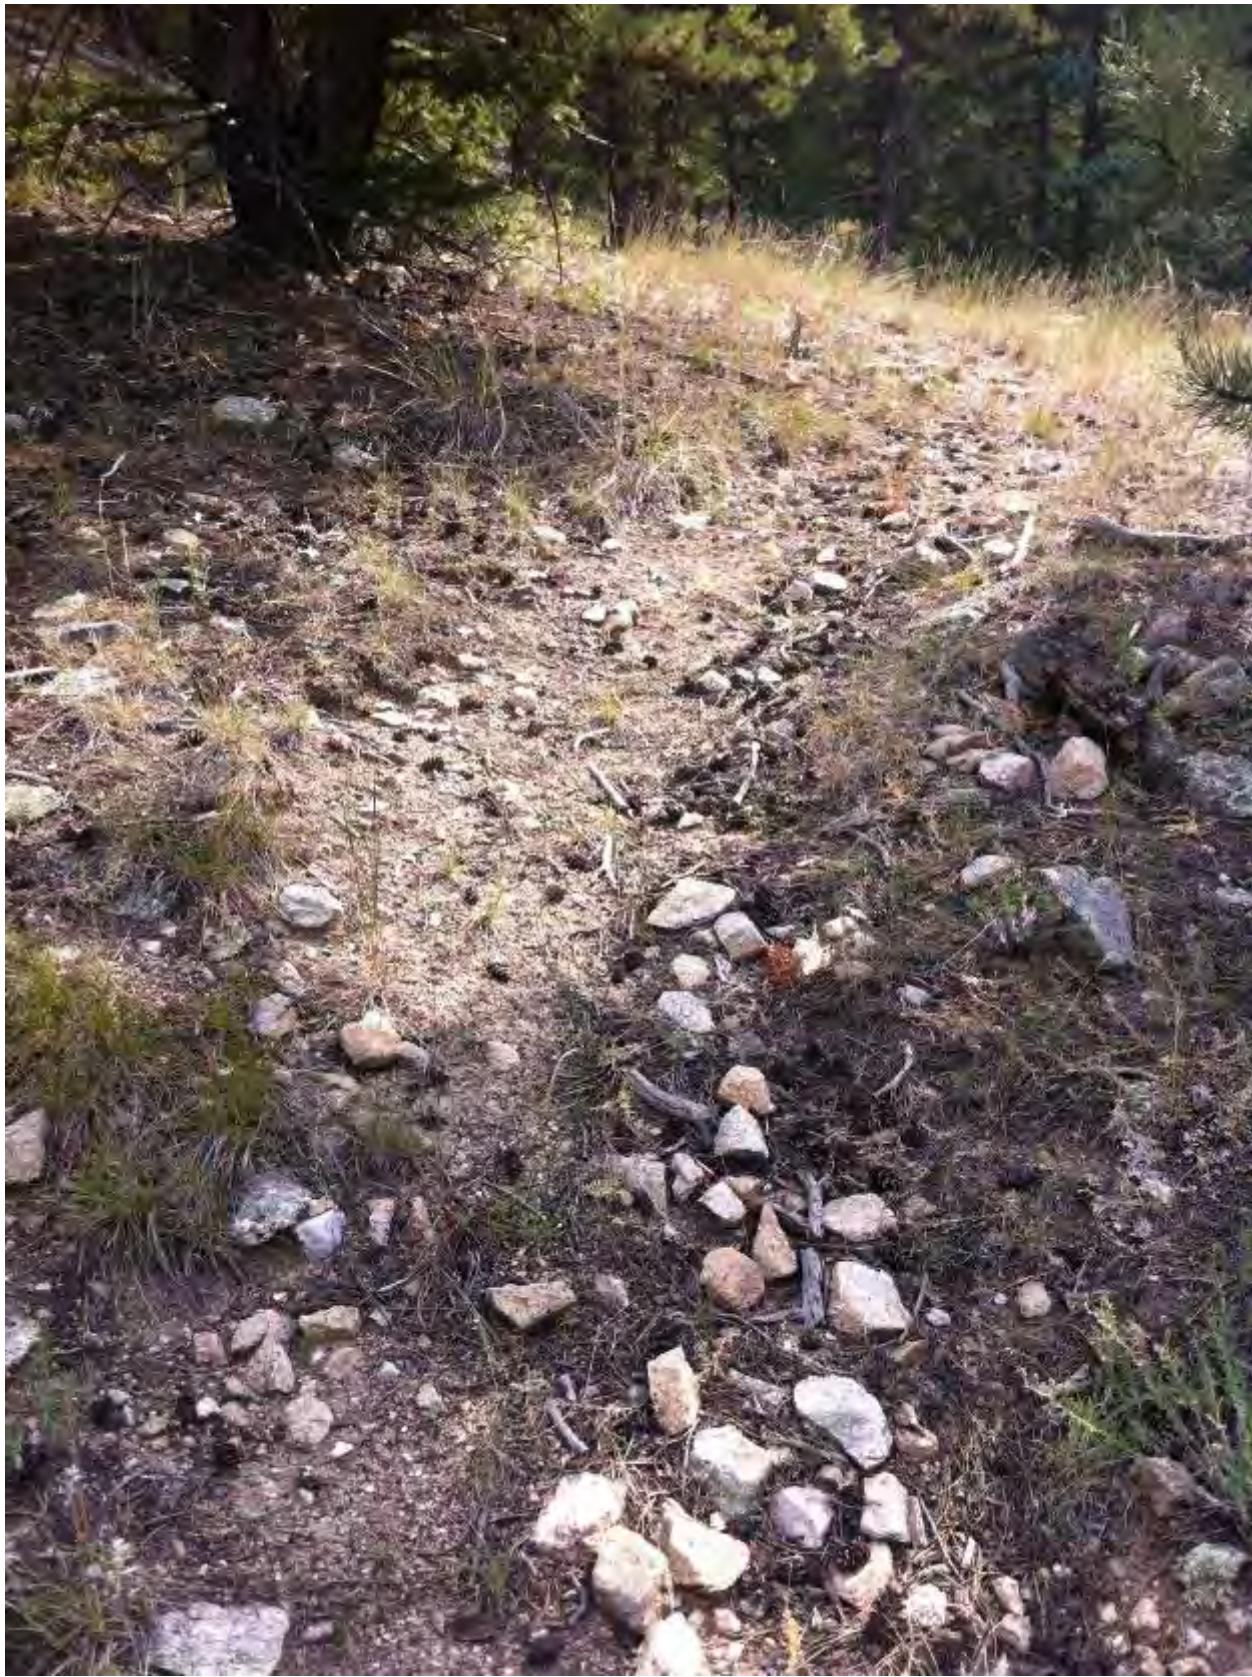
Section A is there, but not terribly obvious

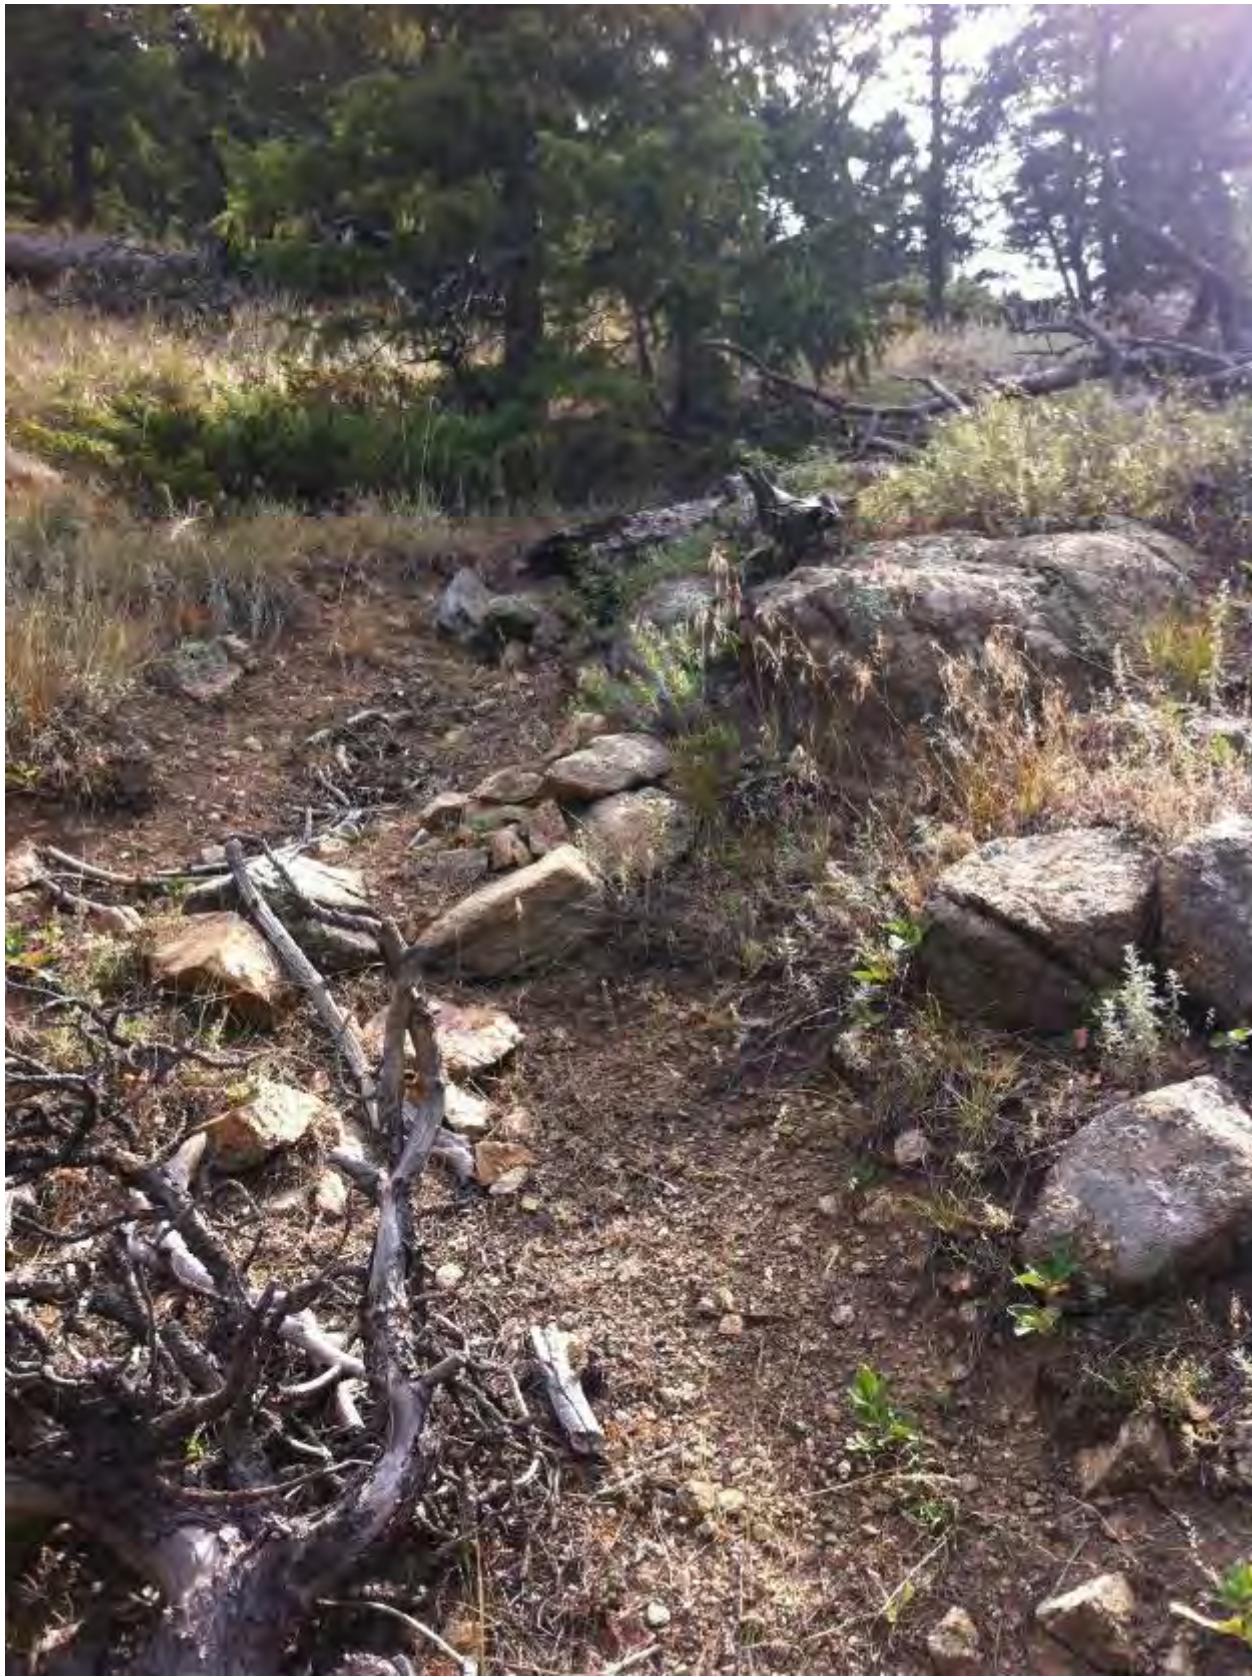
Section A, nicely obscure.

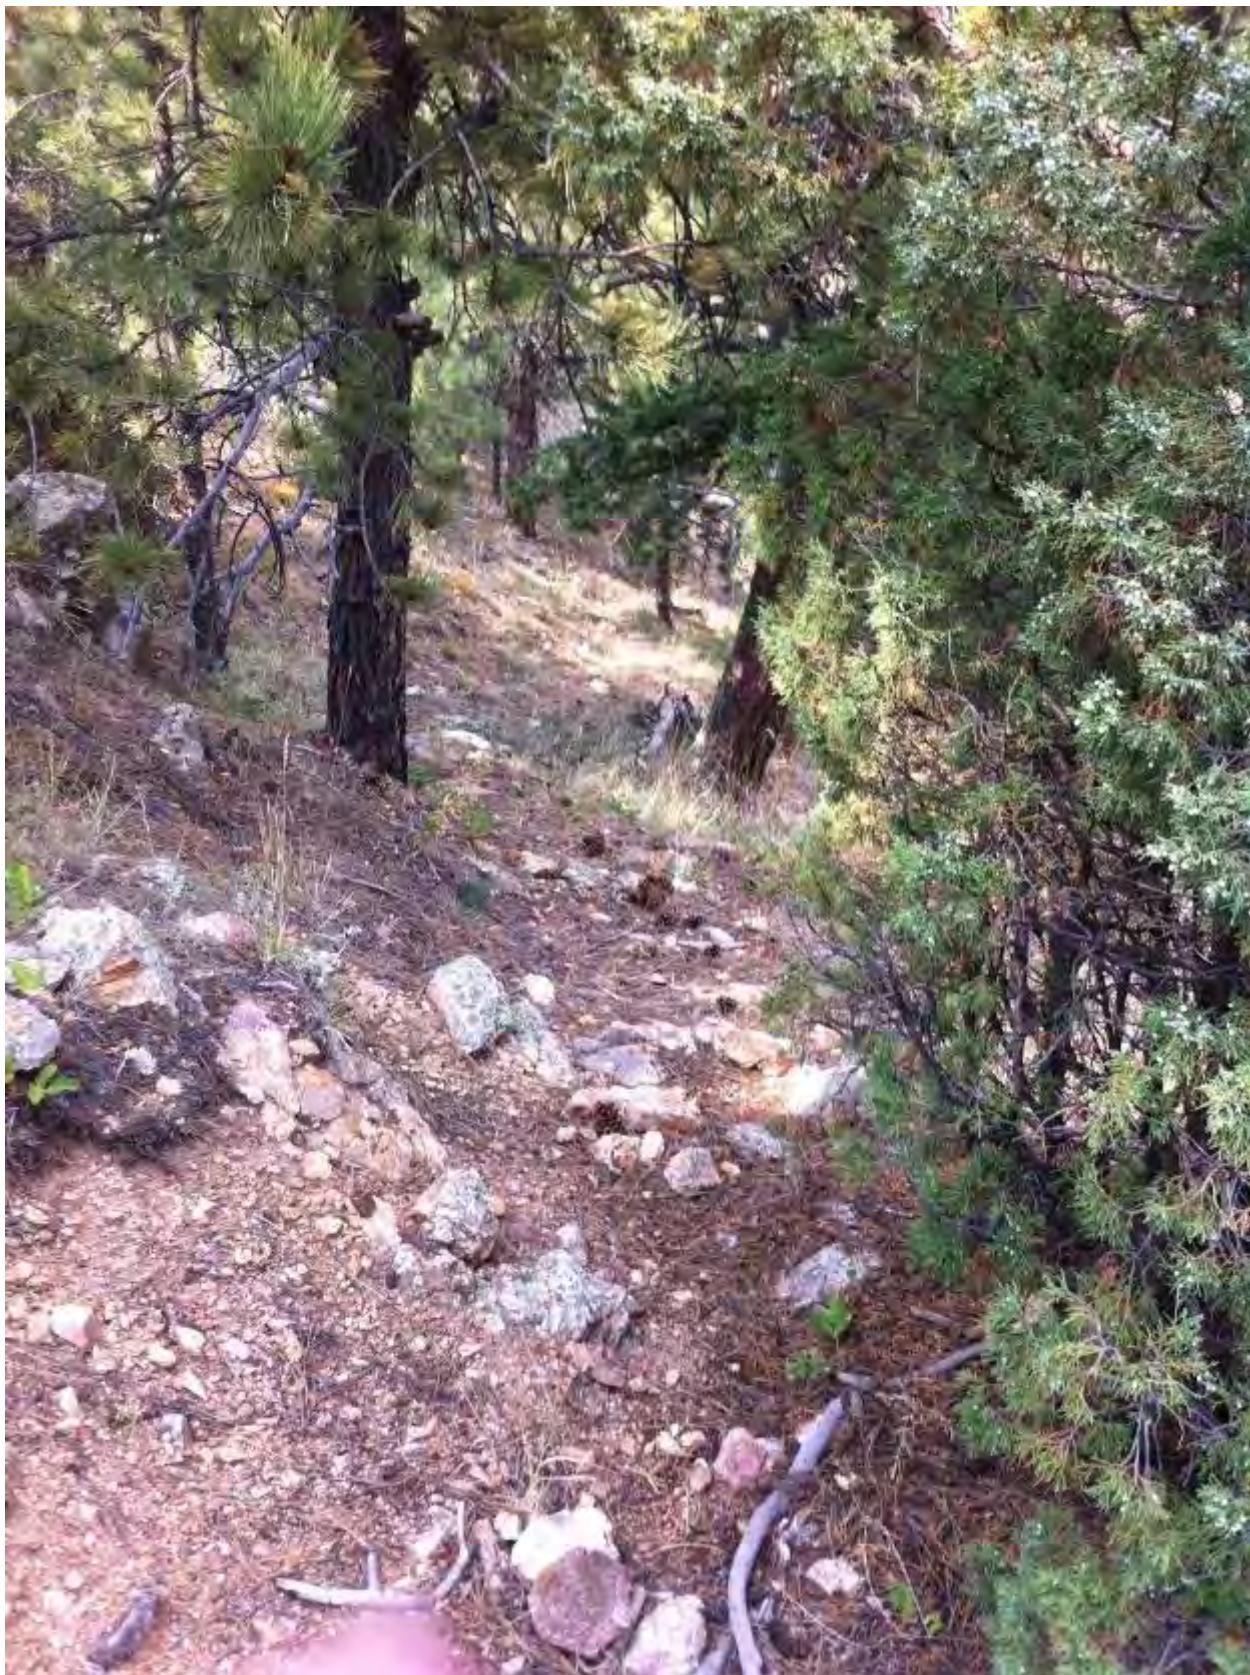
Water bar along Section A, which is holding well.
