Monitoring WRV Projects – What We Learned During 2015  
September 28, 2015  
Laura Backus, Alan Carpenter, Todd Sanford

## **Background and Purpose**

## WRV QUICK MONITOR D R A F T

**Project Name:** Berthoud Pass Restoration

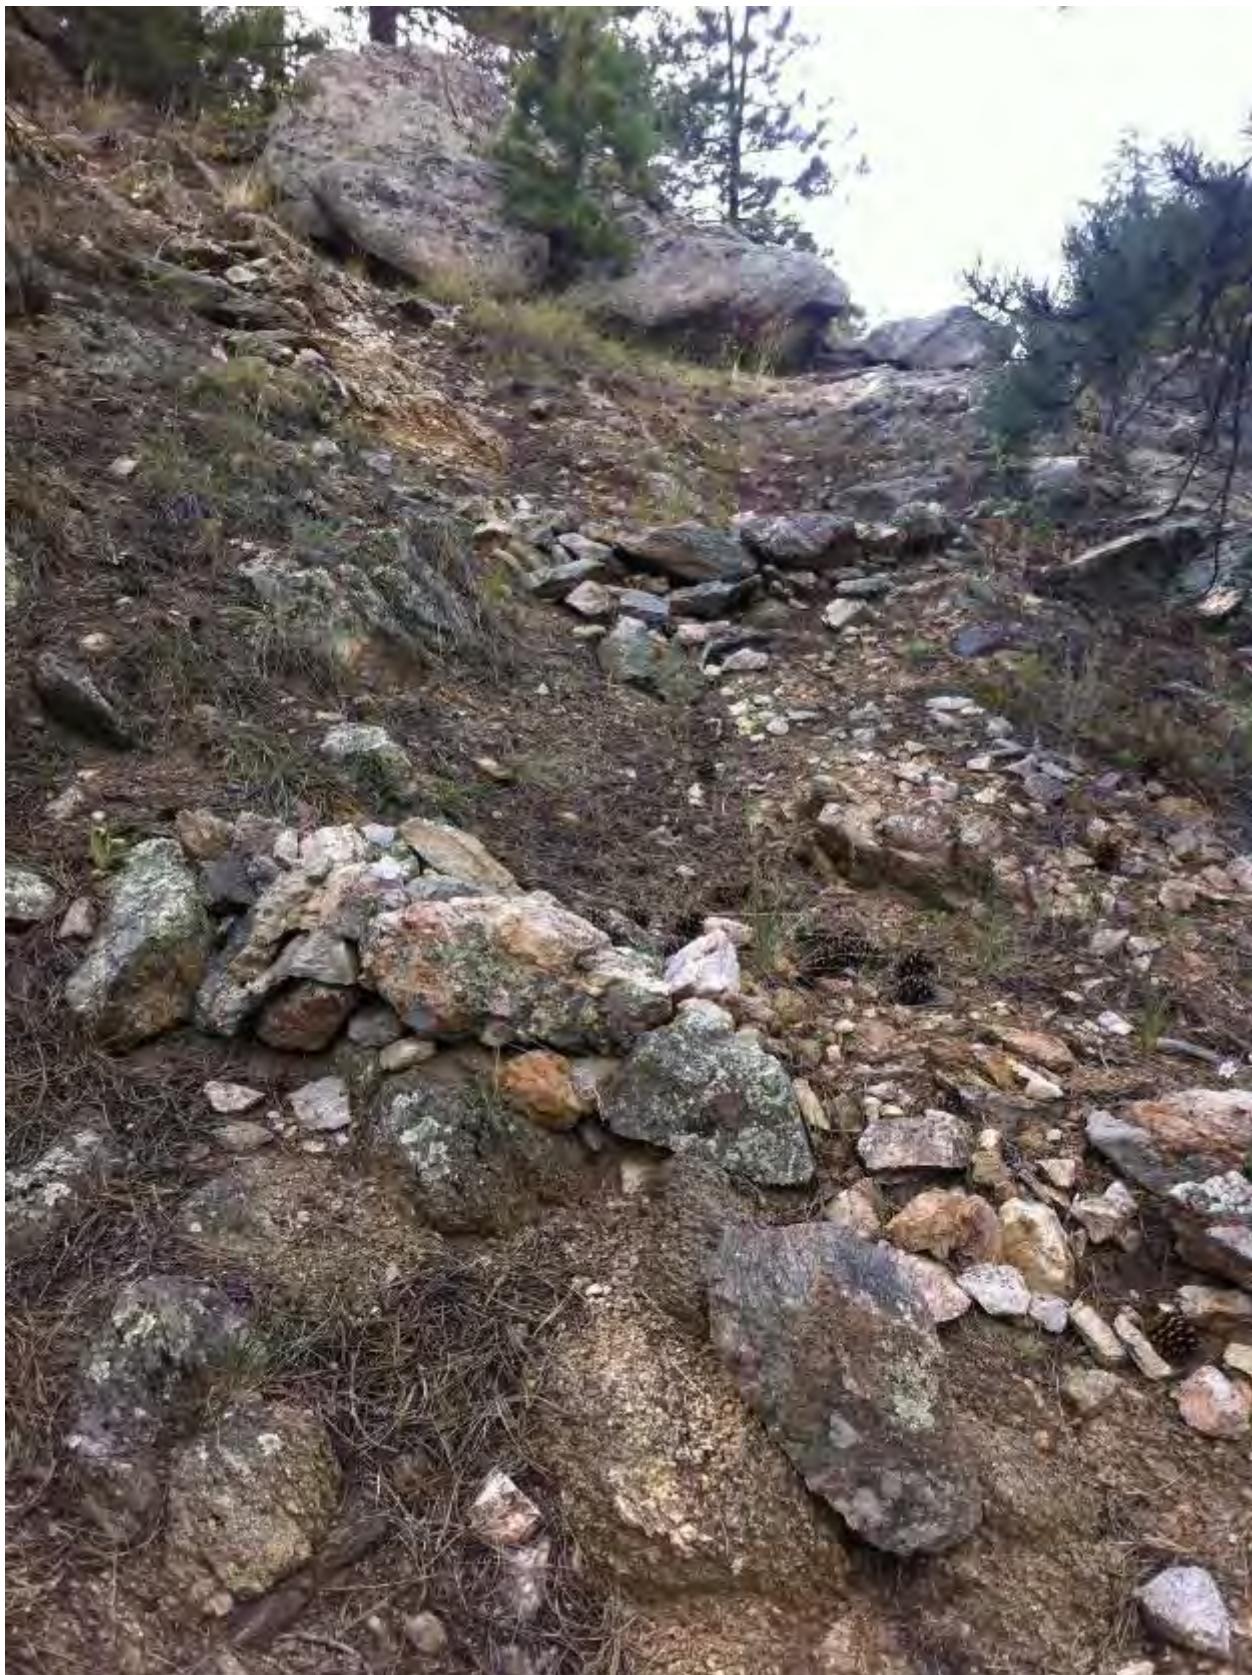
Steep but relatively obscure trail (Section A).

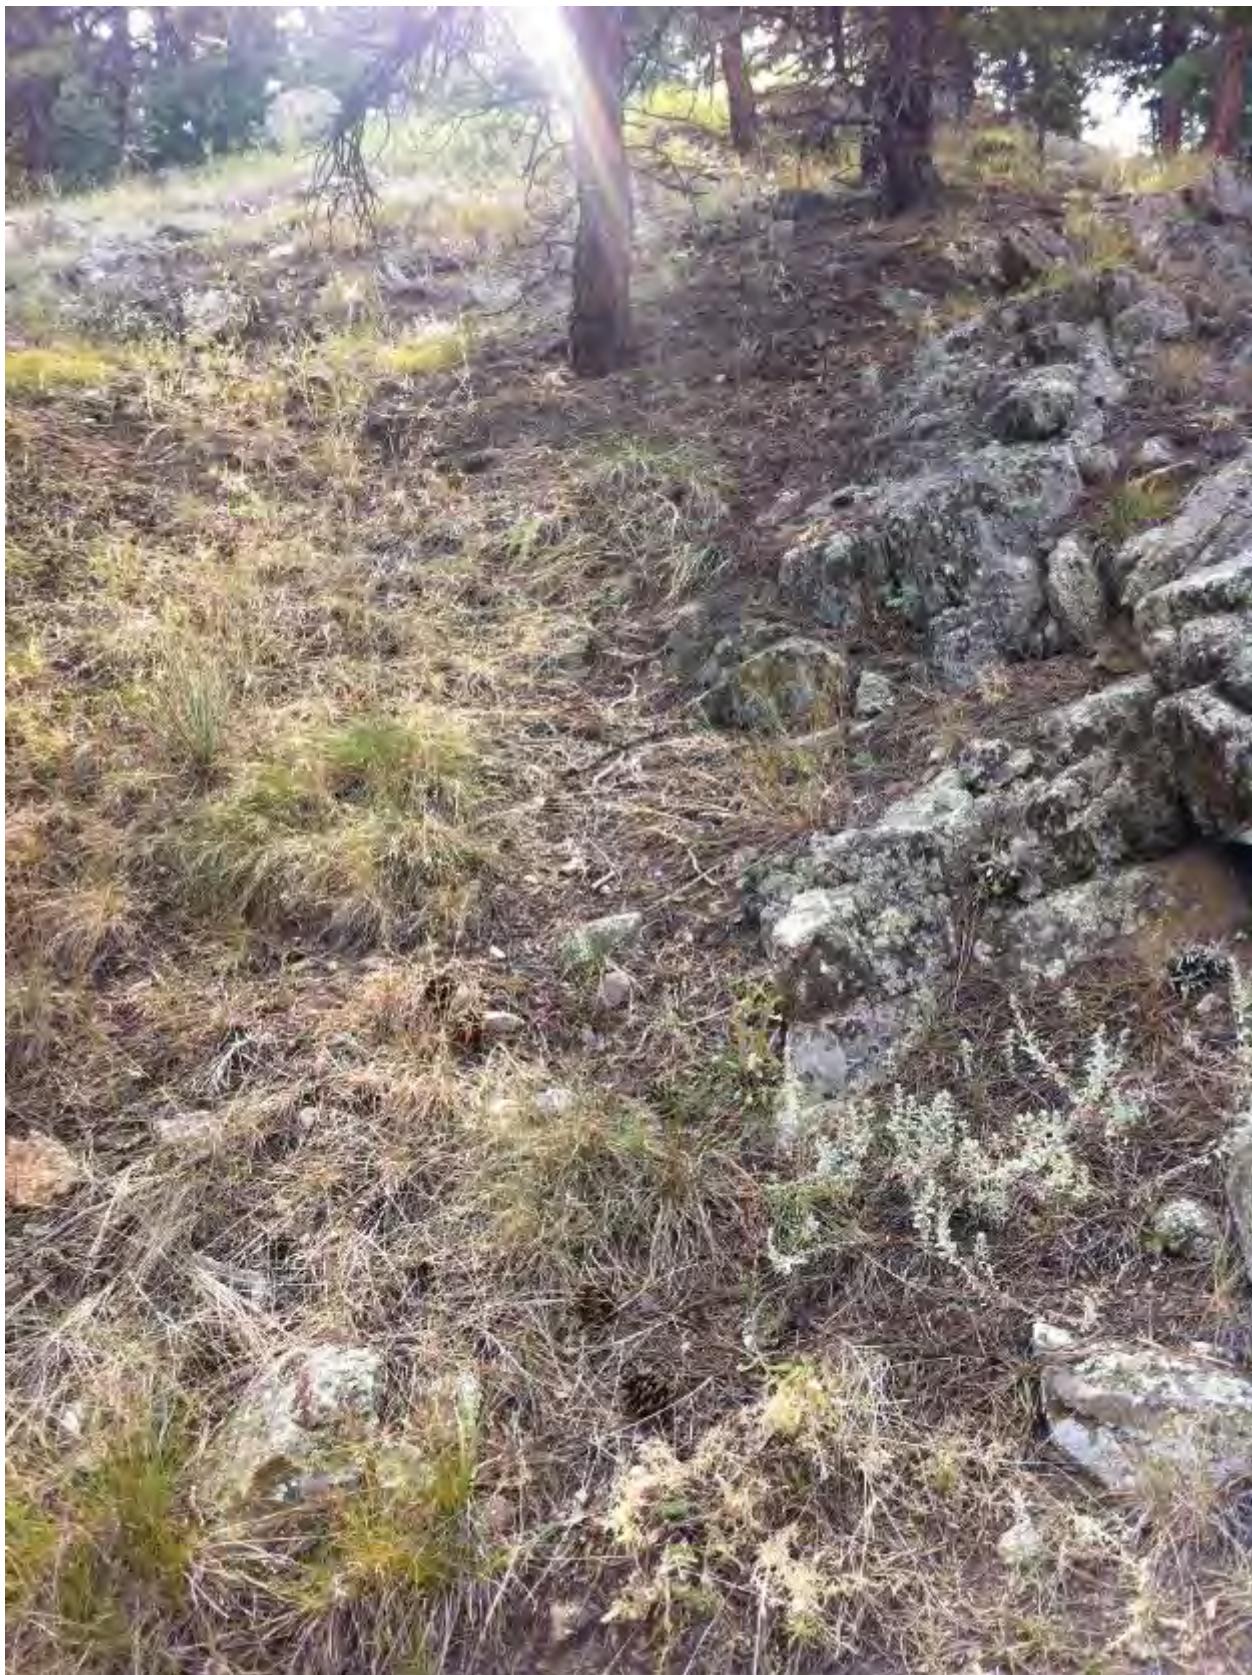
Very steep section of Section A, with water bars holding very well, trail has lots of sediment deposition on top of it.

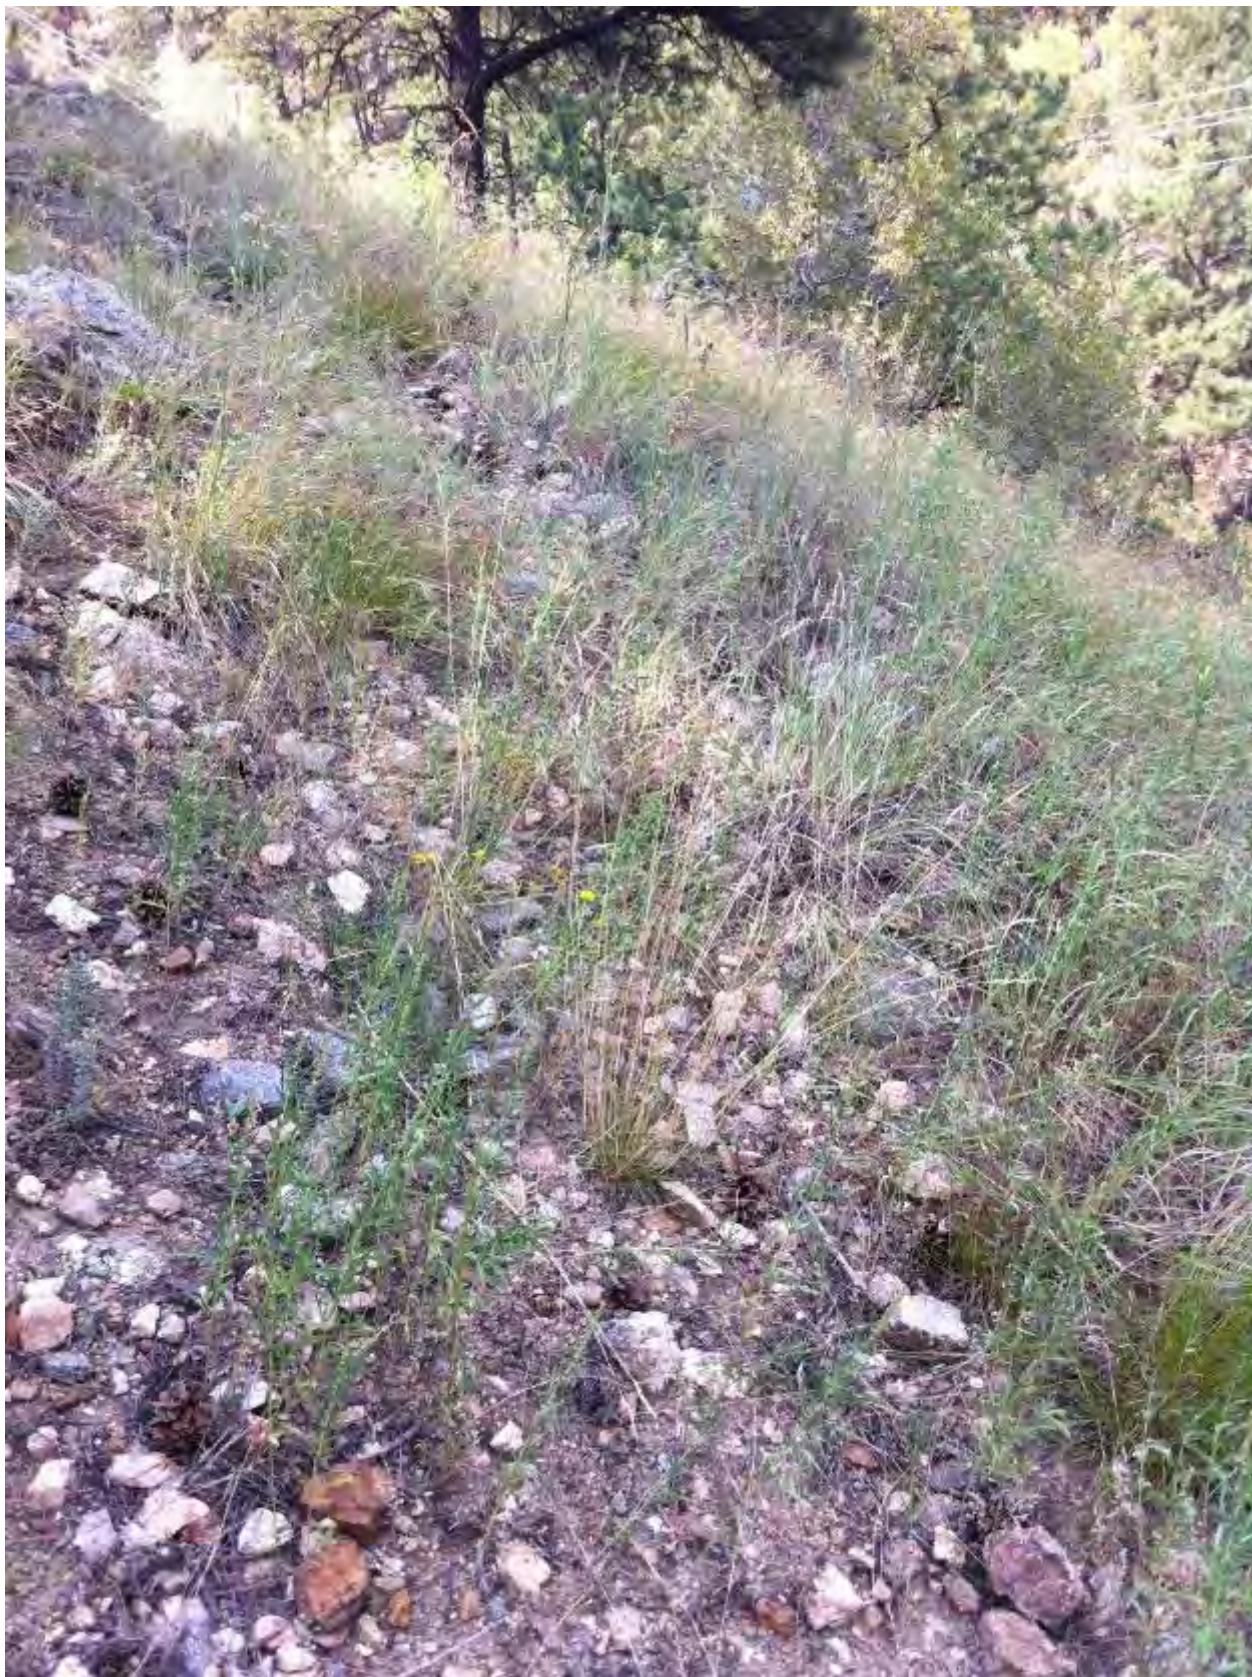
Section A, lower most section near 4-mile canyon access point, is very well vegetated, and totally obscure.

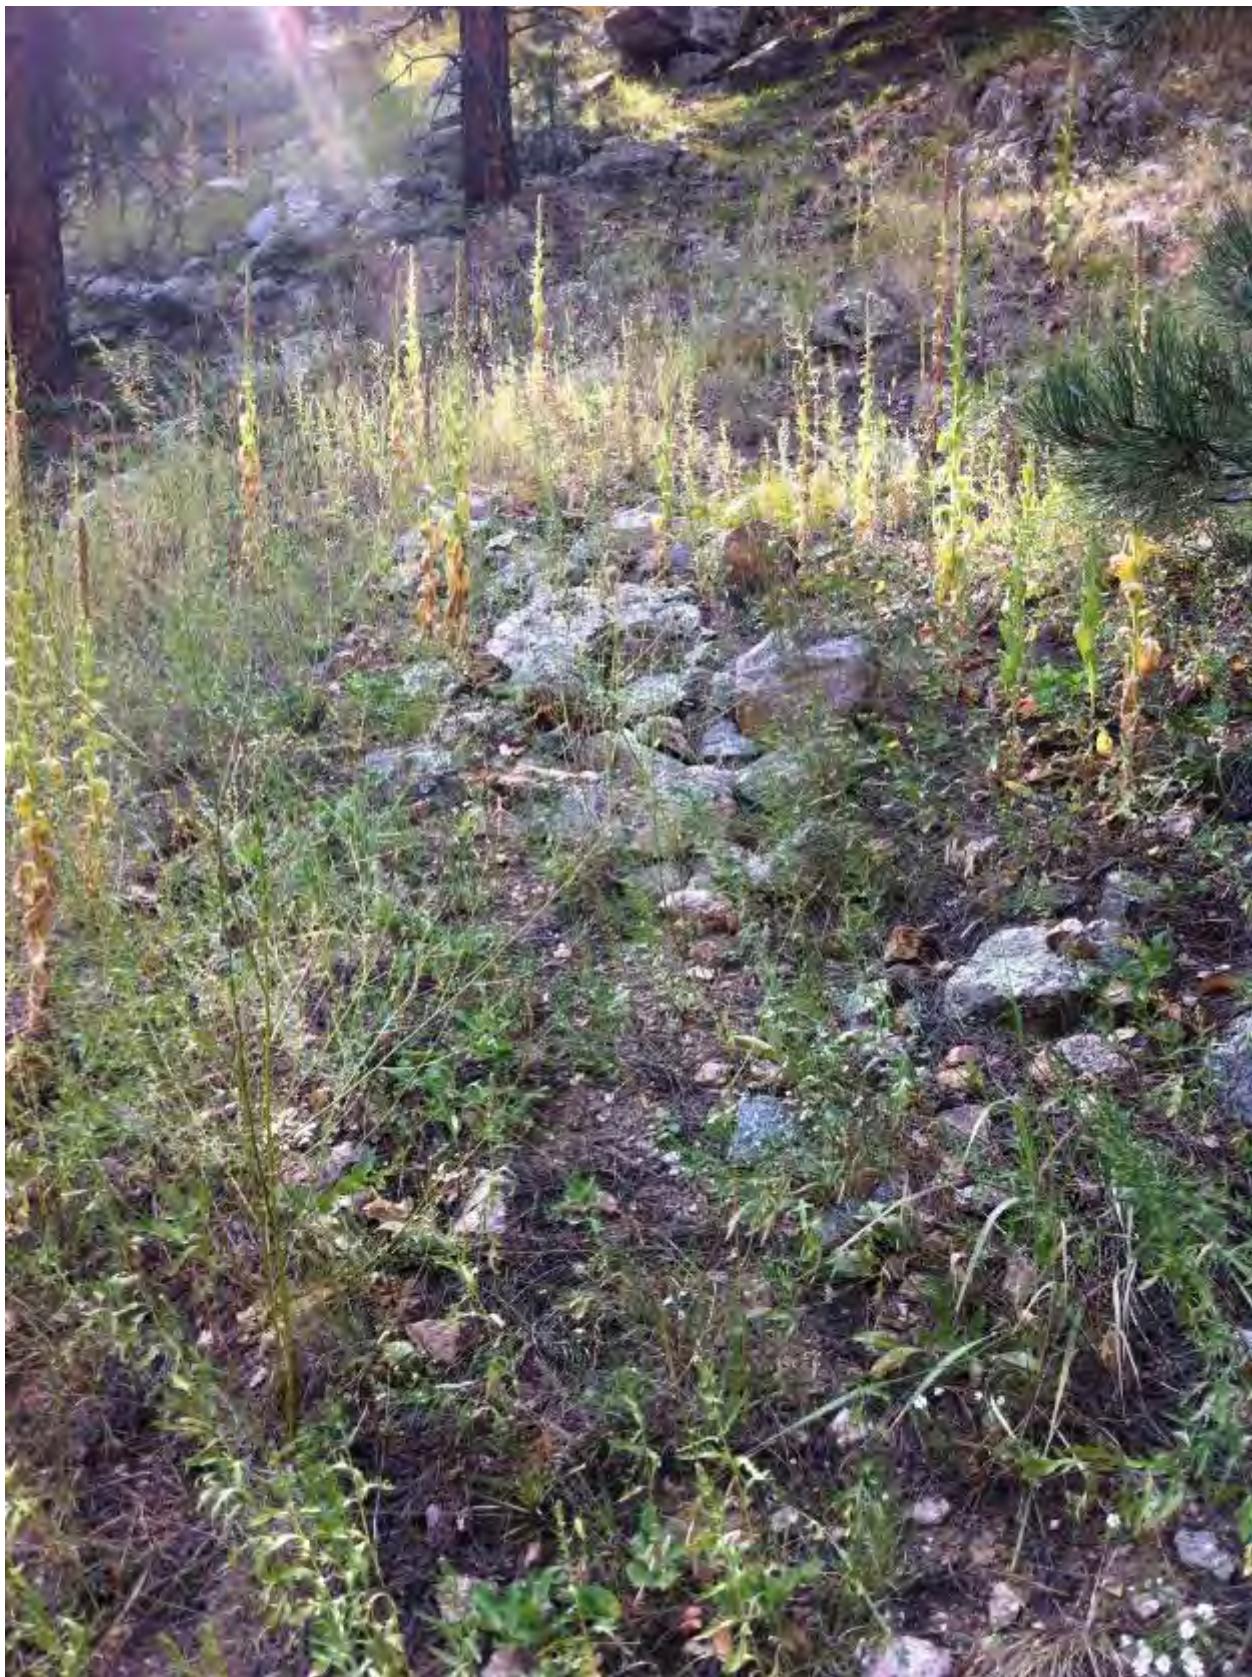
Well vegetated part of the lower part of Section A.

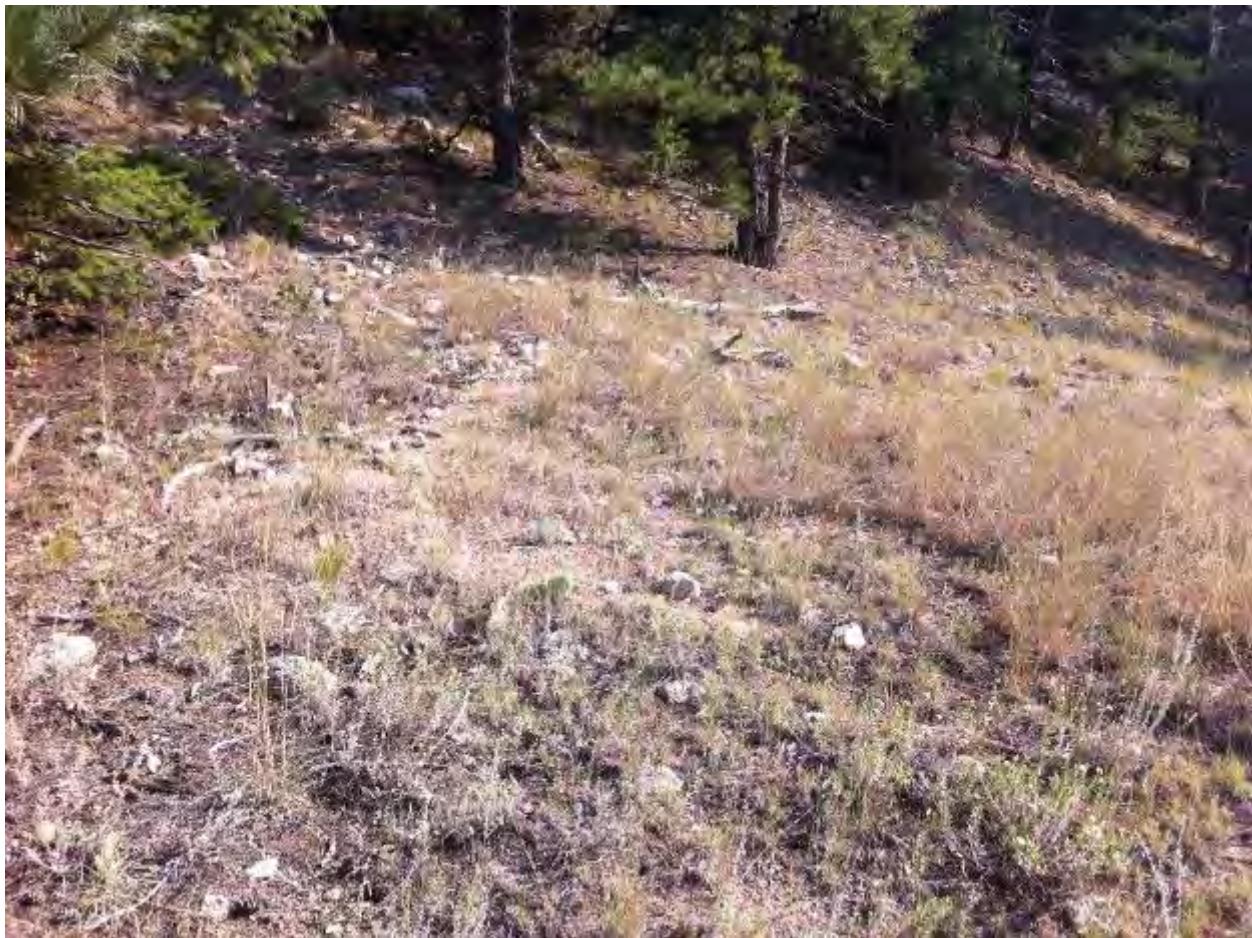
Section A at 4 mile canyon, very well obscured, and can't really tell where the trail used to go for the most part.

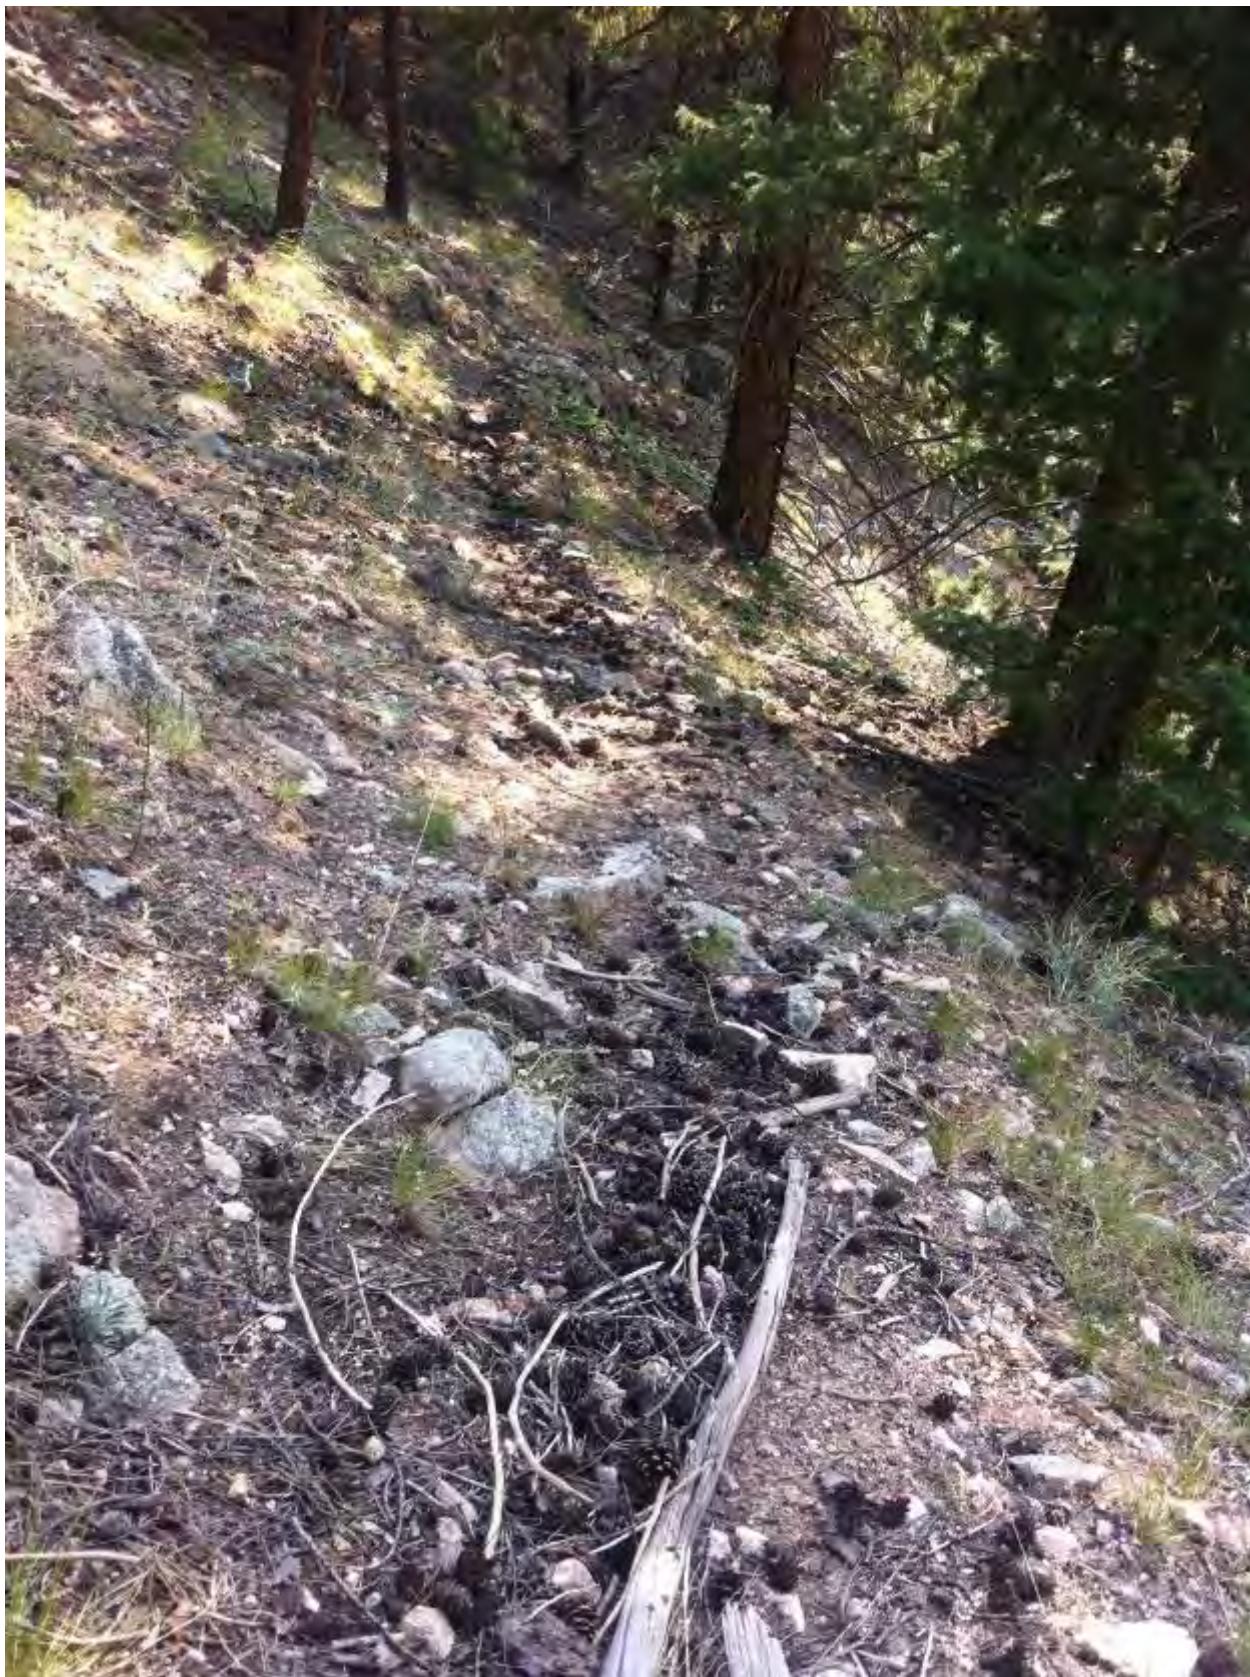
Junction of Social Trail sections A, B and E, not very obvious. Looking west.

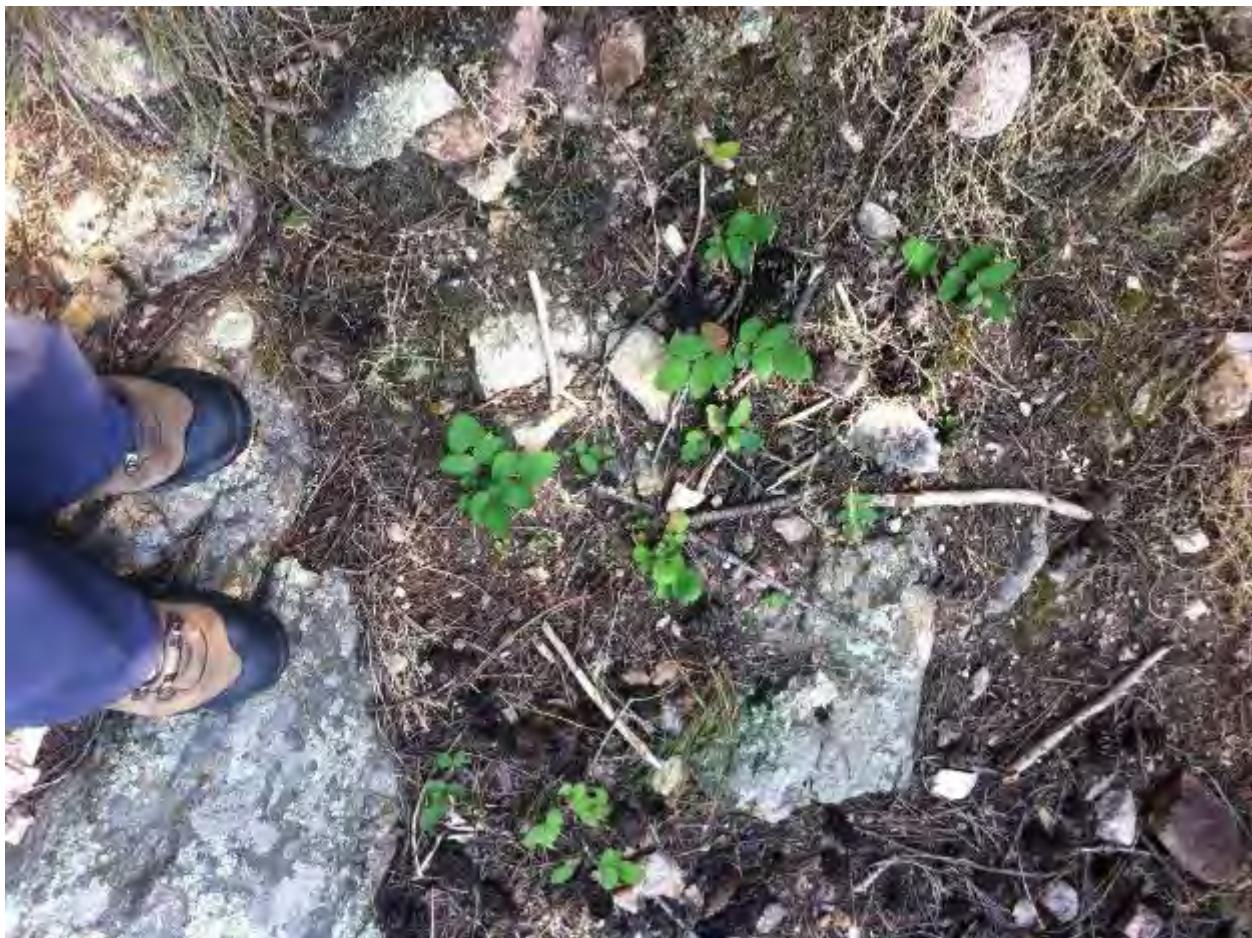
Section E, east end, nicely obscured by woody debris.

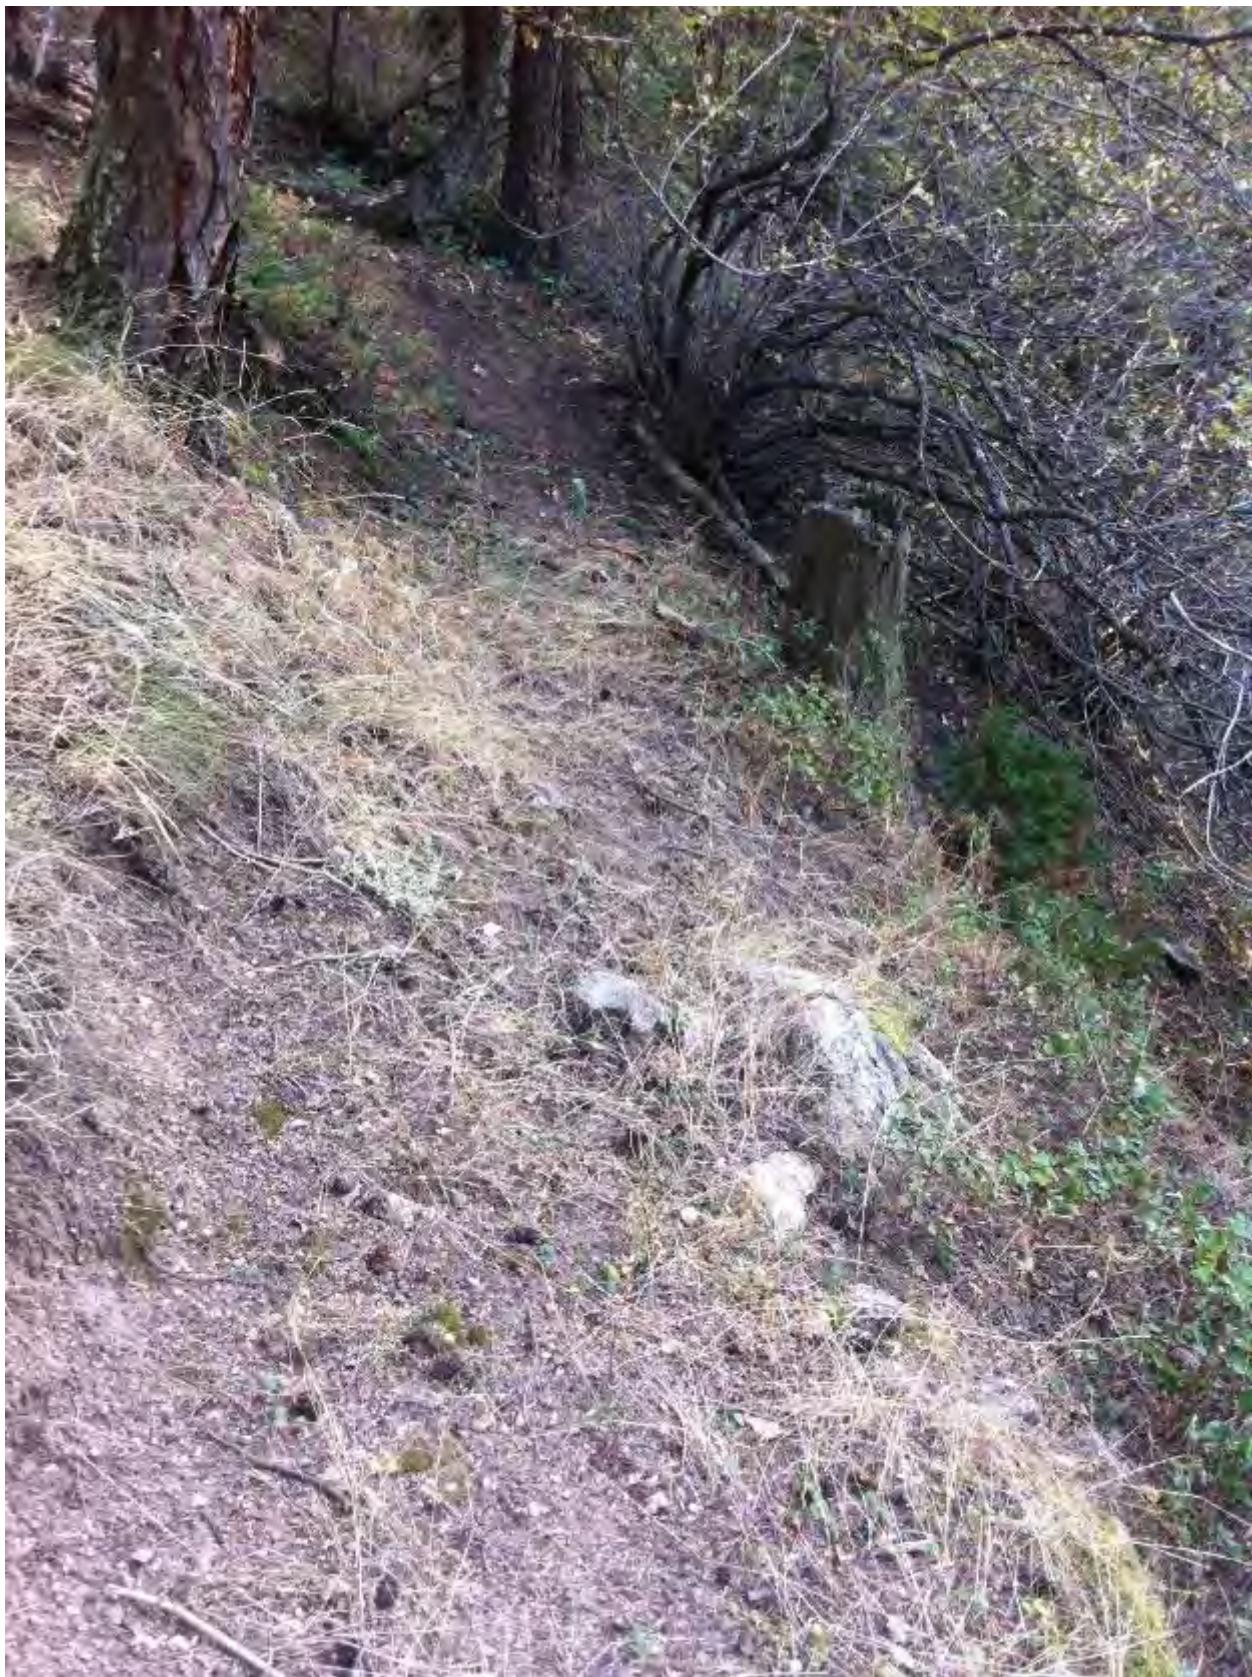
Section E. East end, Oregon grape growing right out of the old trail

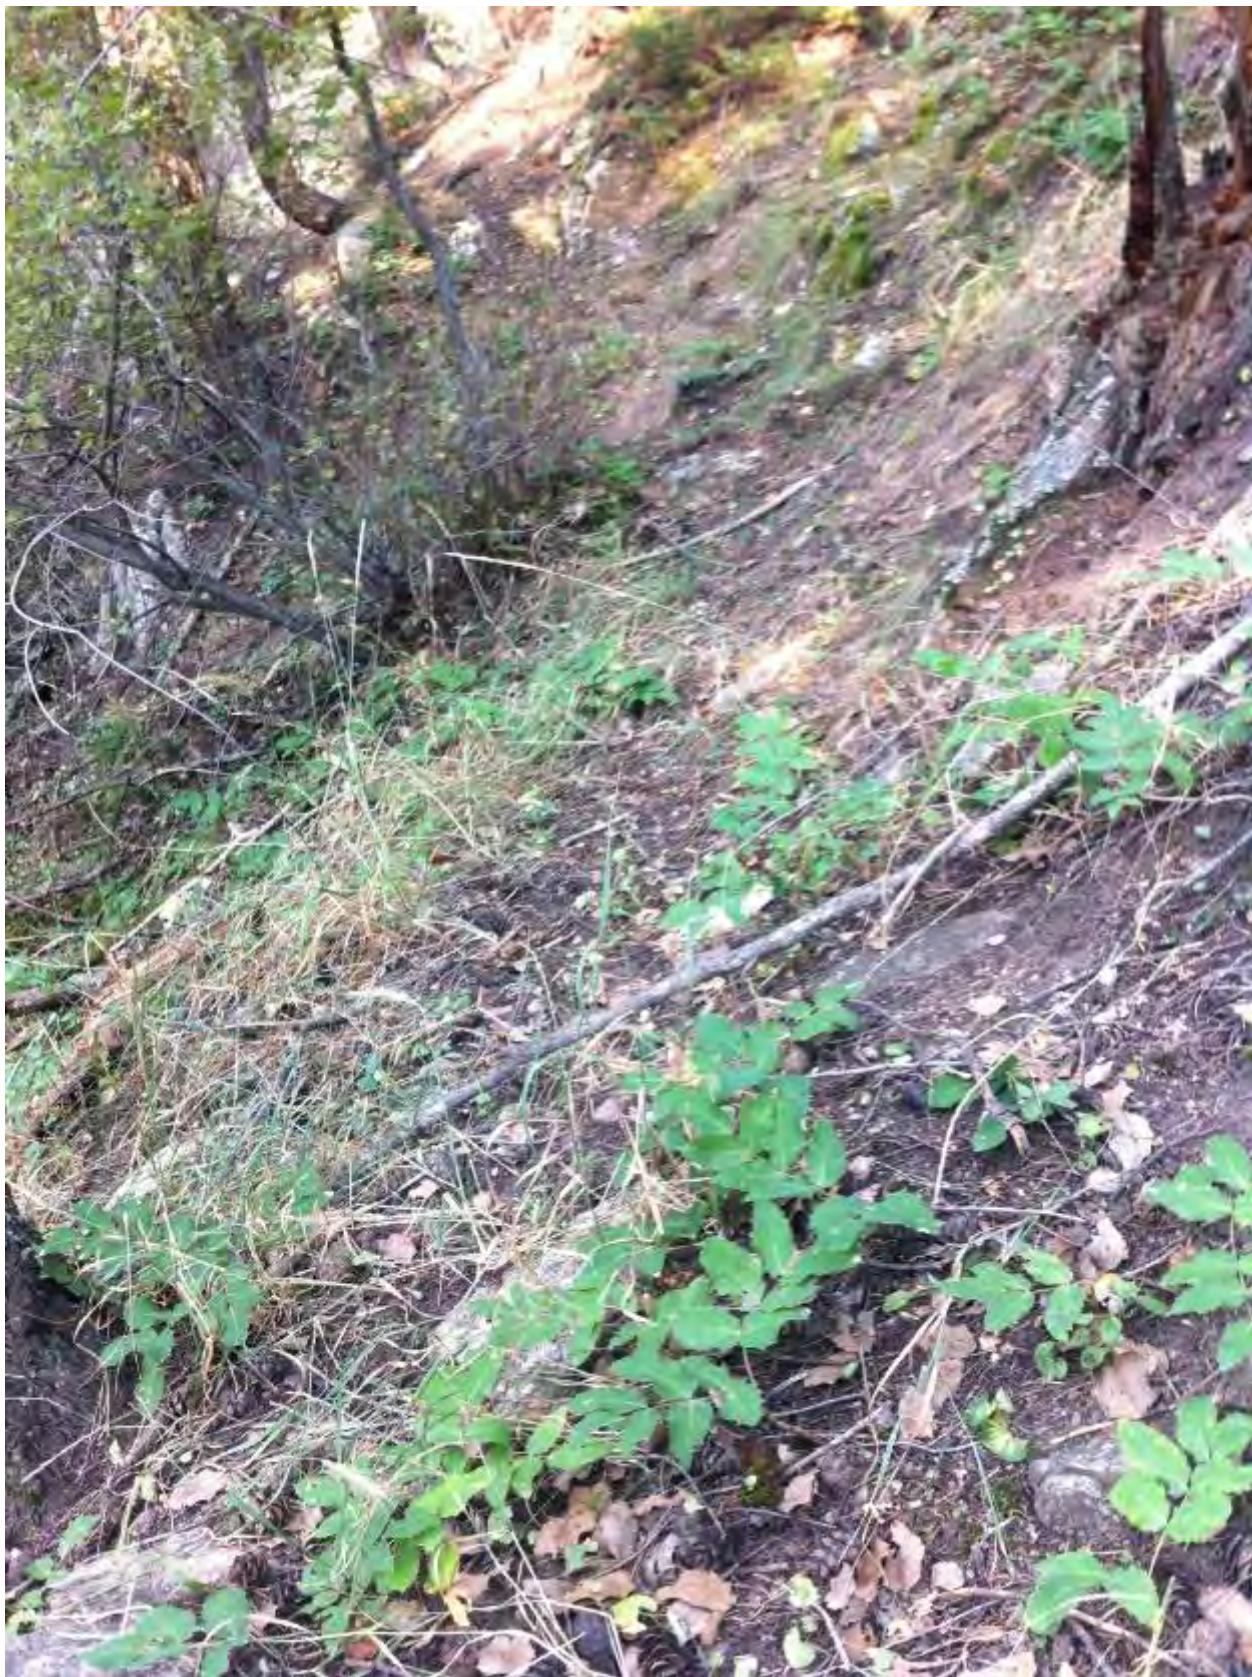
Section E, east end, approaching creek, very well vegetated.

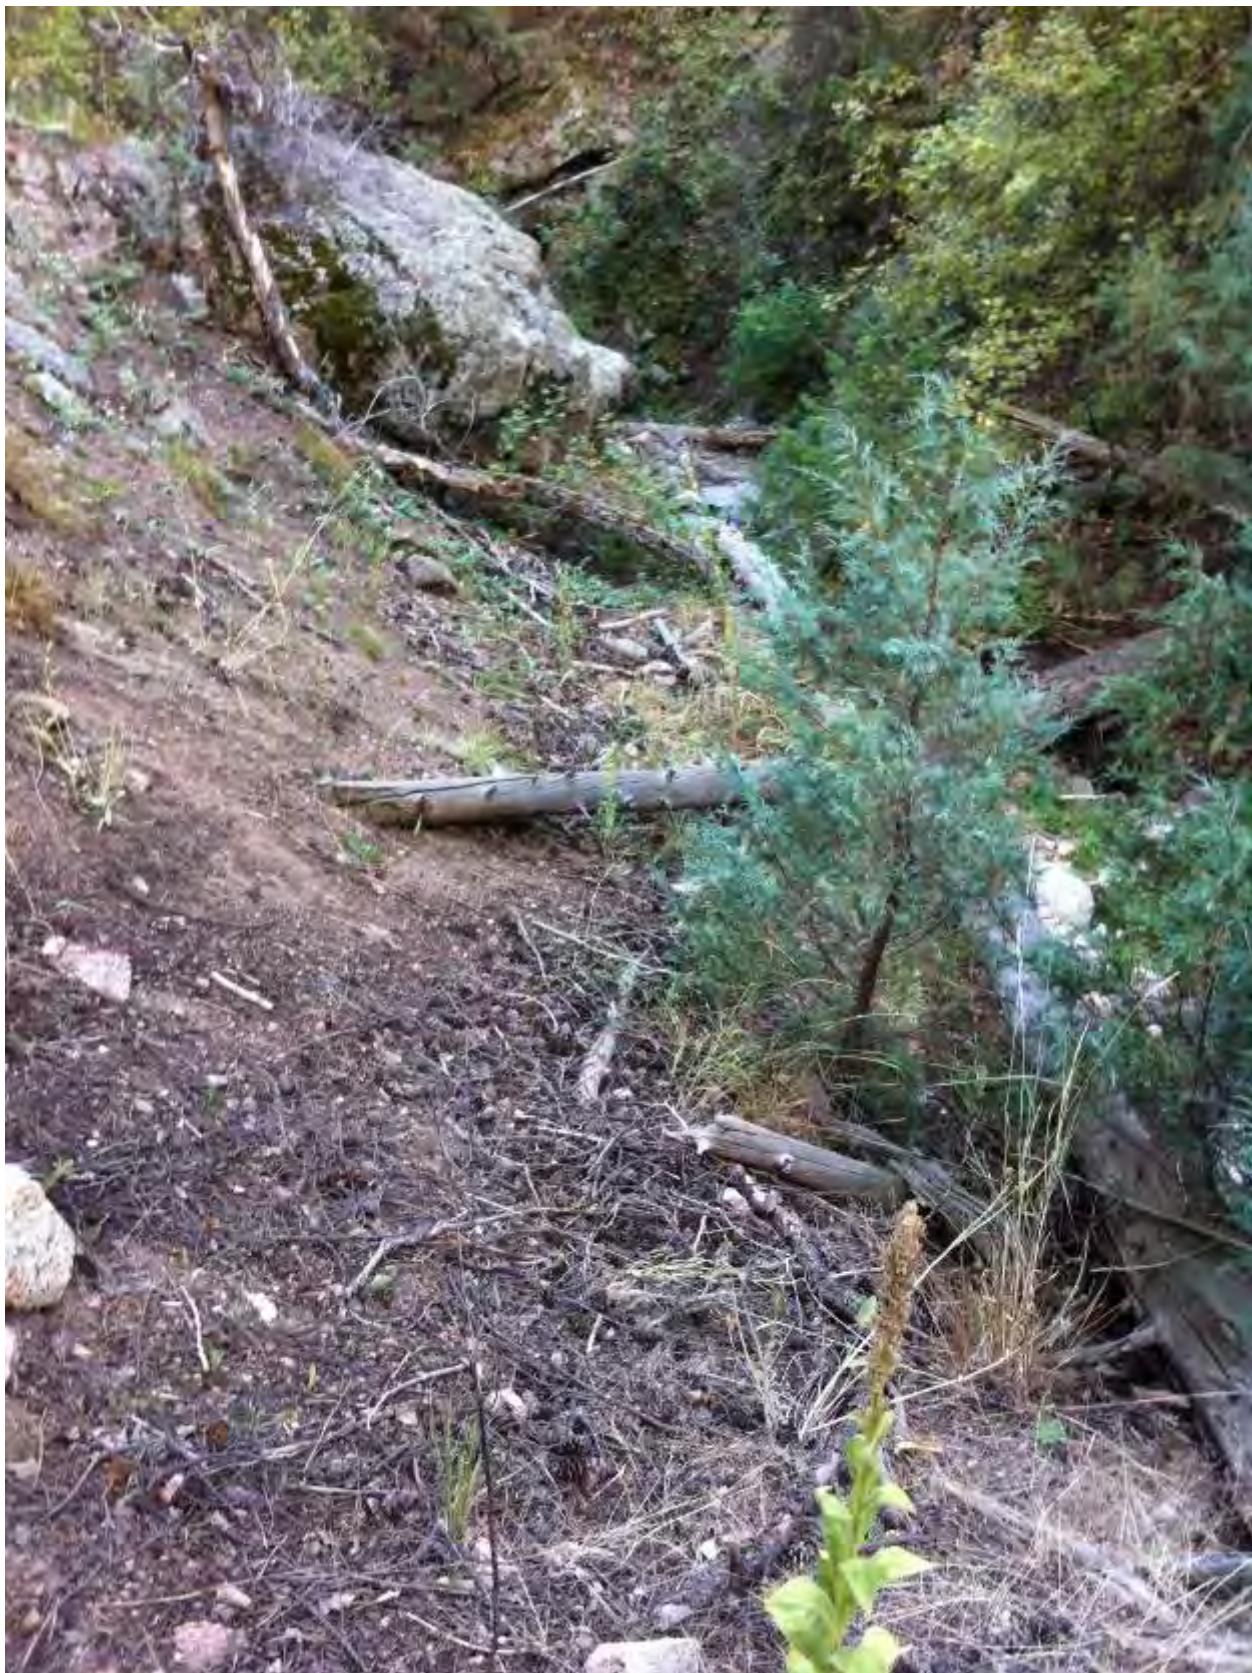
Section E, approaching creek at east end, Oregon grape growing right out of the trail.

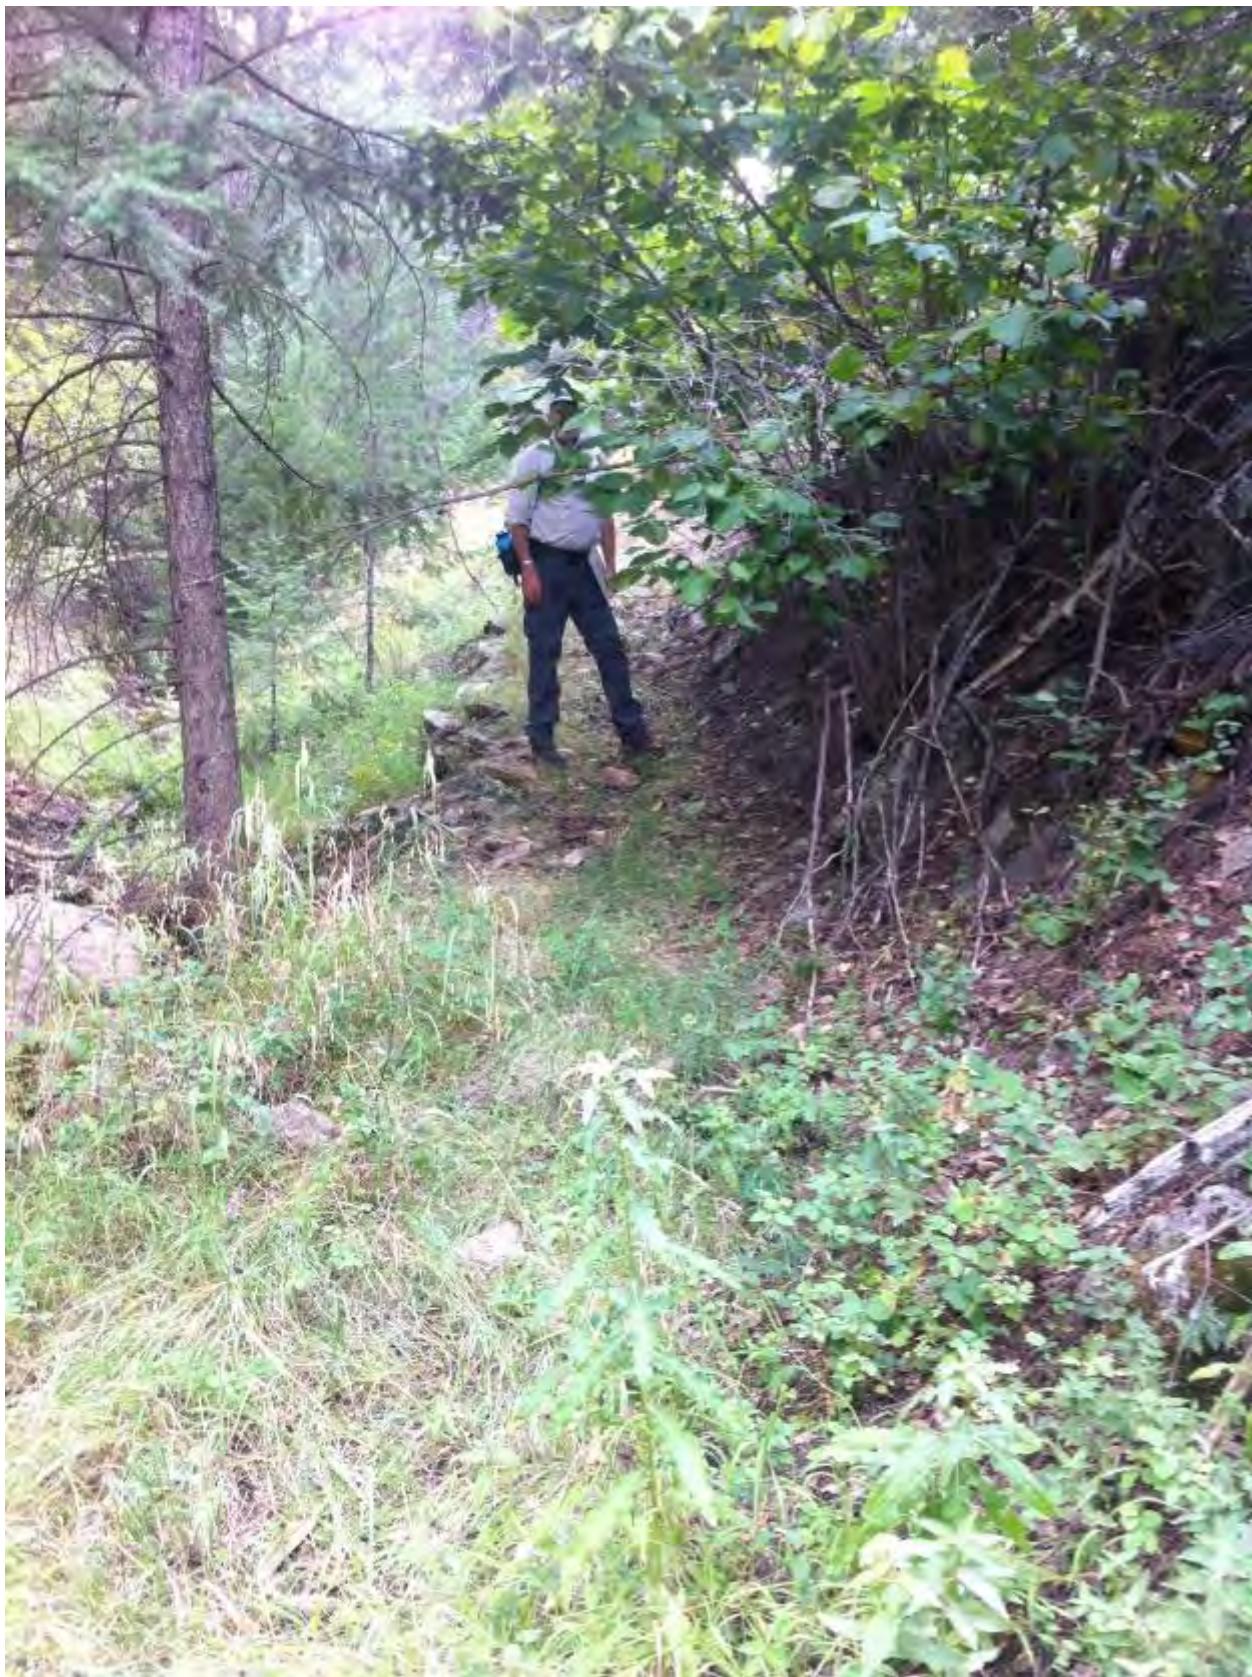
Section E, very nice water bar made with a combination rock and log, holding well, allowing vegetation to build up on the uphill side.
