Monitoring WRV Projects – What We Learned During 2015  
September 28, 2015  
Laura Backus, Alan Carpenter, Todd Sanford

## **Background and Purpose**

## WRV QUICK MONITOR D R A F T

**Project Name:** Berthoud Pass Restoration

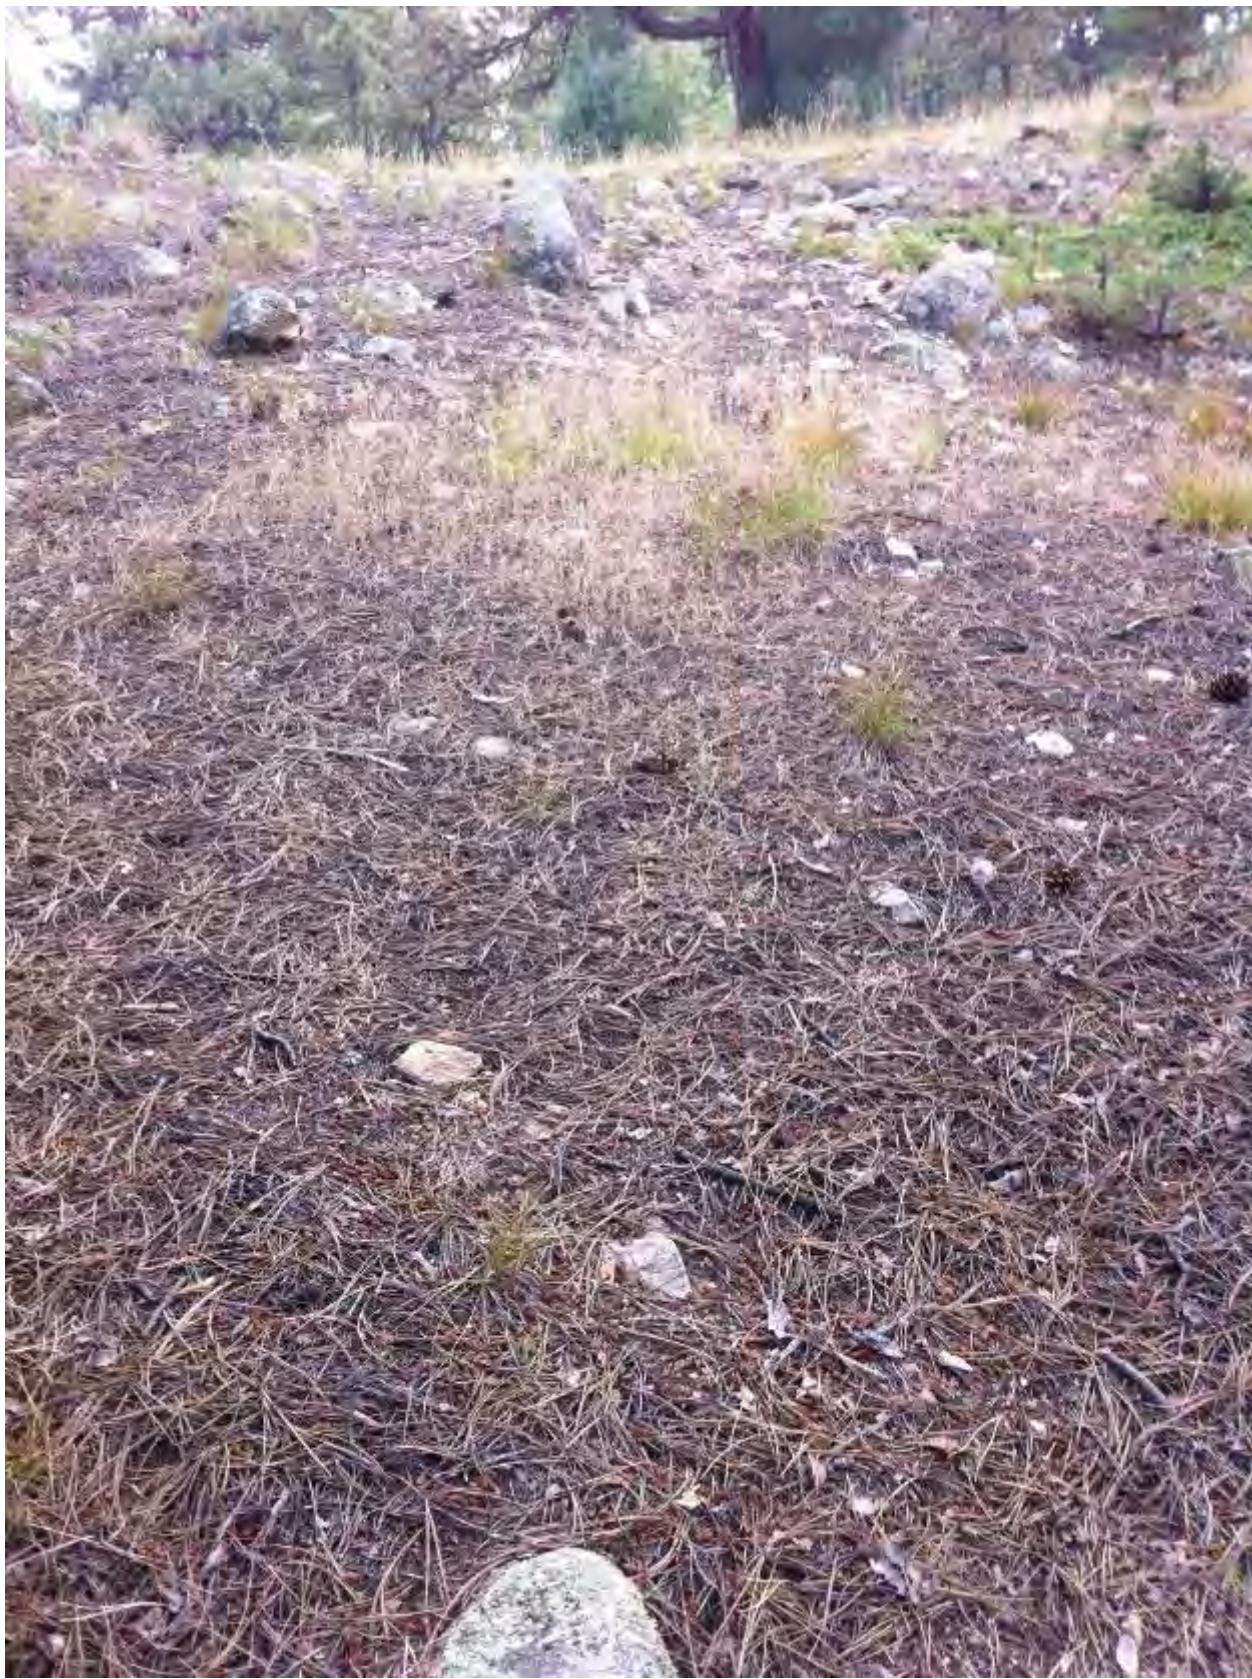
Section D very well obscured by litter.

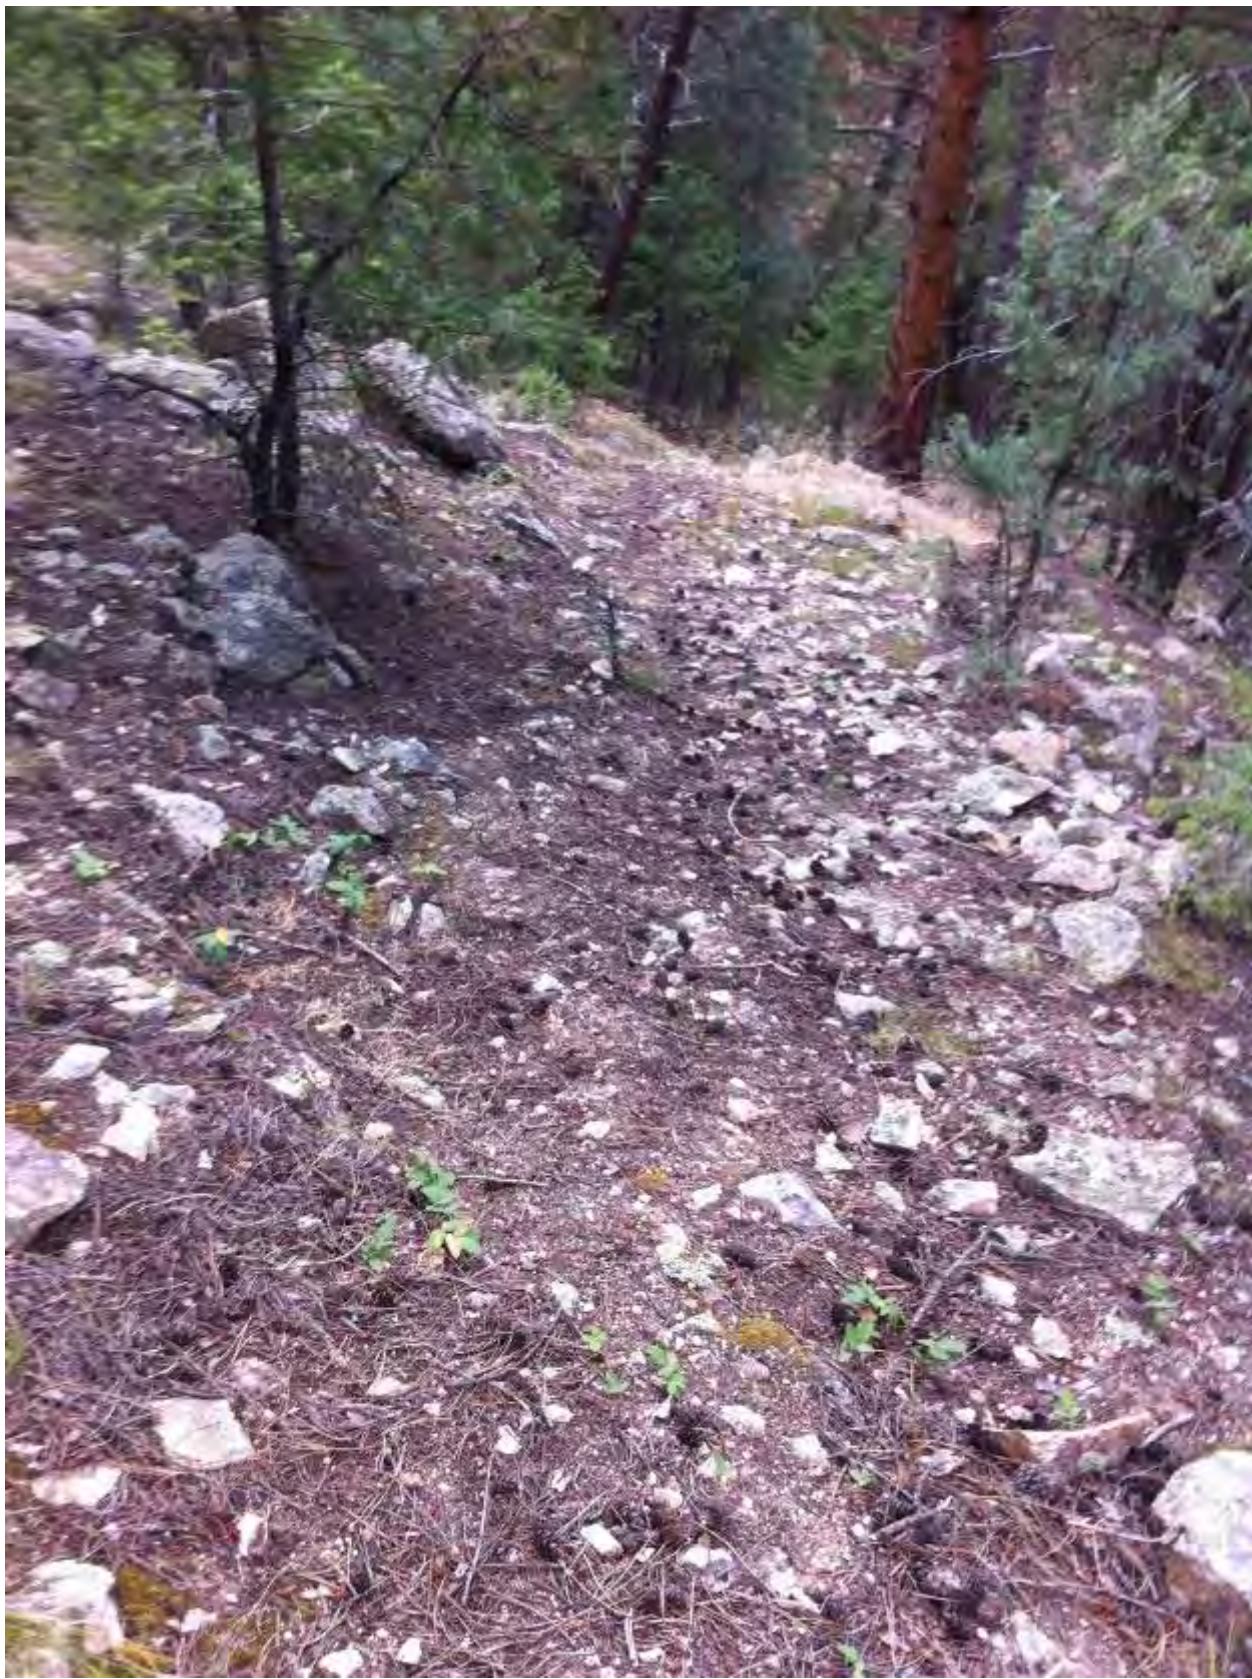
Section D very well obscured by rocks and woody debris.

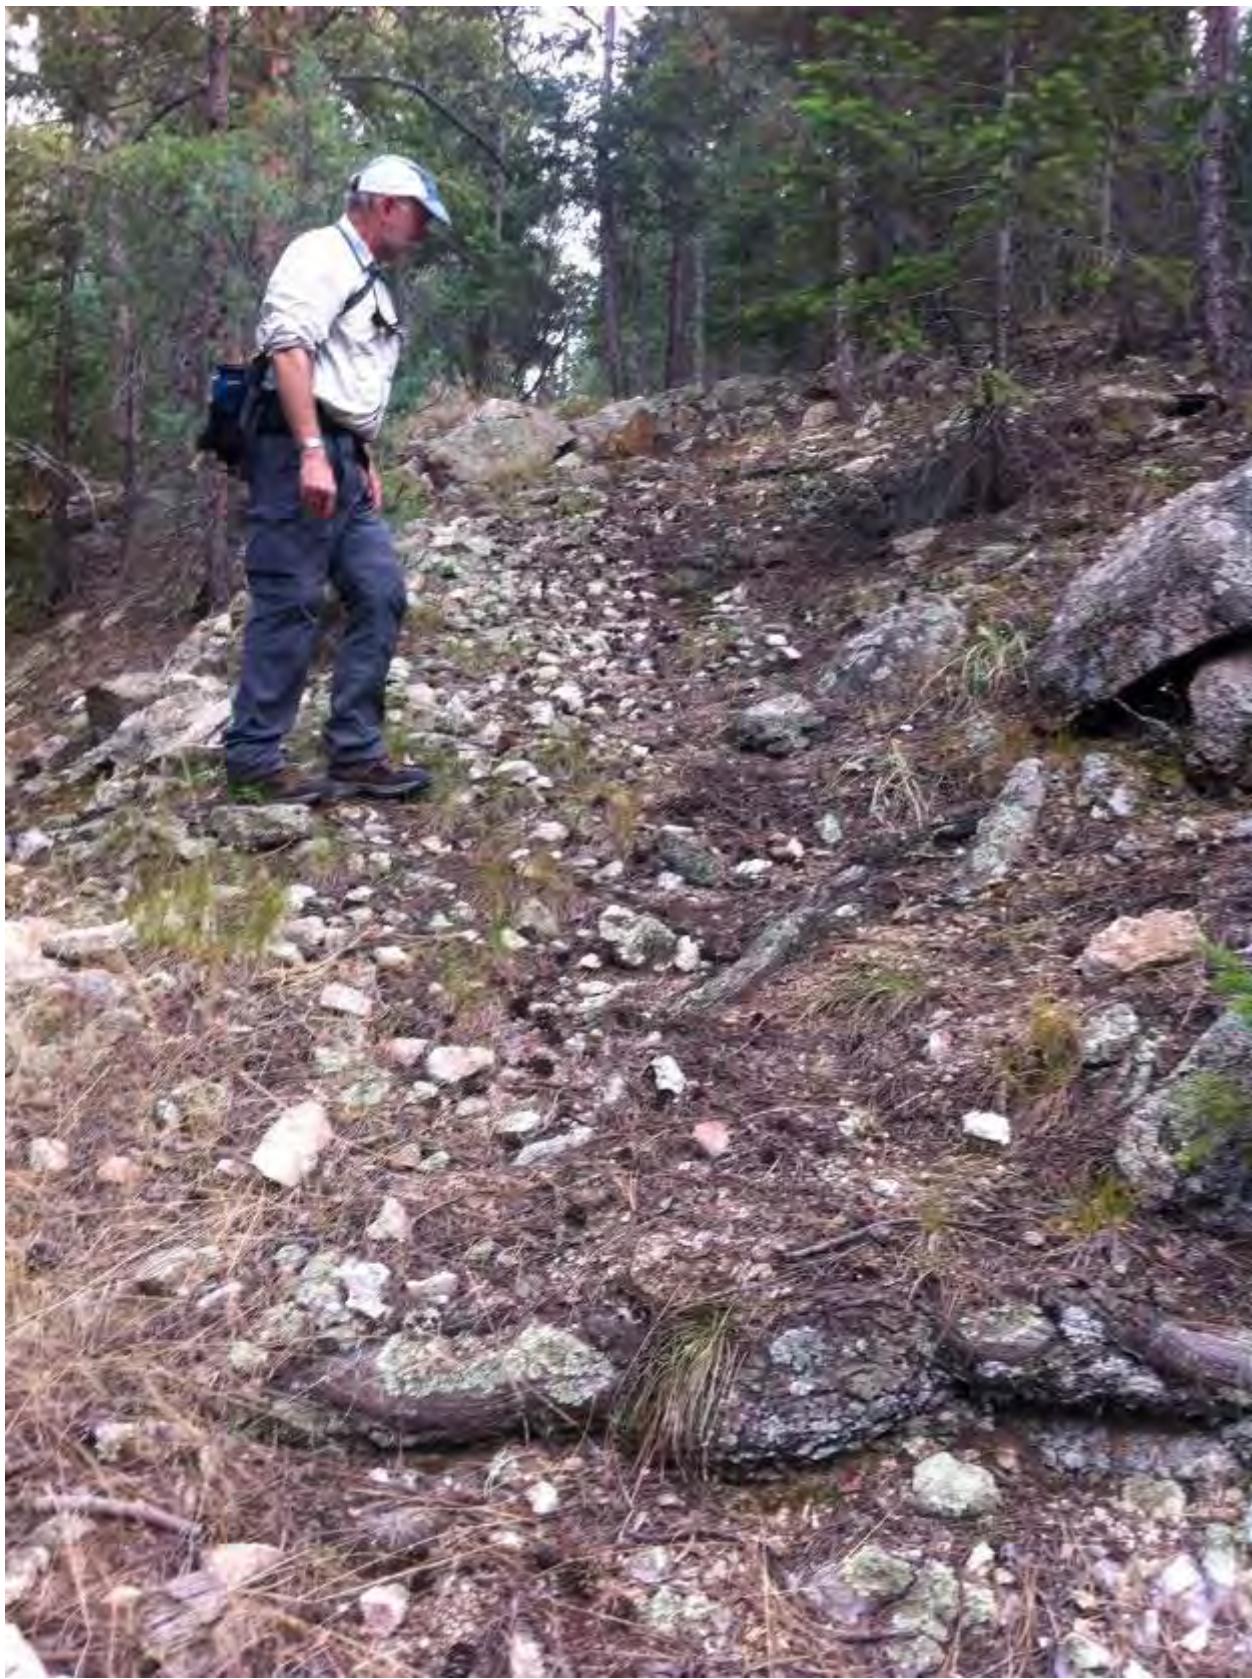
Section D, nicely obscured by well bars and rocks and woody debris.

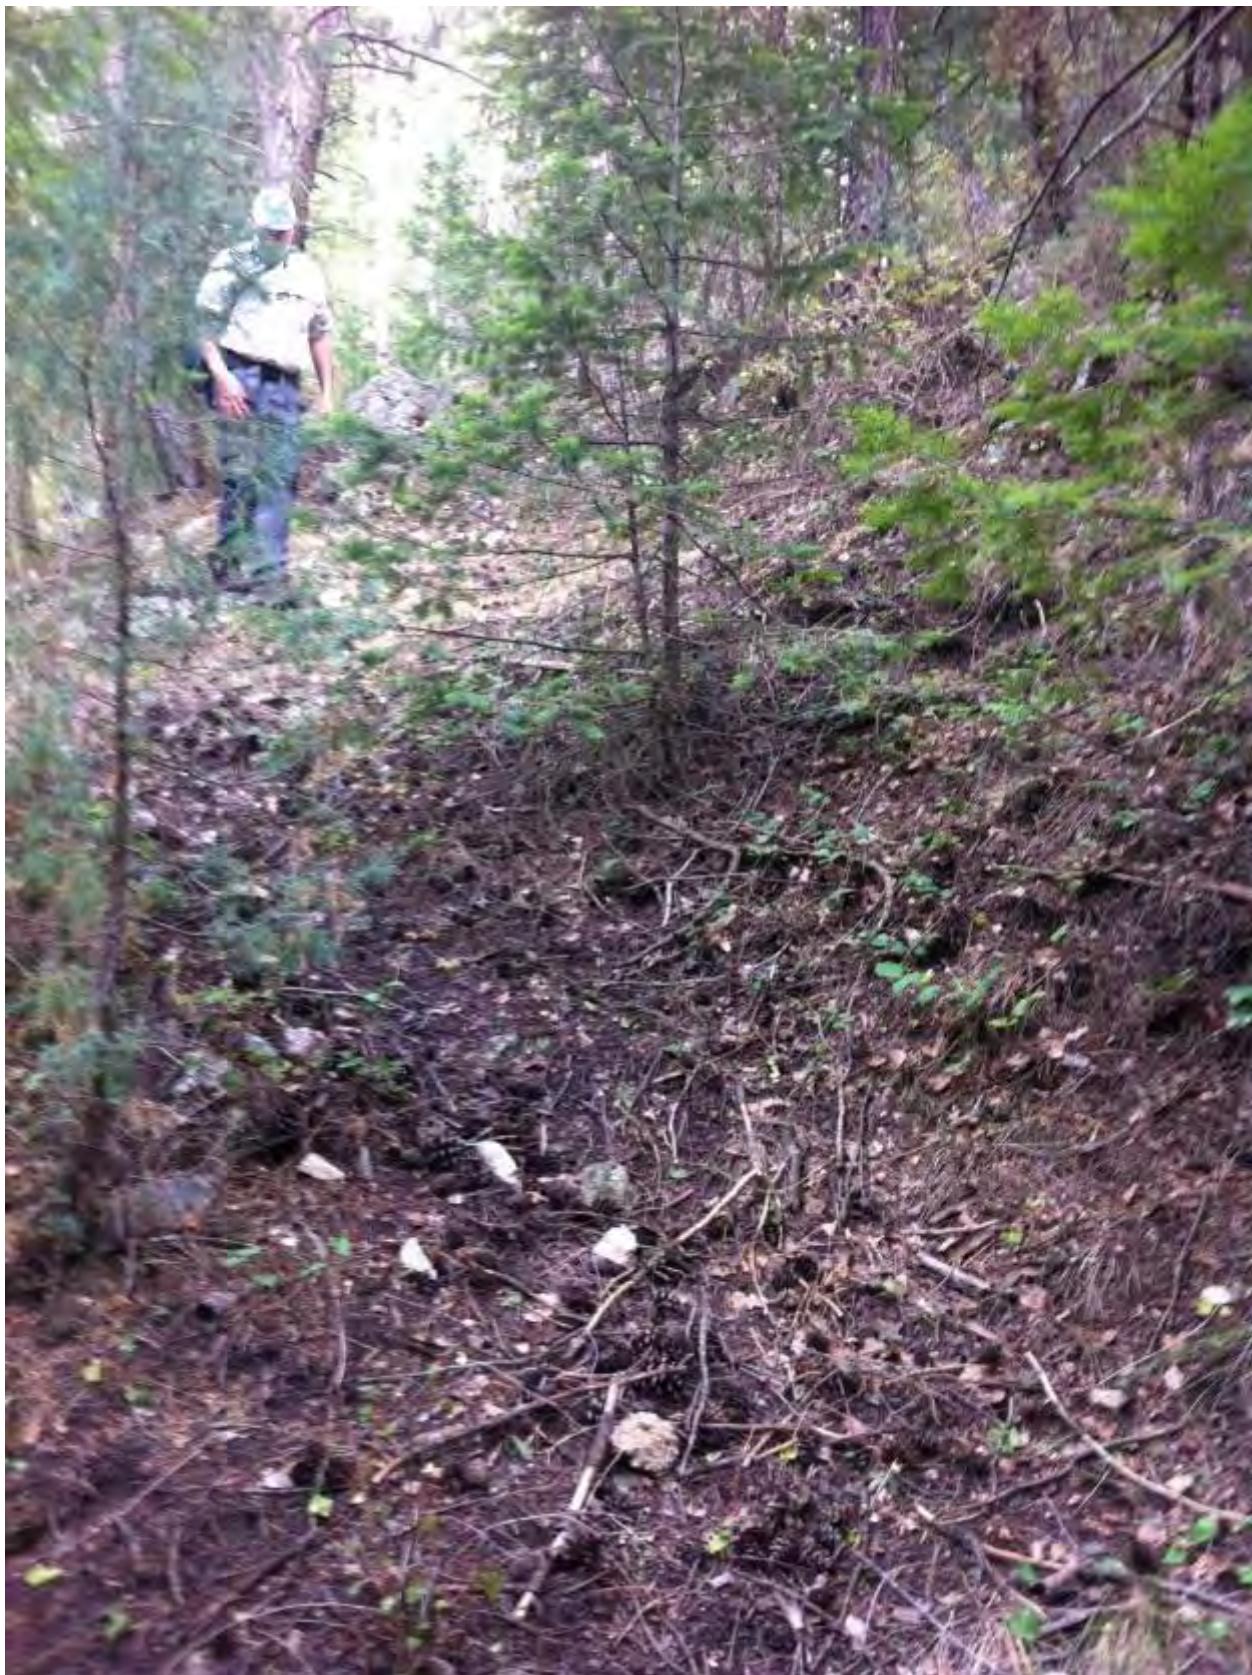
Section D looking more like a deer trail than a social trail, again woody debris and scattered rocks are working well.

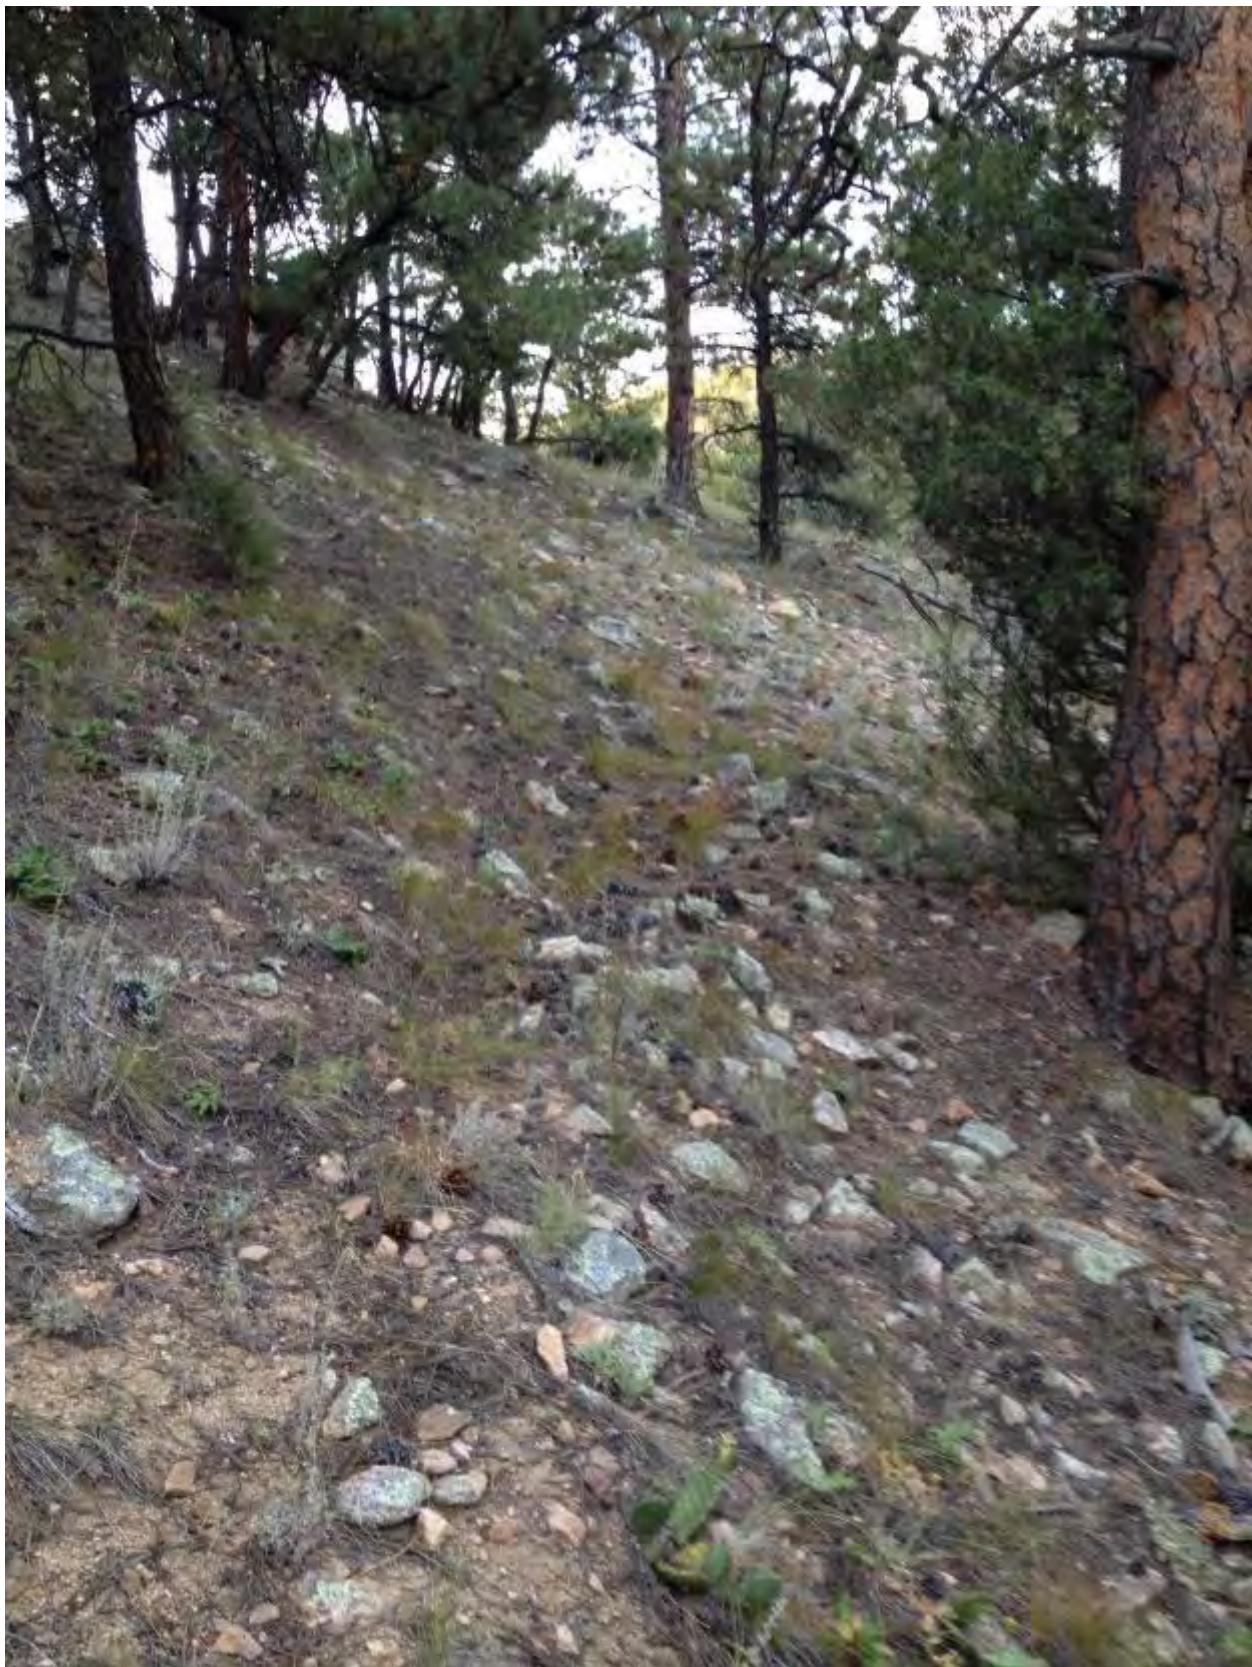
Section F, steep section between creek and new trail, well obliterated by rocks and debris.

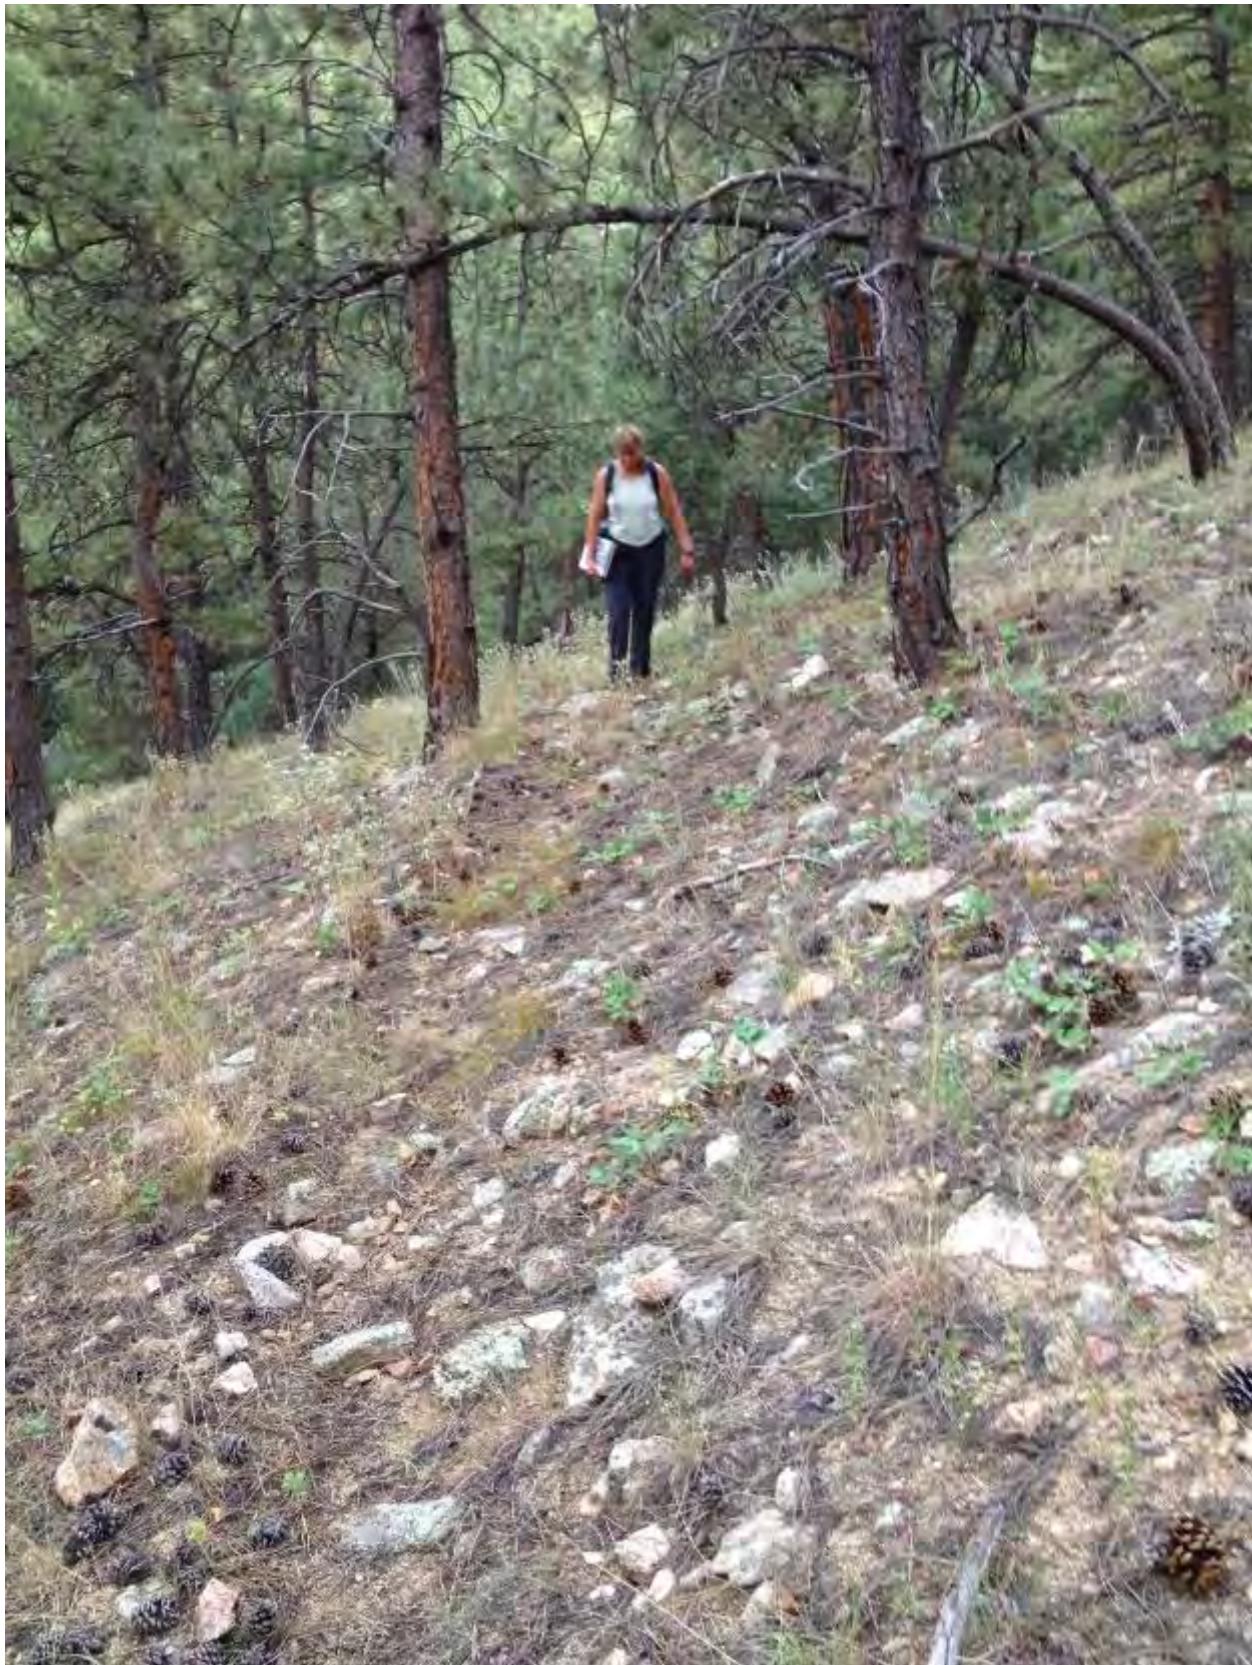
Am I on the trail? Not sure! (Section F)

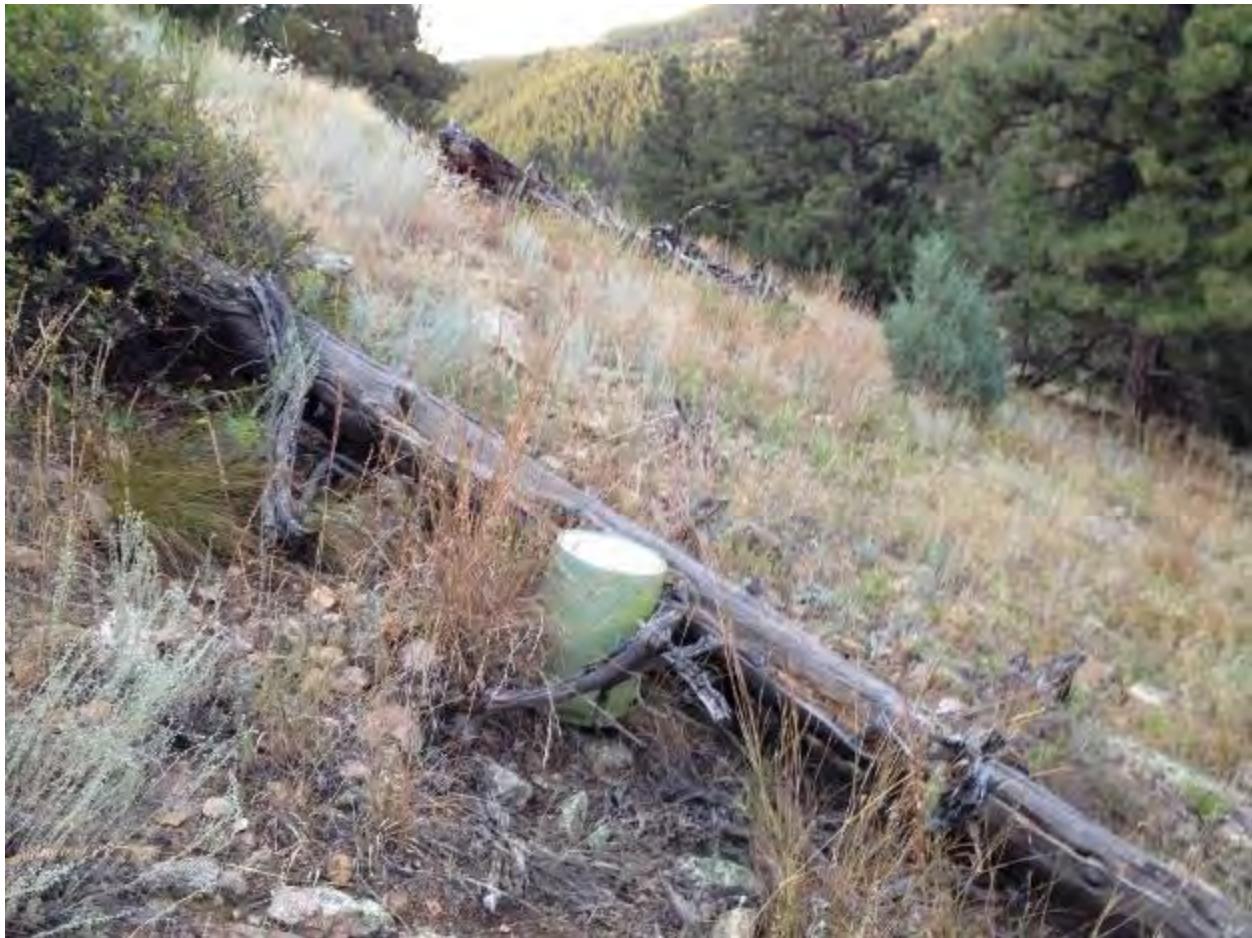
Section F, maybe this was part of the water bar?

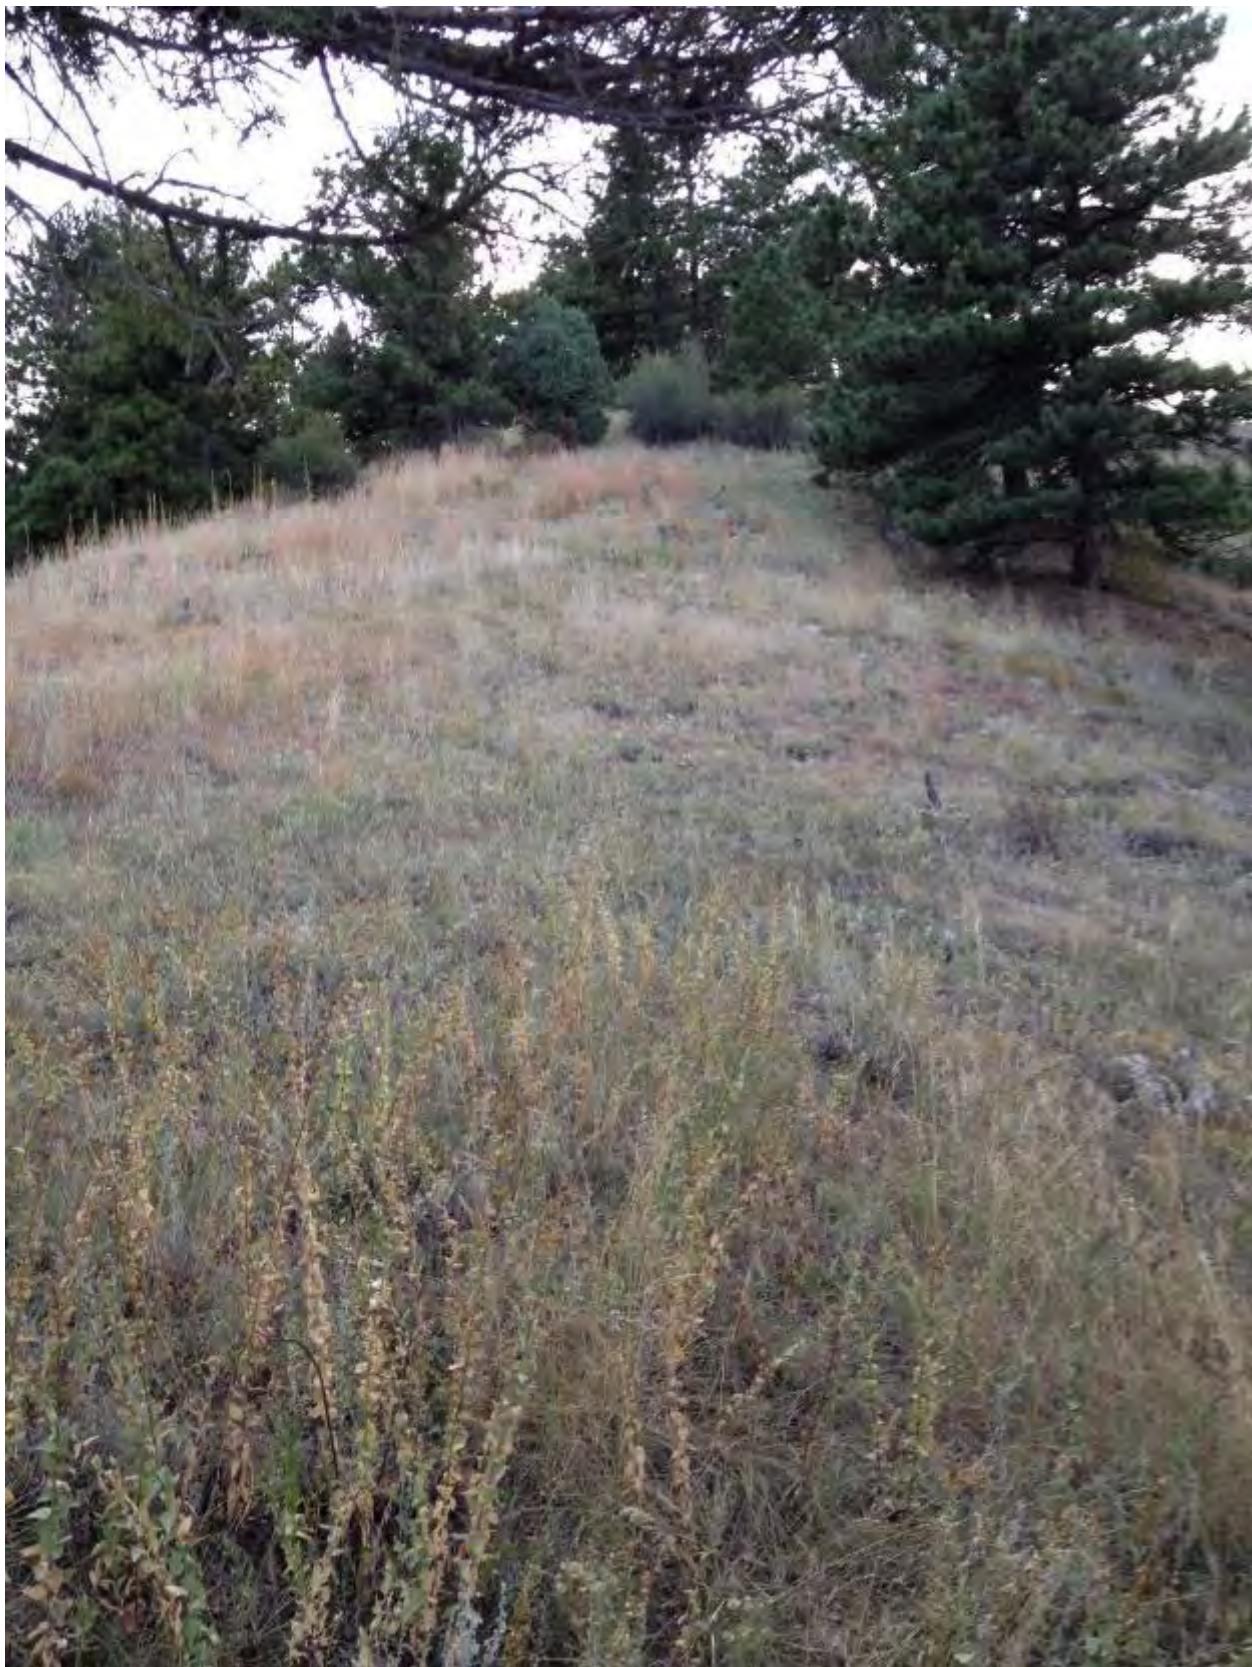
Section F above new trails, well vegetated, difficult to see old social trail.

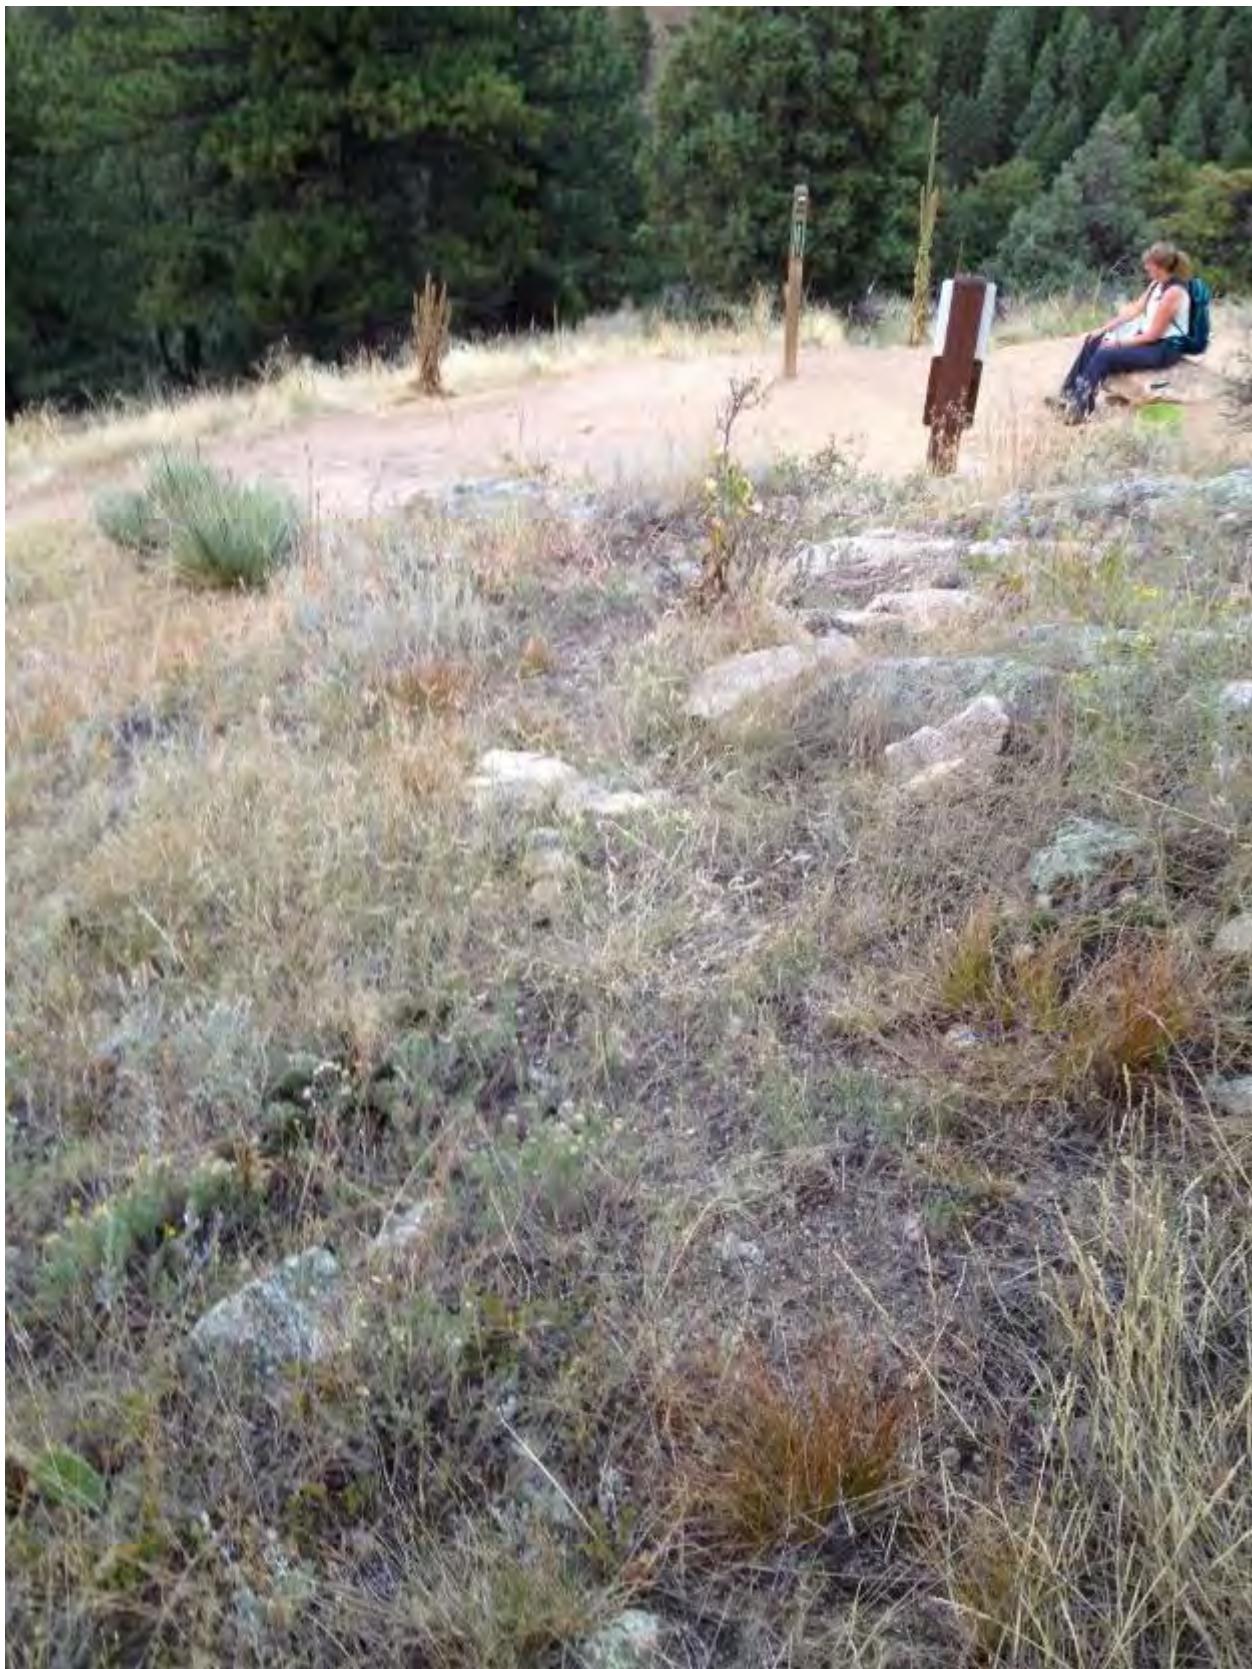
Section F, above new trails, very well vegetated.

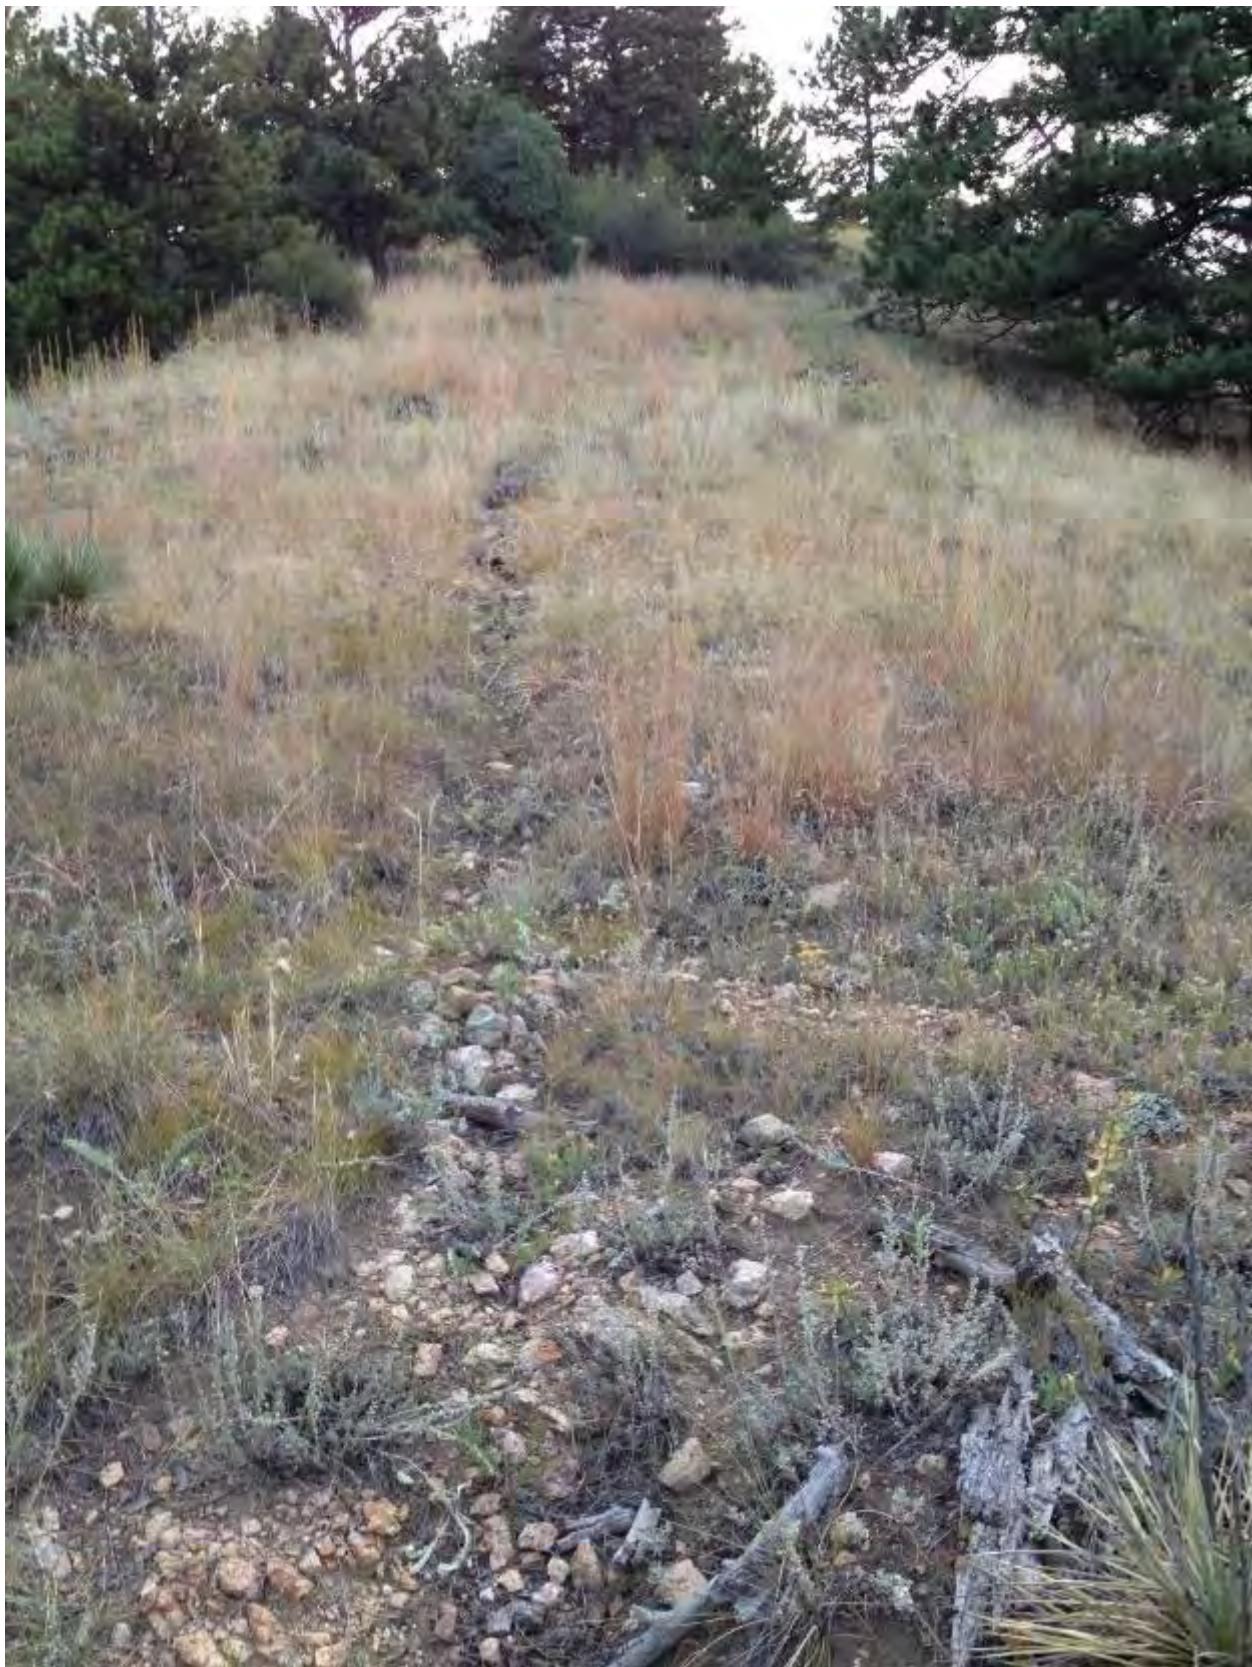
Section F, above new trail, looking West, you can find it, but it's pretty well vegetated.

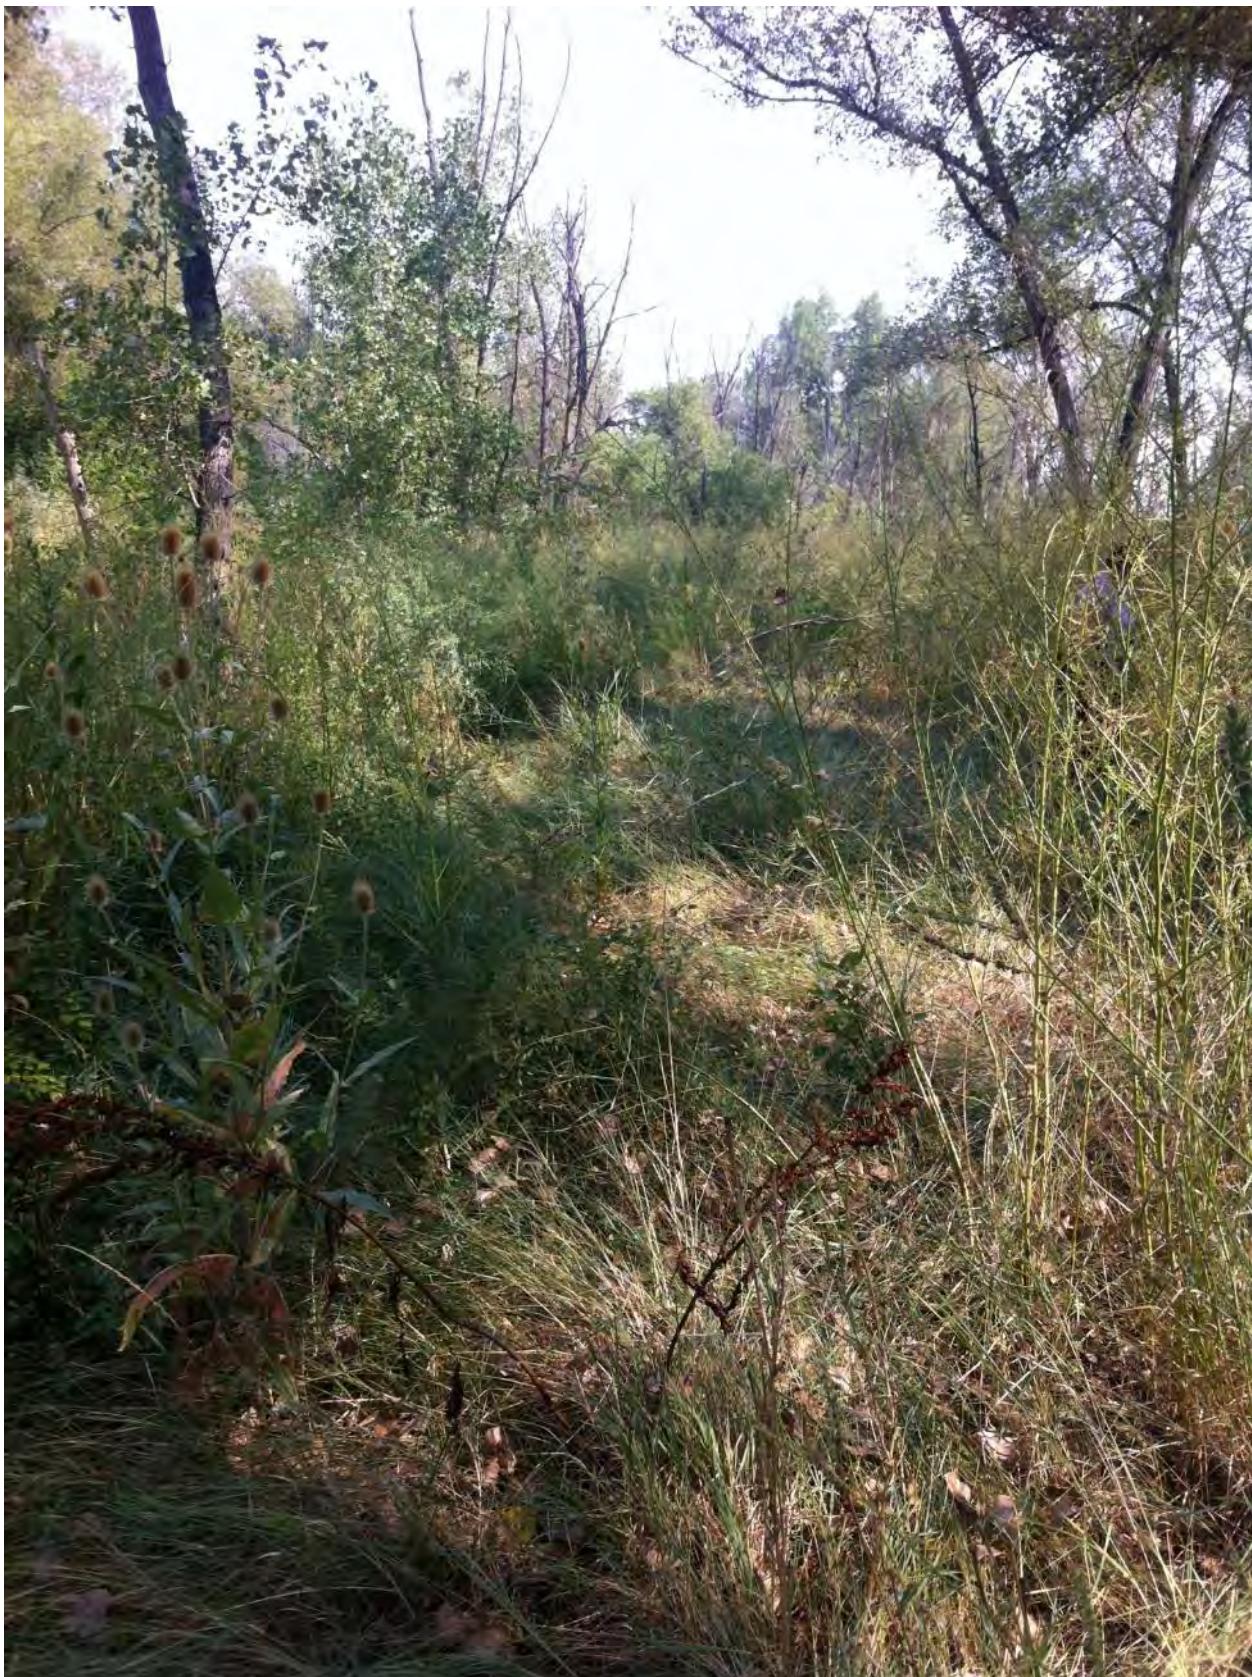
Area 1-- Tall weeds, teasel, white clover, many native and non-native grasses.
