Monitoring WRV Projects – What We Learned During 2015  
September 28, 2015  
Laura Backus, Alan Carpenter, Todd Sanford

## **Background and Purpose**

## WRV QUICK MONITOR D R A F T

**Project Name:** Berthoud Pass Restoration

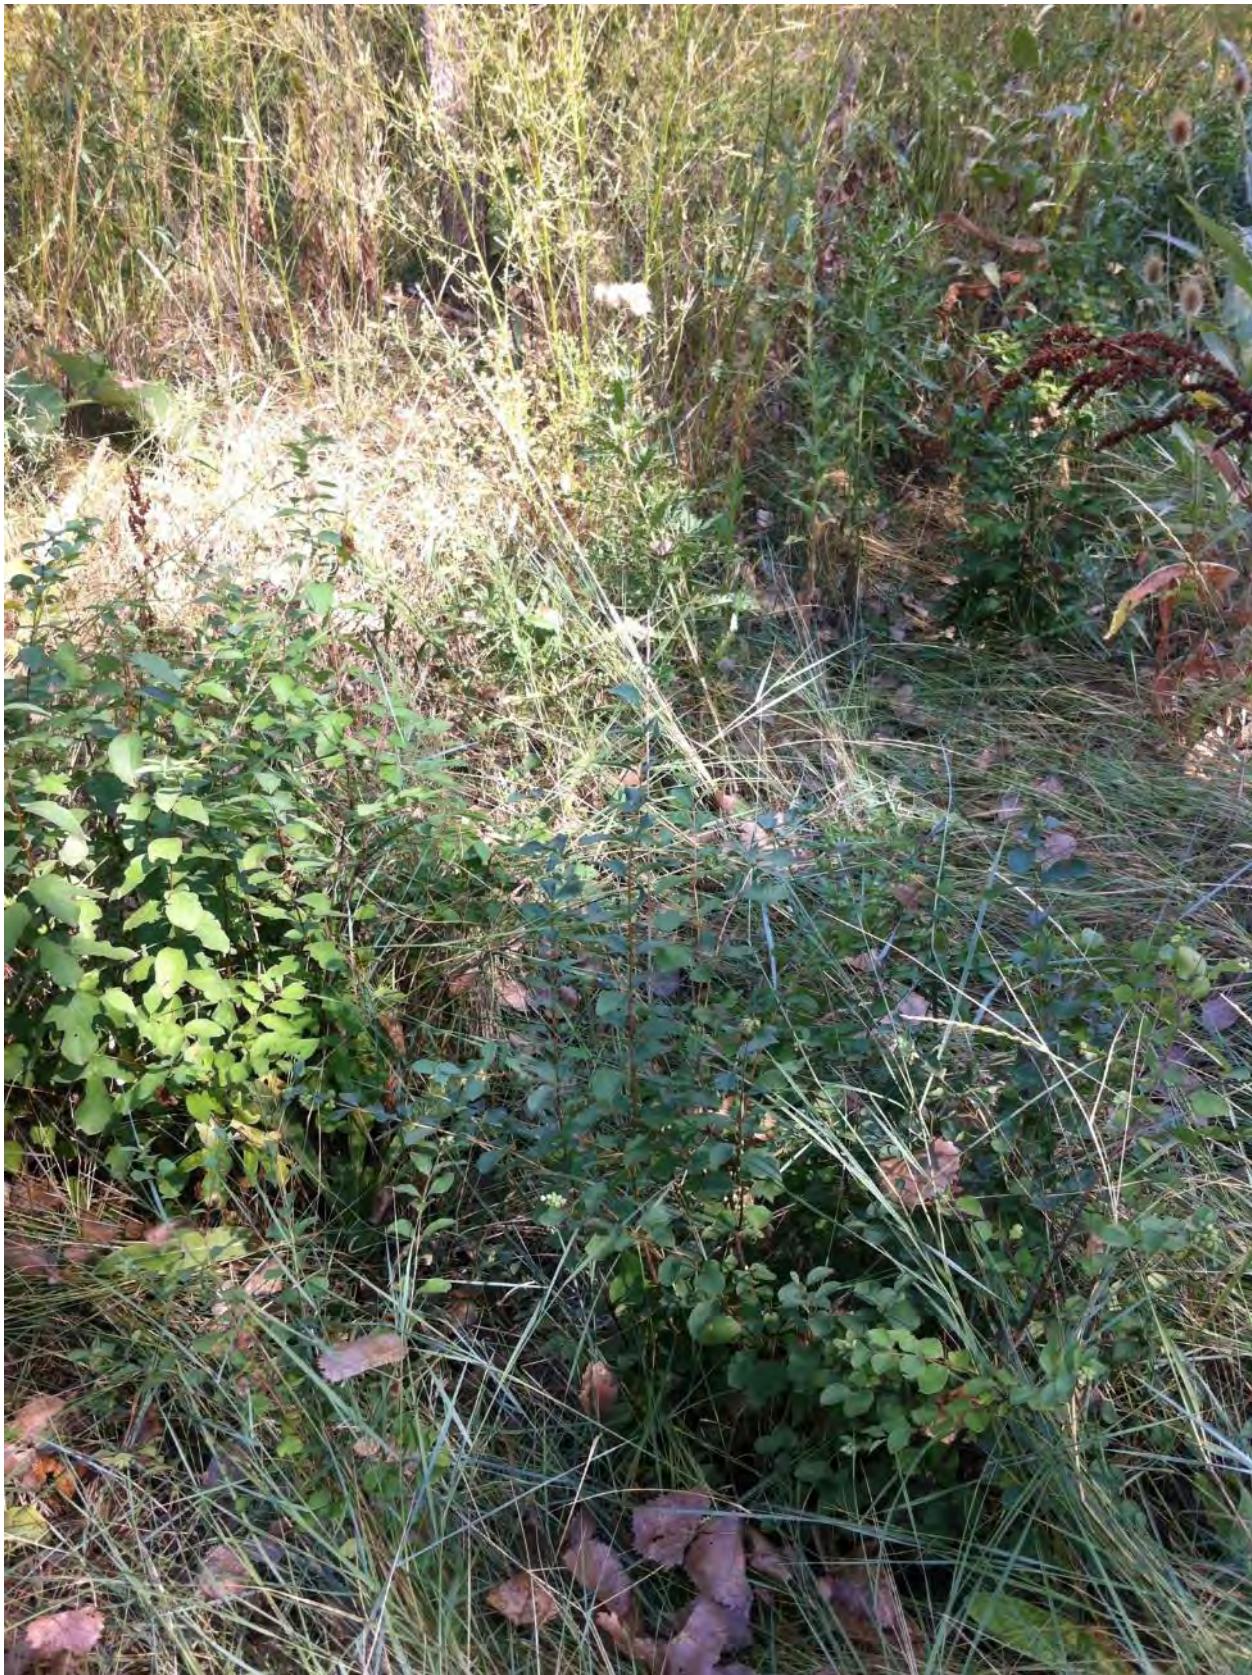
Area 1 Snowberry plants

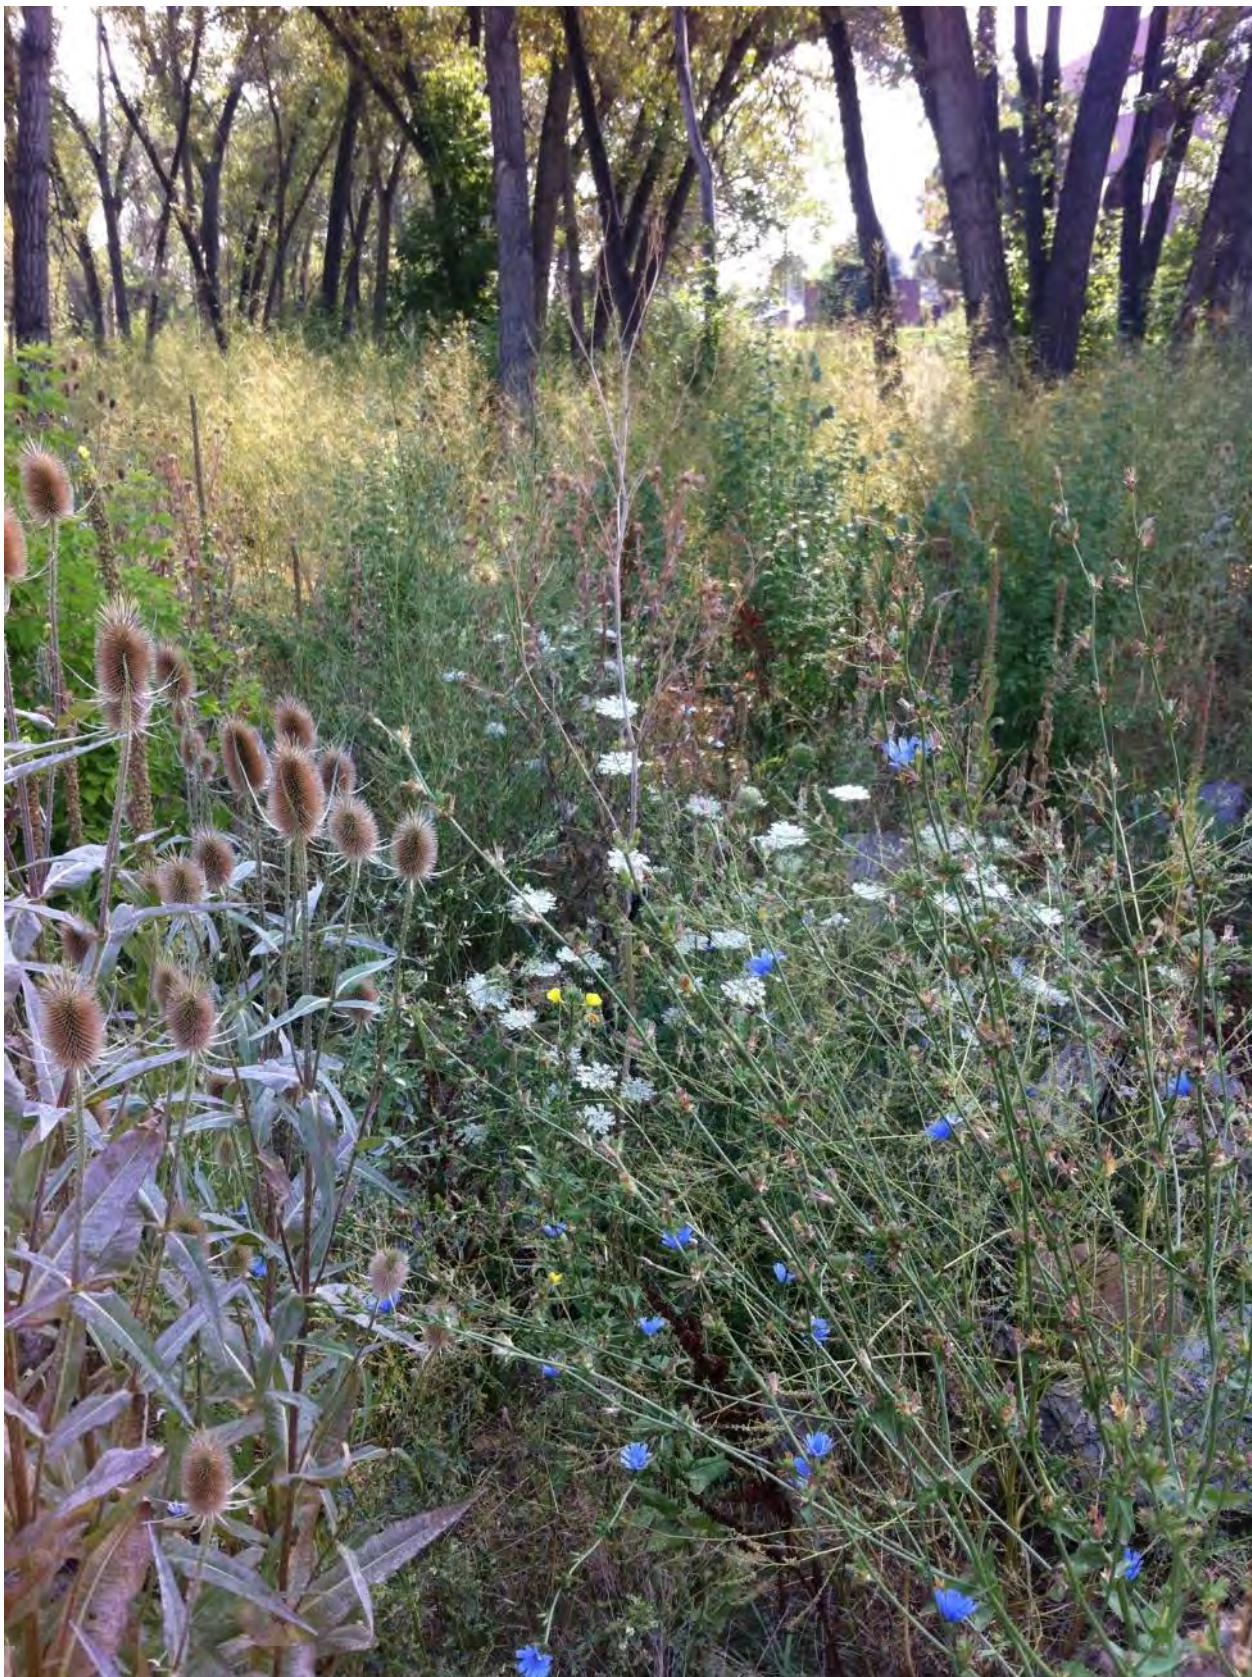
Area 1 weeds

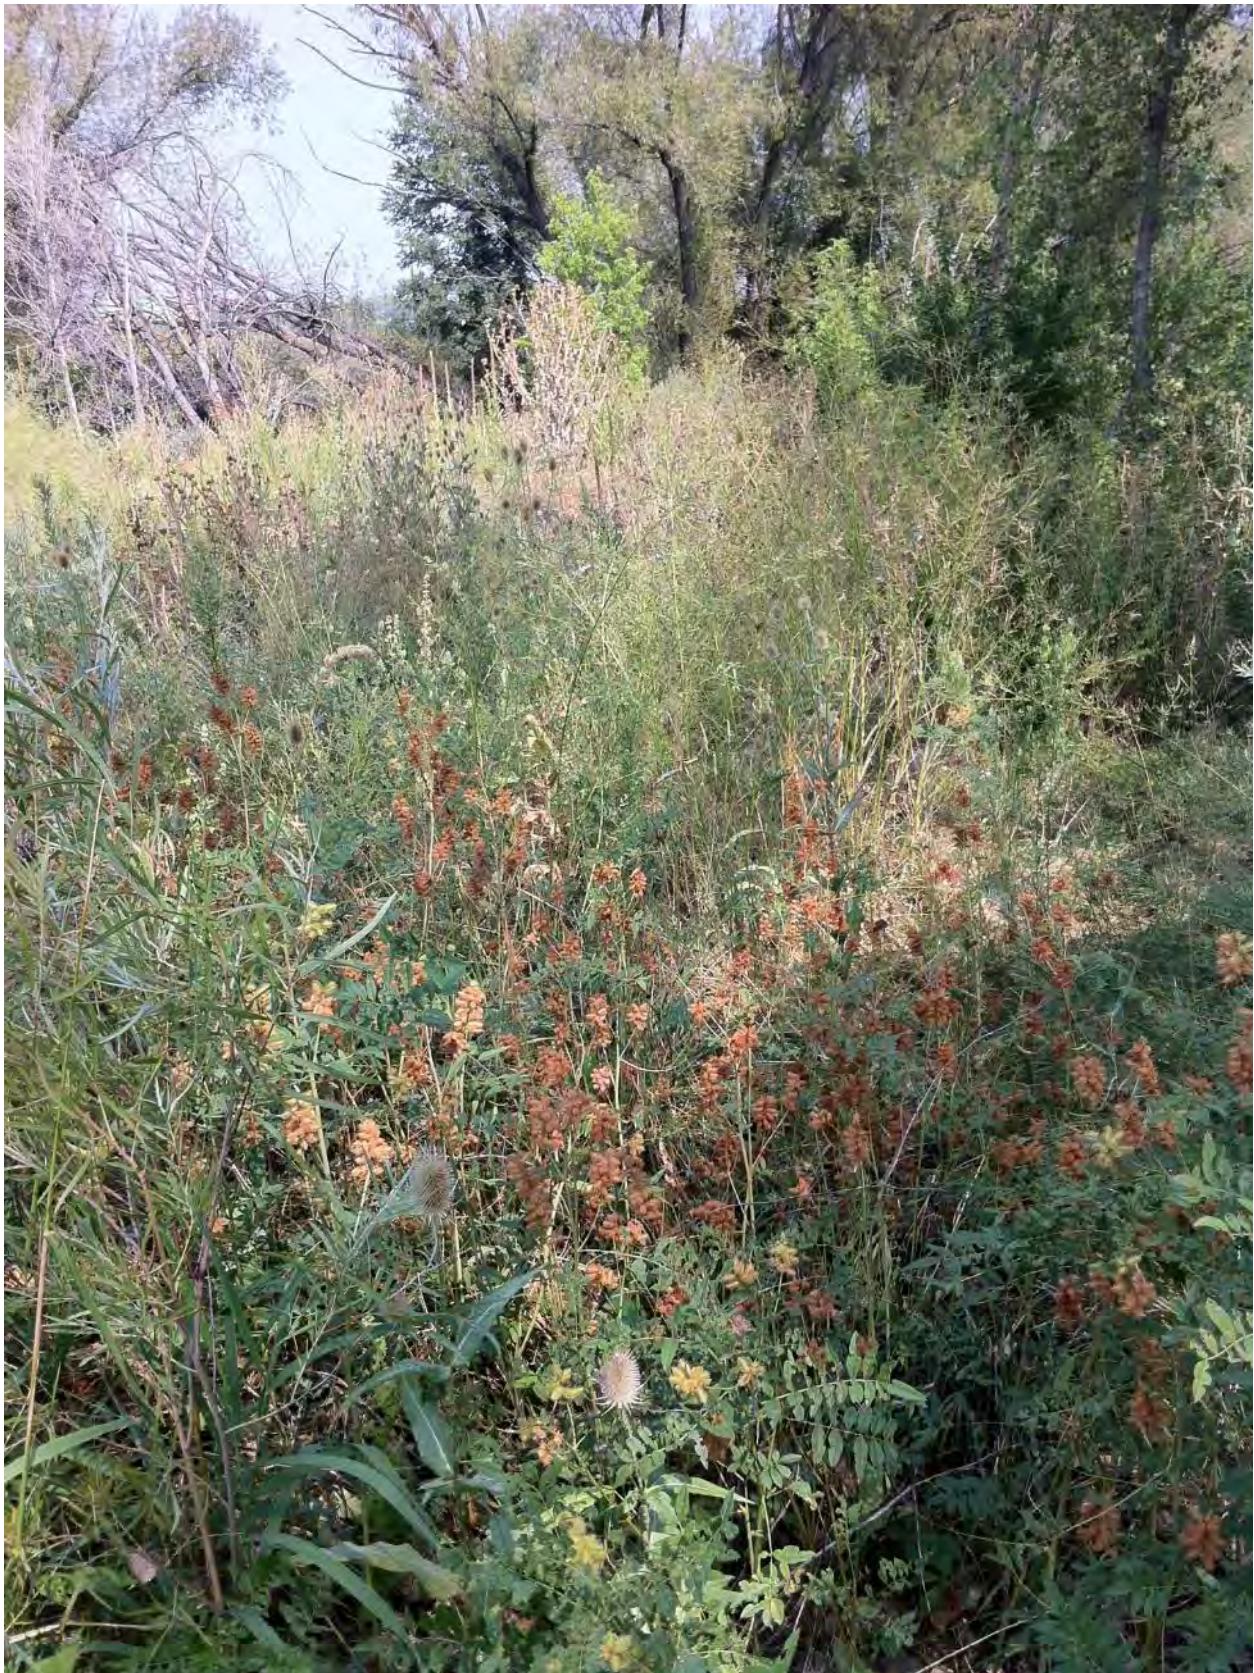
Area 2 weedy

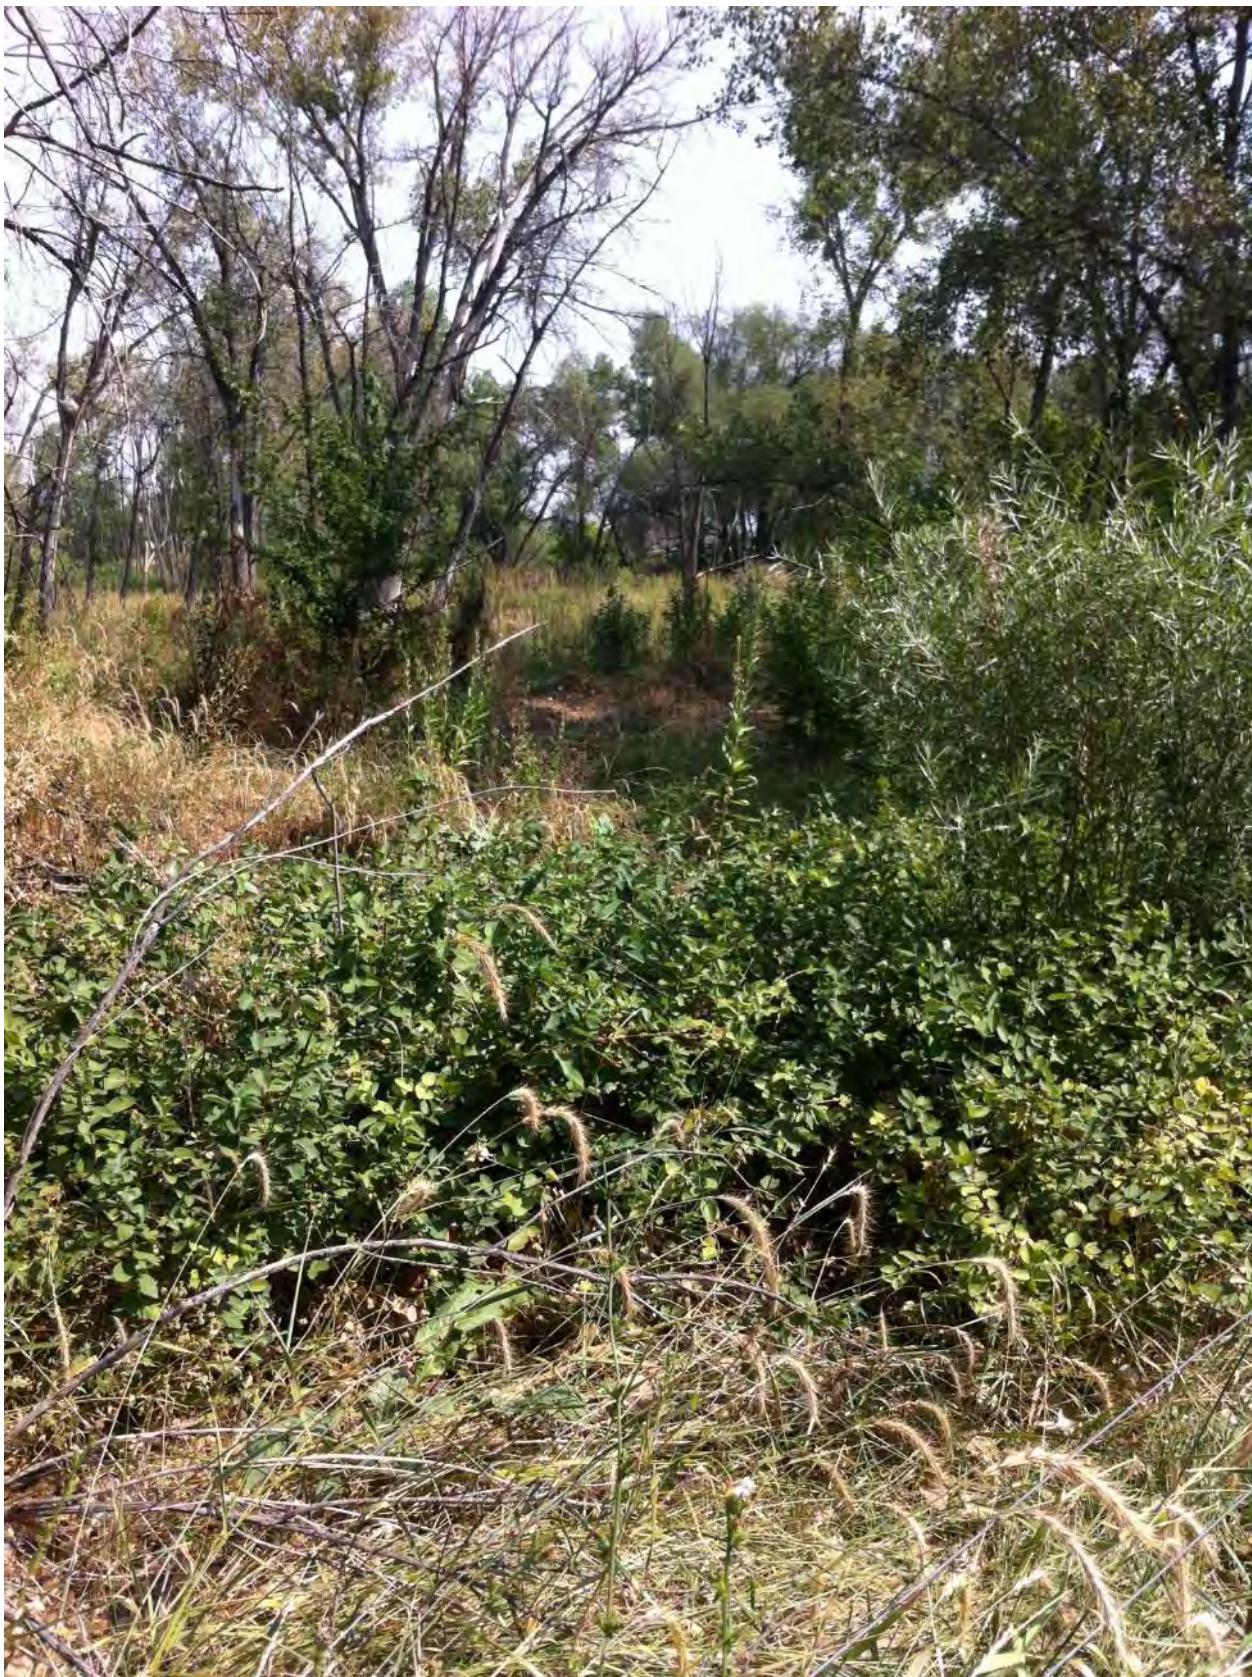
Areas 5 surviving chokecherry shrubs

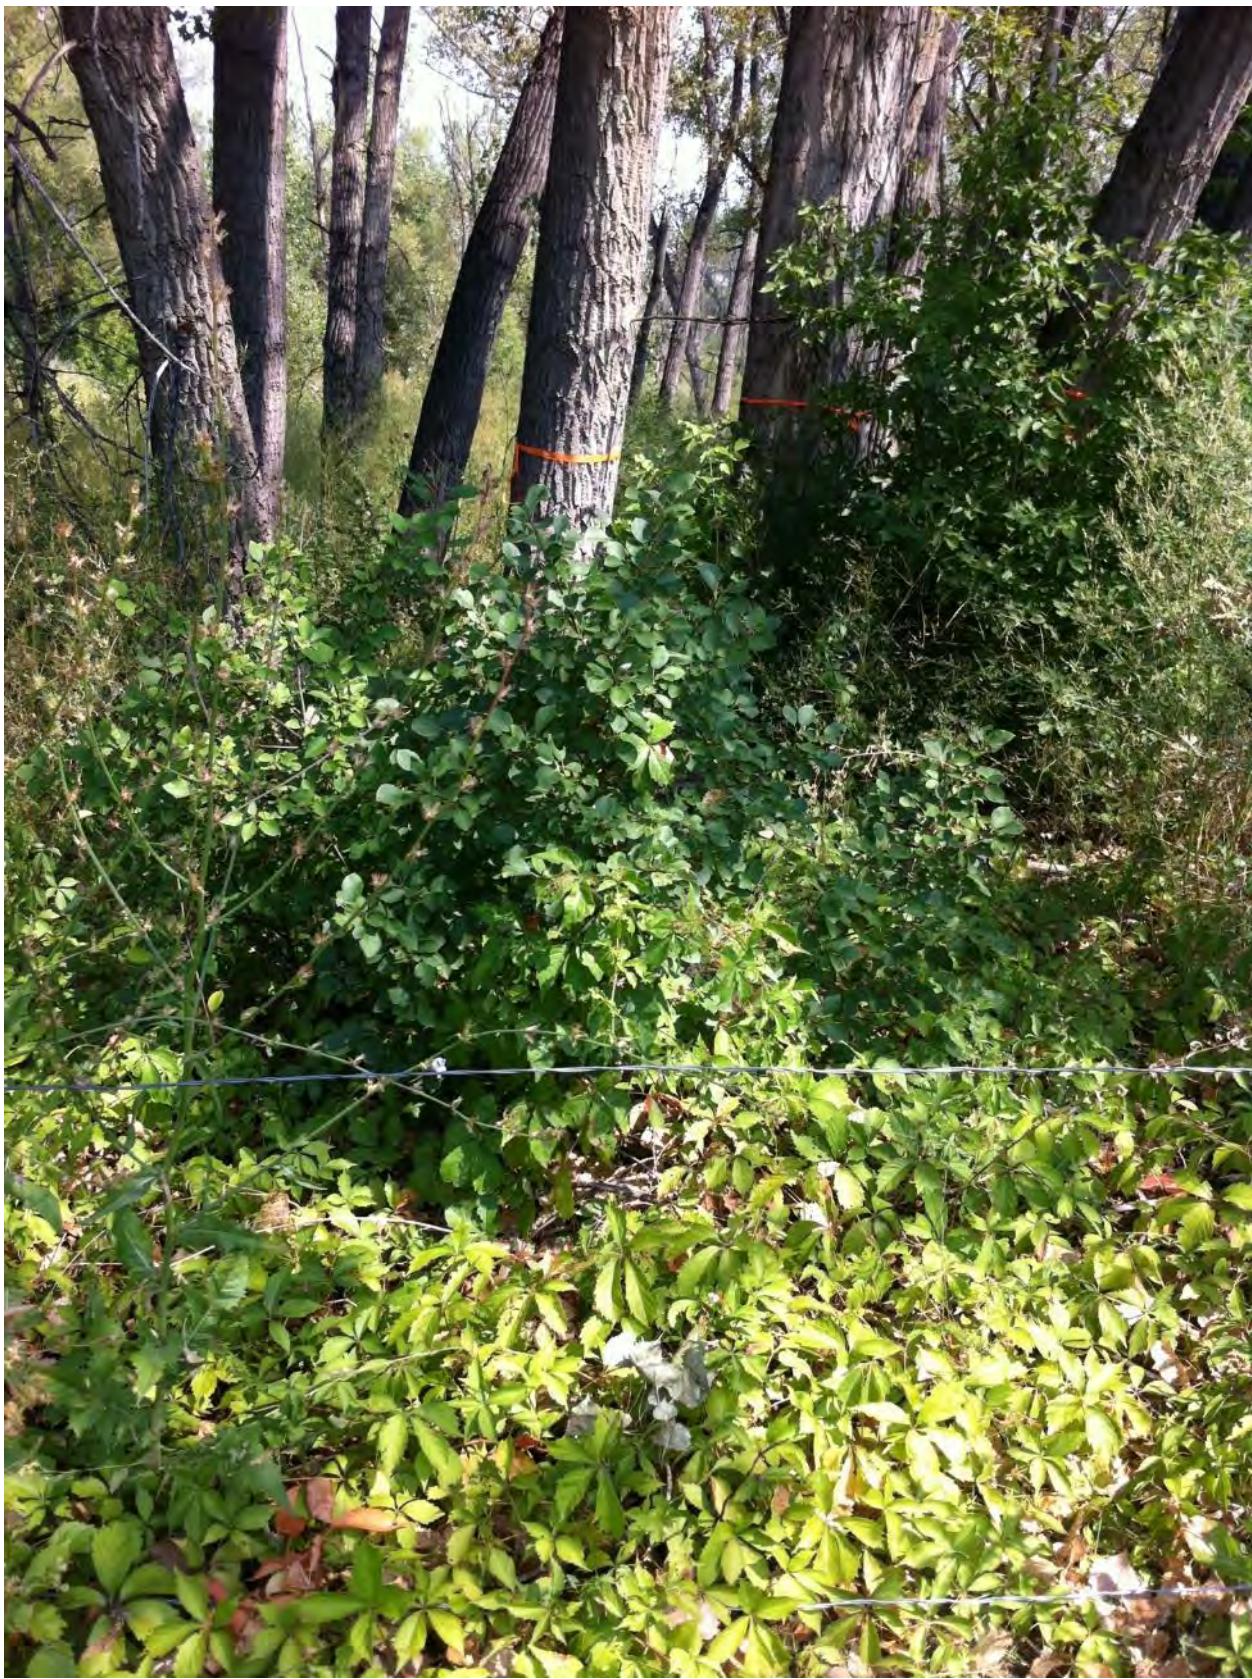
Area 6 Choke cherry and Virginia creeper

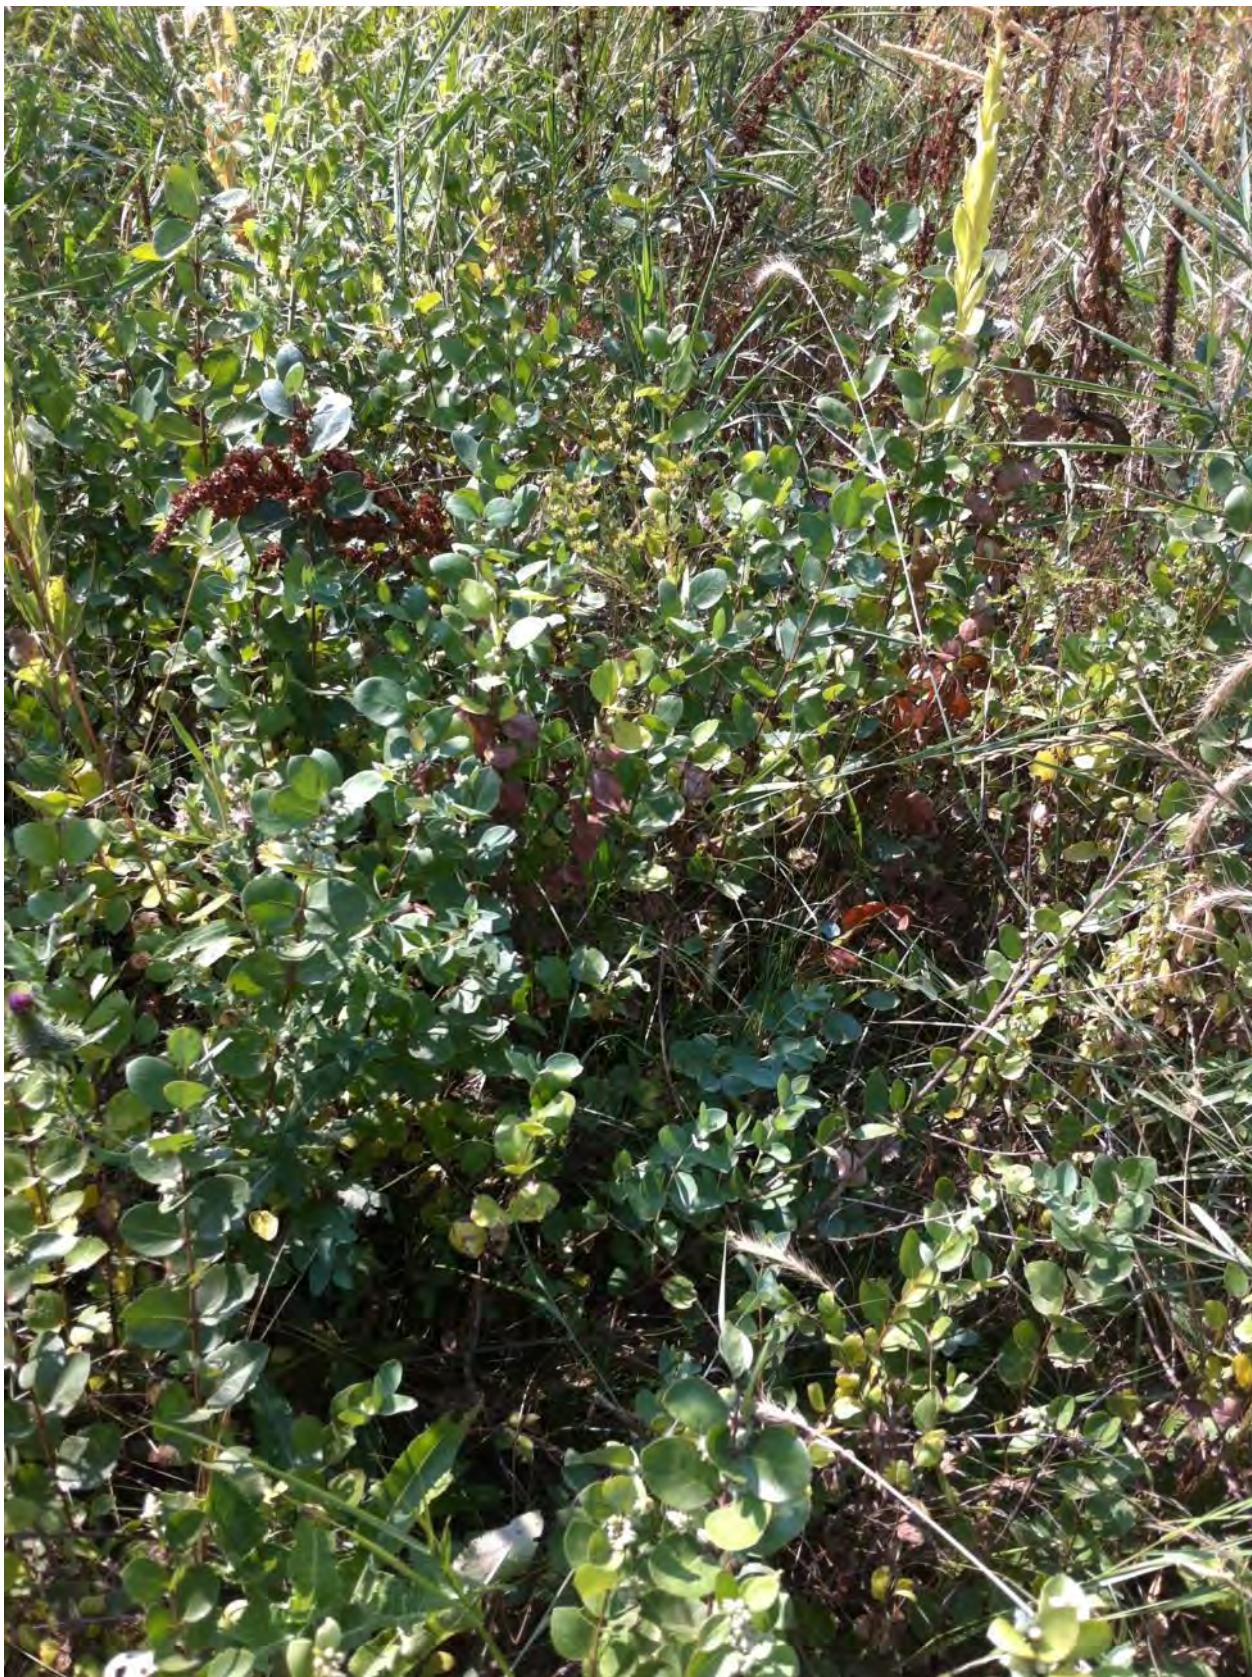
Area 3 Snowberry

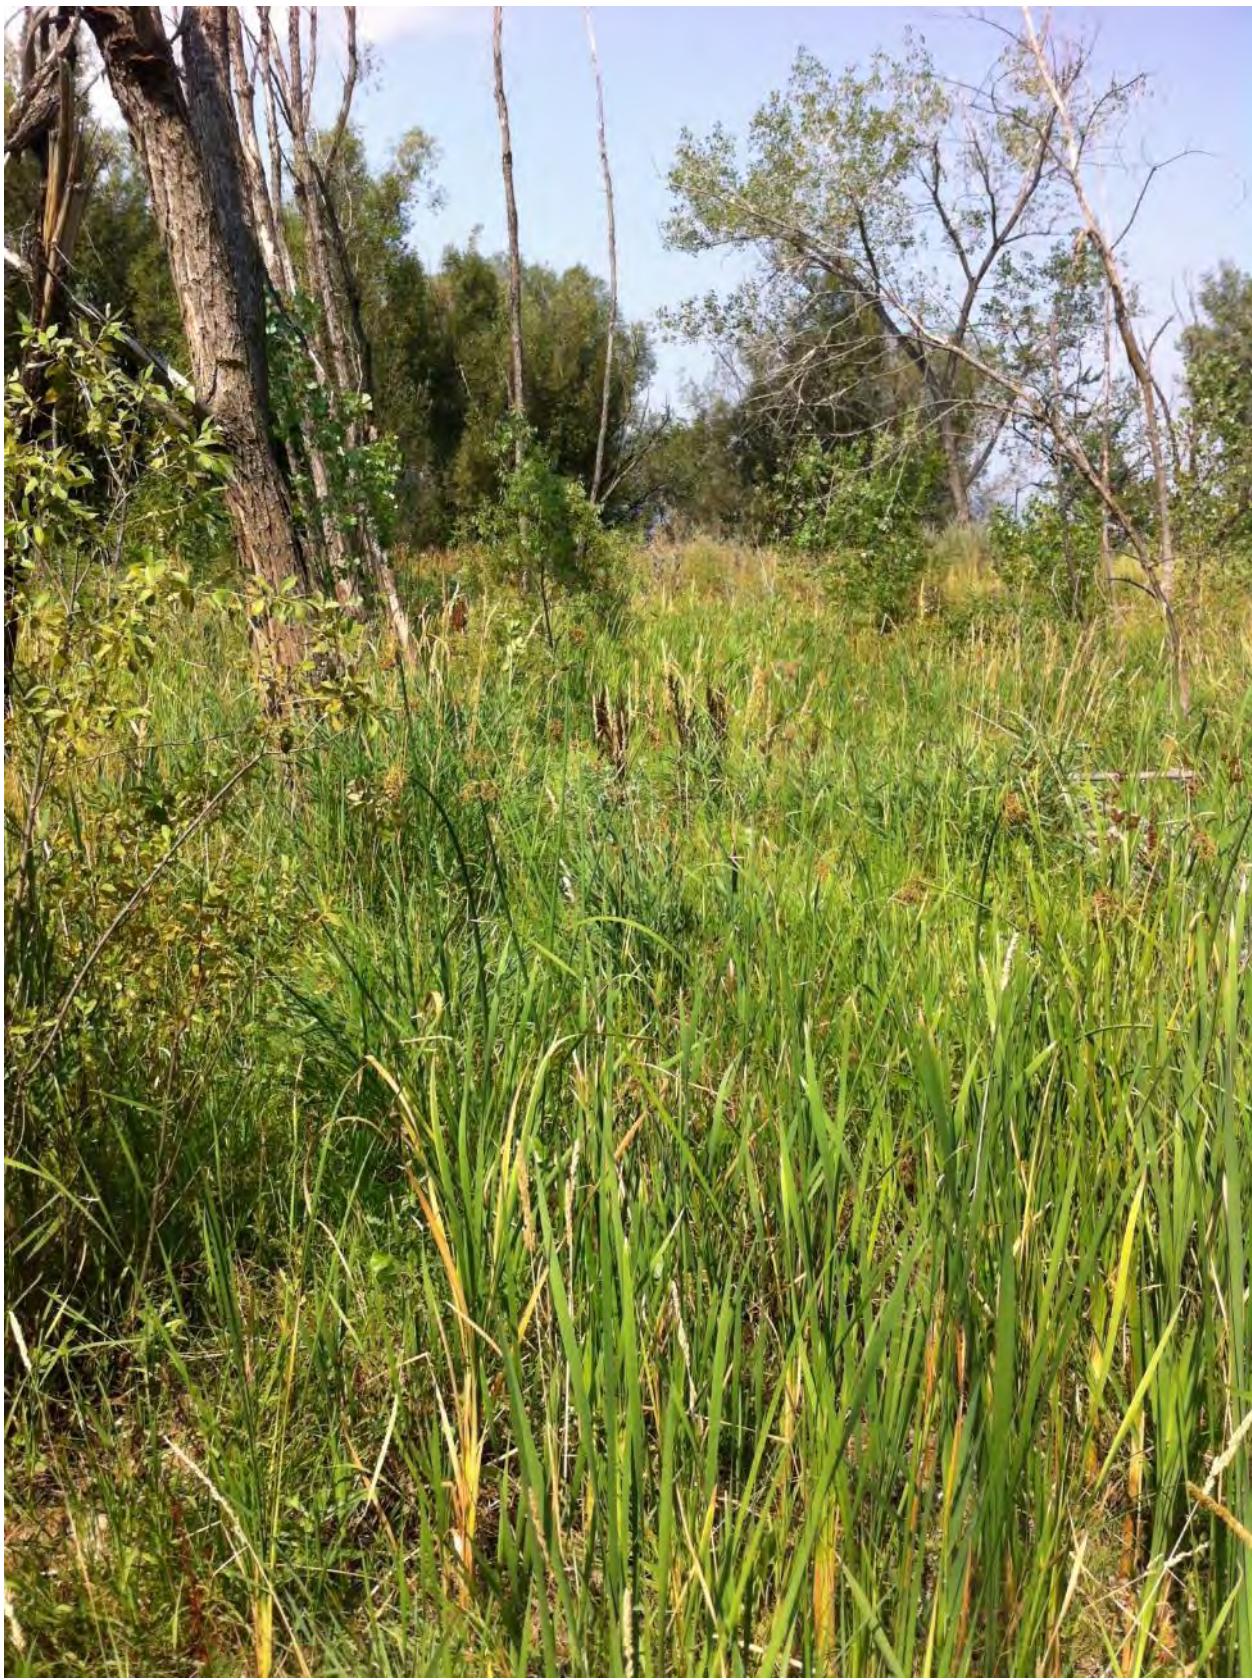
Area between 8 and 9, cattails, young peach-leaf willows

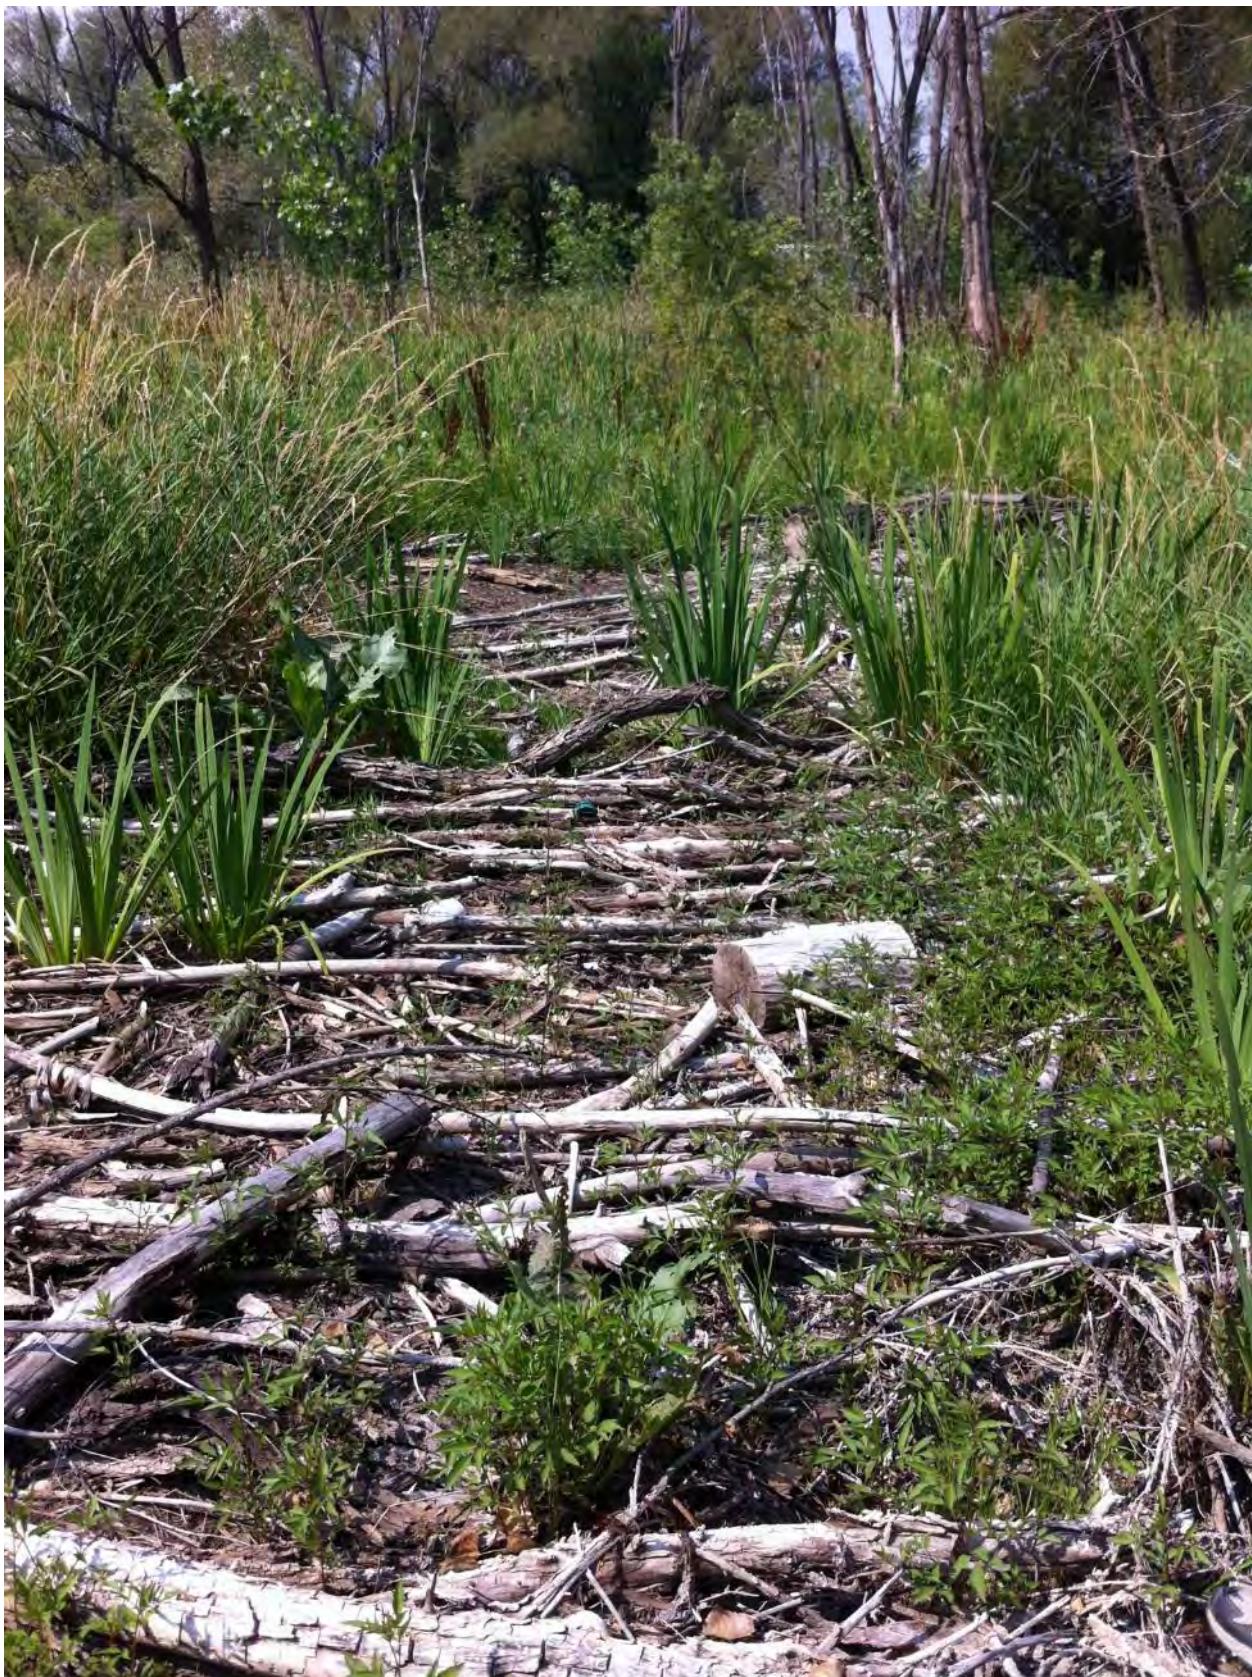
Areas between 8 and 9, flood debris, cattails

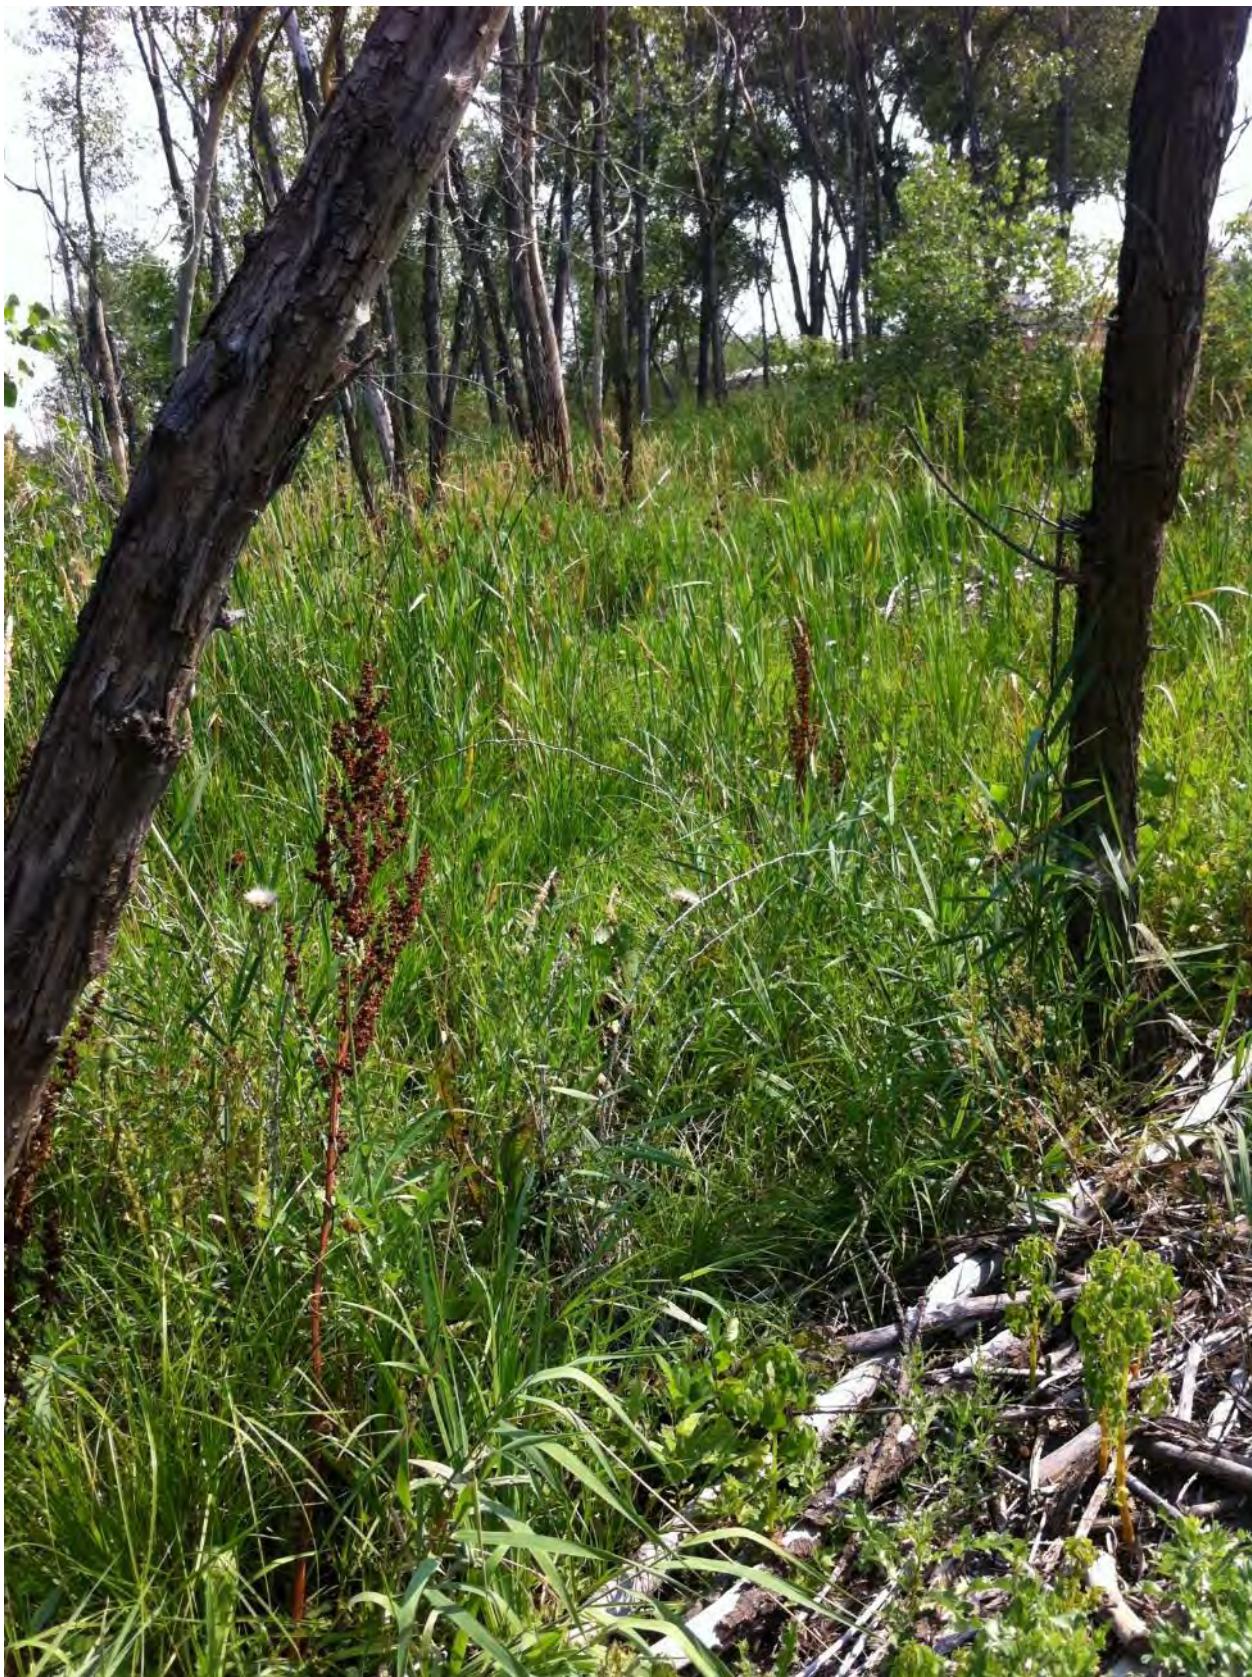
Area between 8 and 9, Lots of native graminoid growth

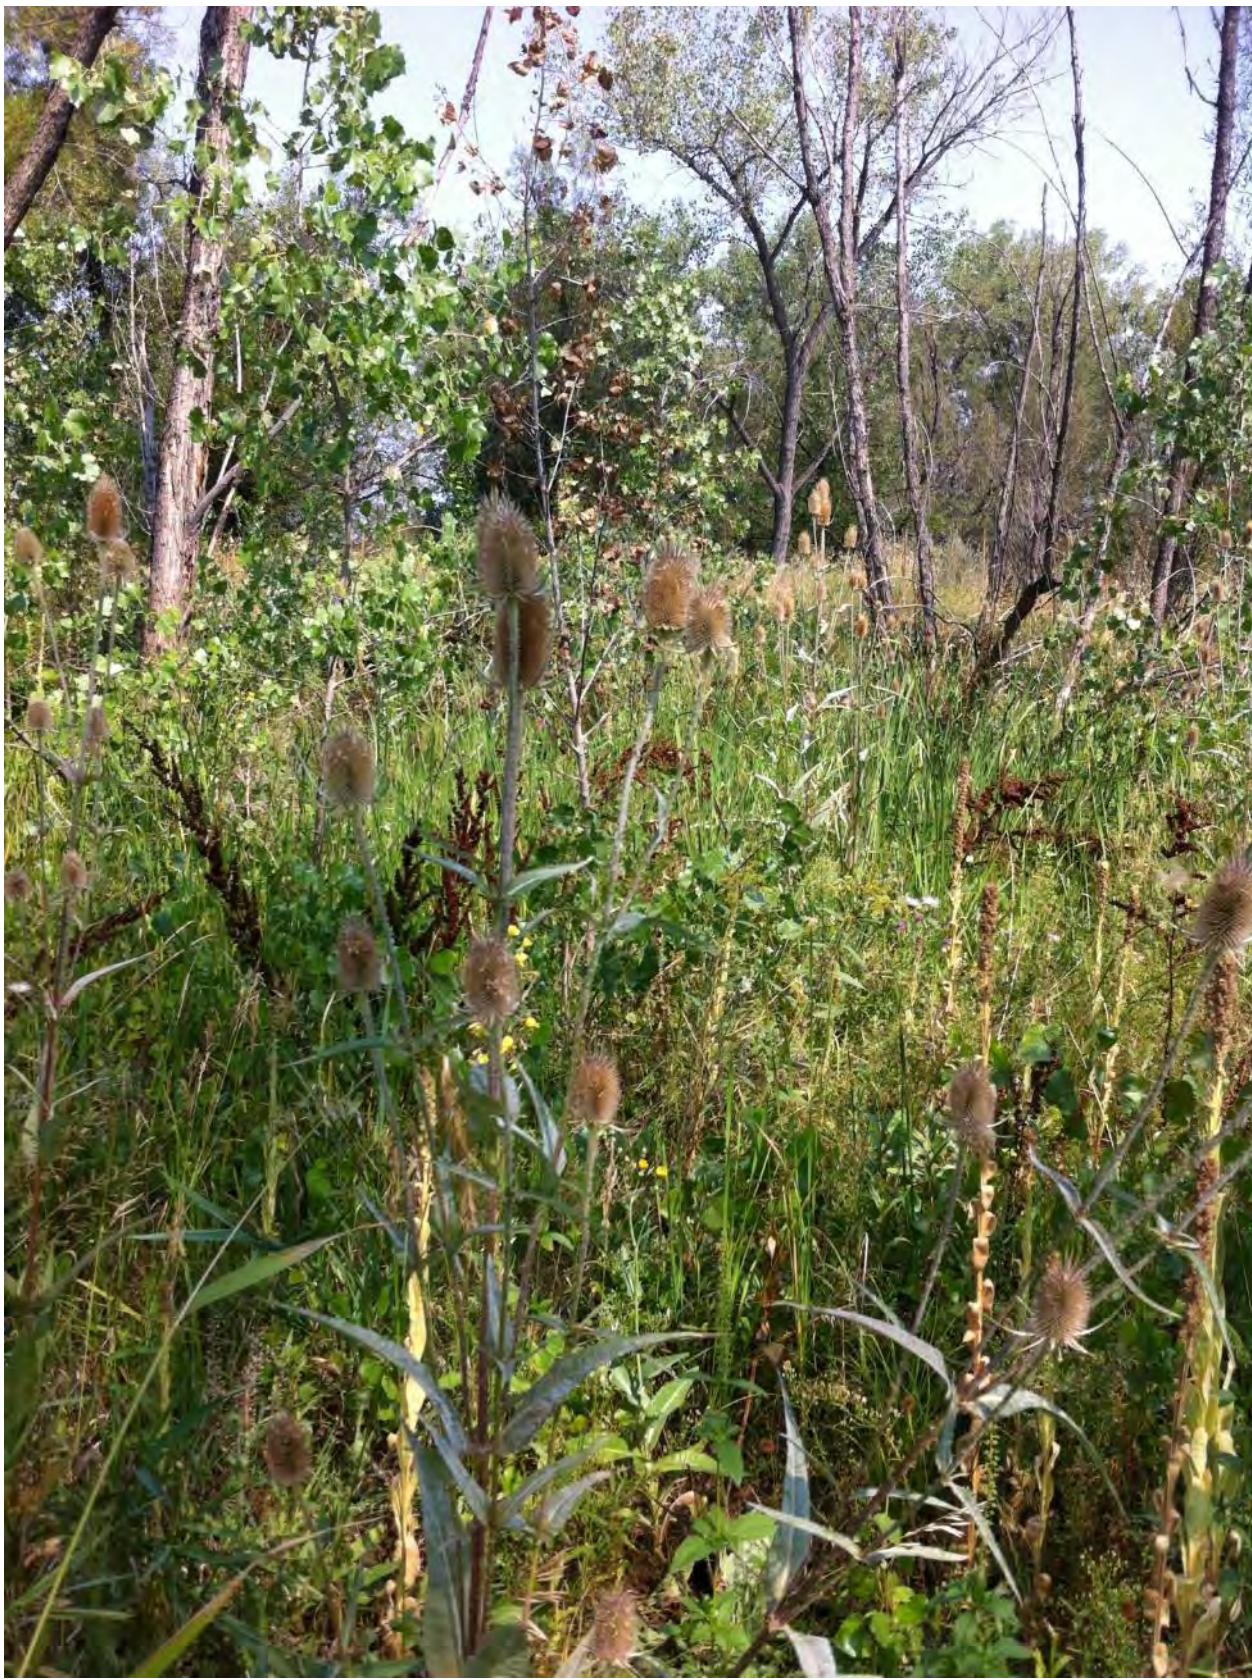
Area 7, Weeds and young cottonwoods

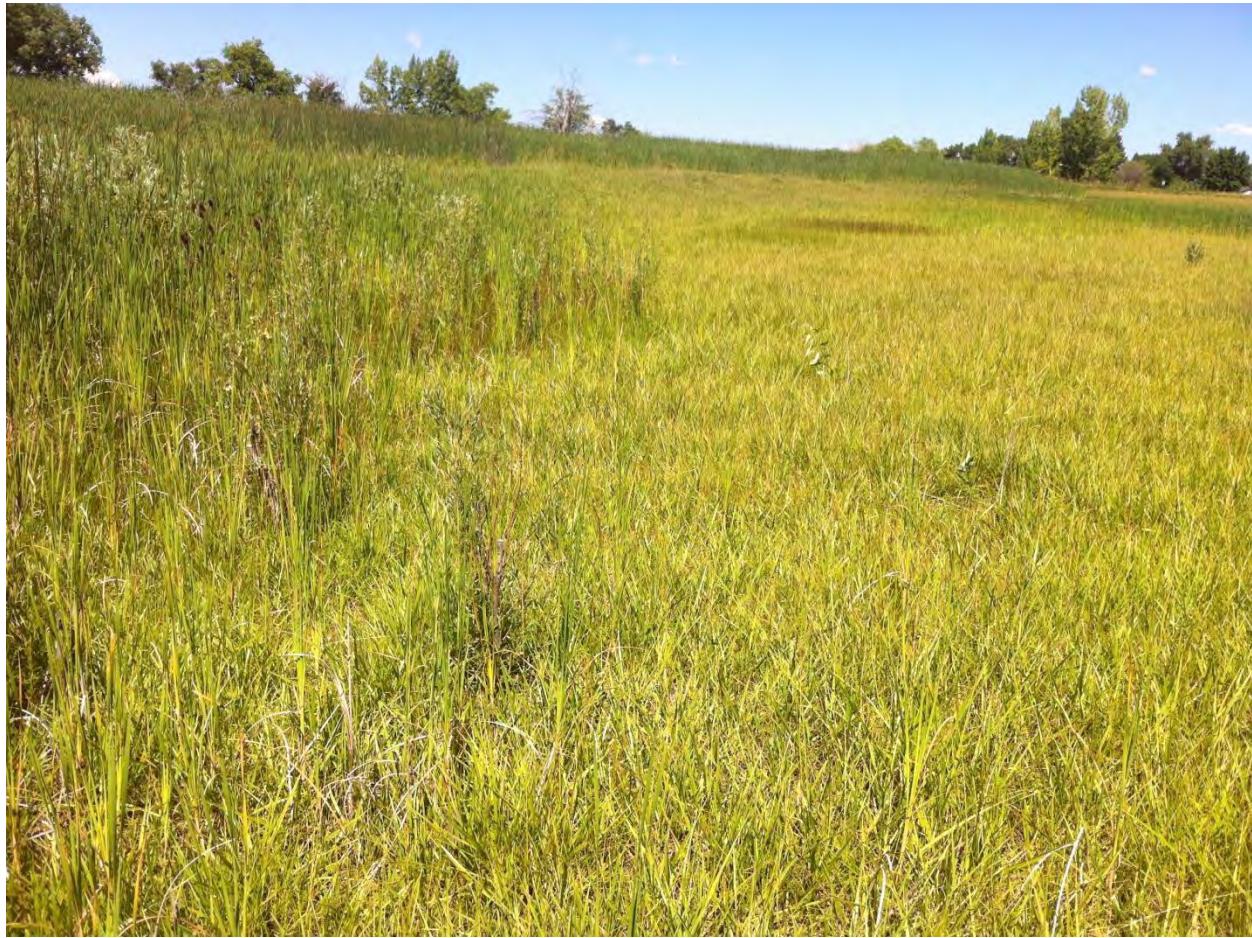
Photo 6: Peachleaf willow planting area. Note several surviving trees in photo right
