Monitoring WRV Projects – What We Learned During 2015  
September 28, 2015  
Laura Backus, Alan Carpenter, Todd Sanford

## **Background and Purpose**

## WRV QUICK MONITOR D R A F T

**Project Name:** Berthoud Pass Restoration

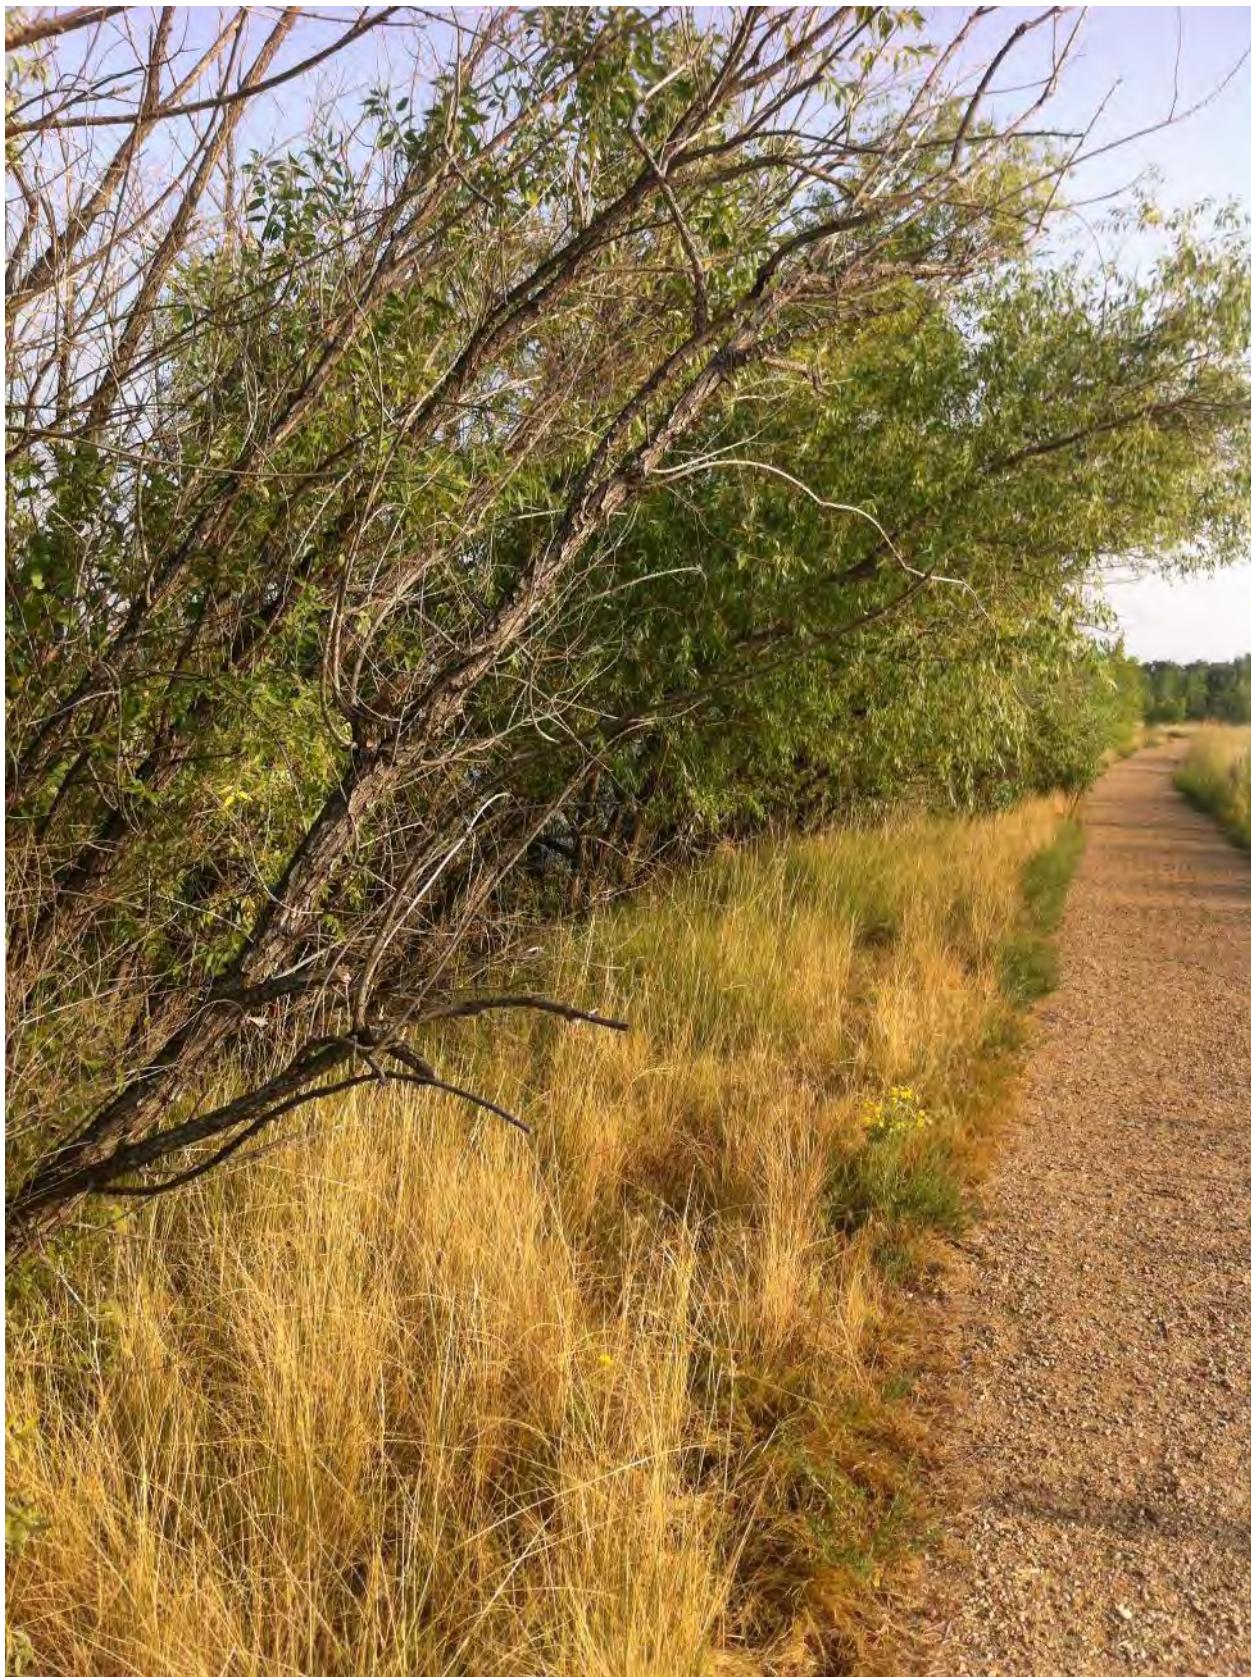
Thick native grass cover, east side, note Russian knapweed at trail edge

**Corrective or Maintenance activities needed:** Crack willow needs to be eradicated. I documented each plant location with GPS pts (about 8-10), tamarisk is also there, only about 3-4 plants, also GPS location documented. Cheatgrass and Russian knapweed occurs in small patches on the southwest side of the pond.

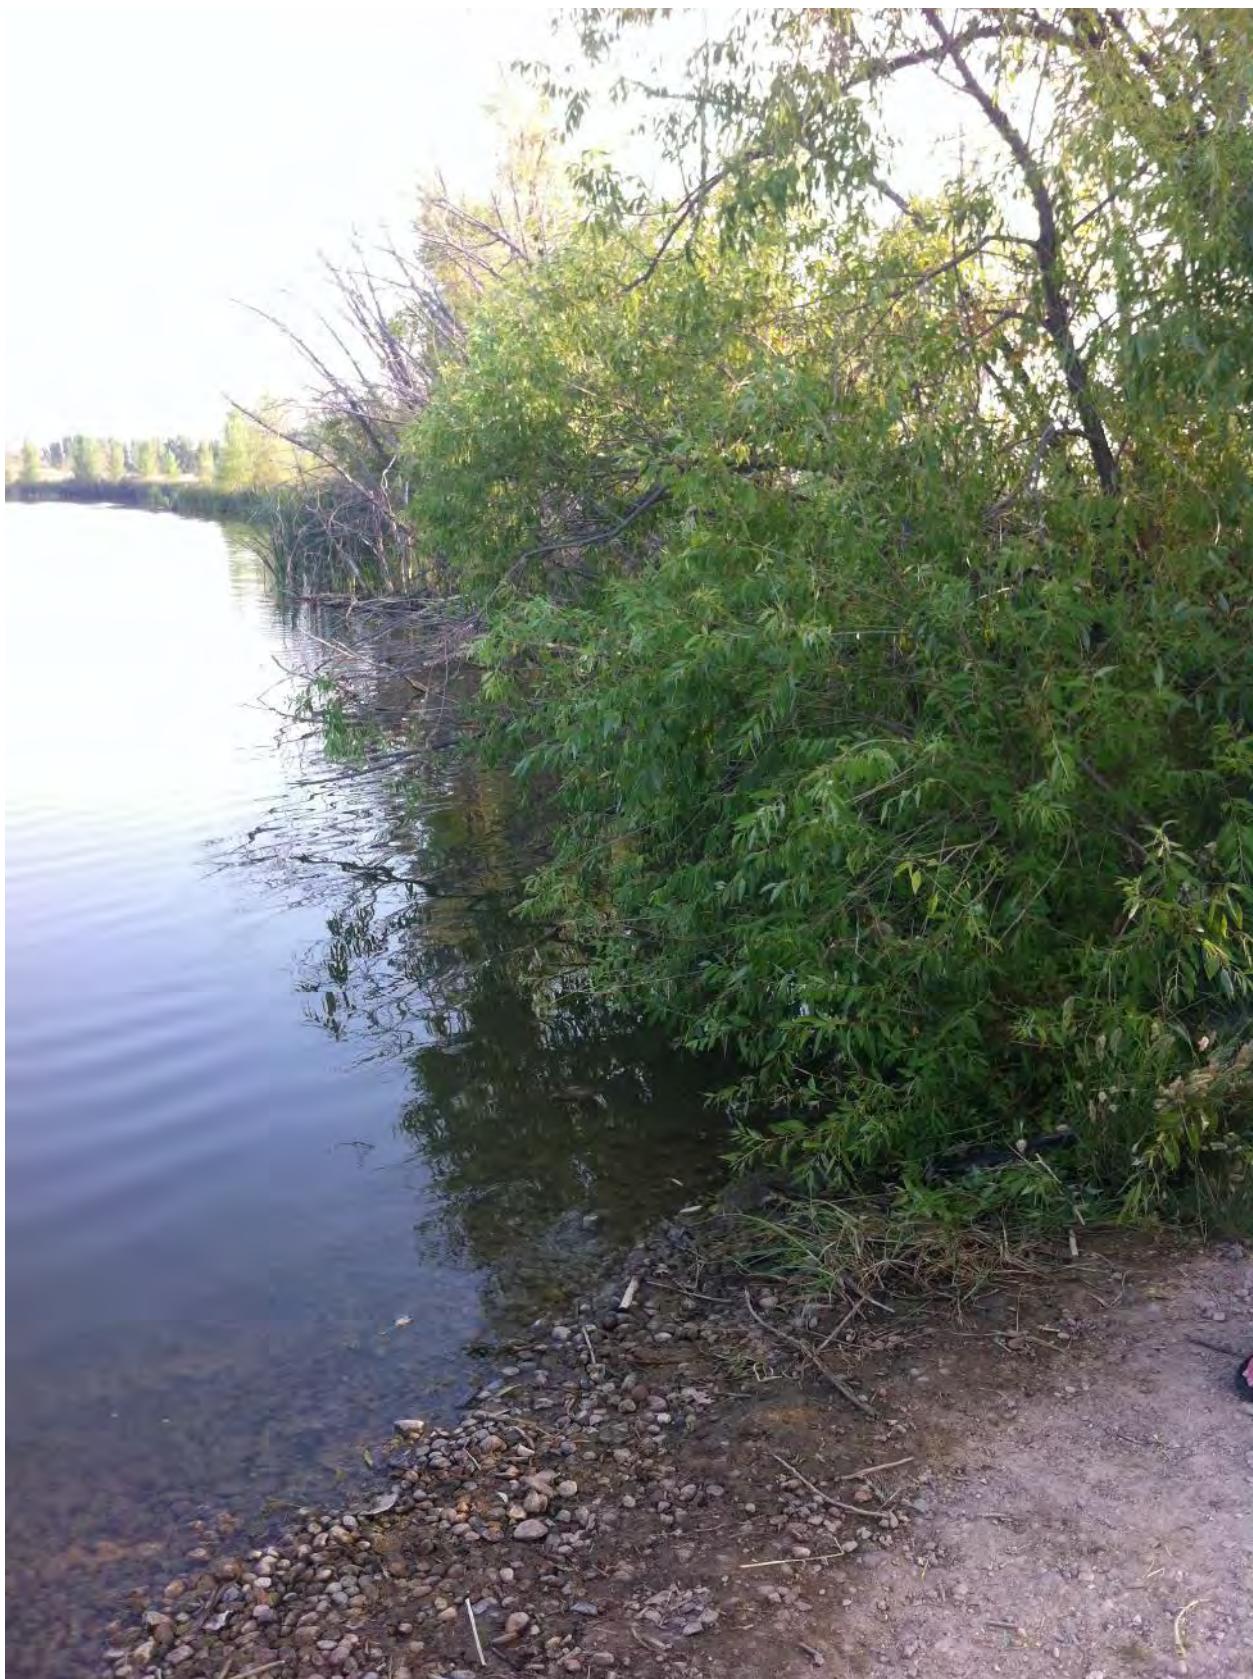
Dense grass understory on east side, dead peach leaf willow stems

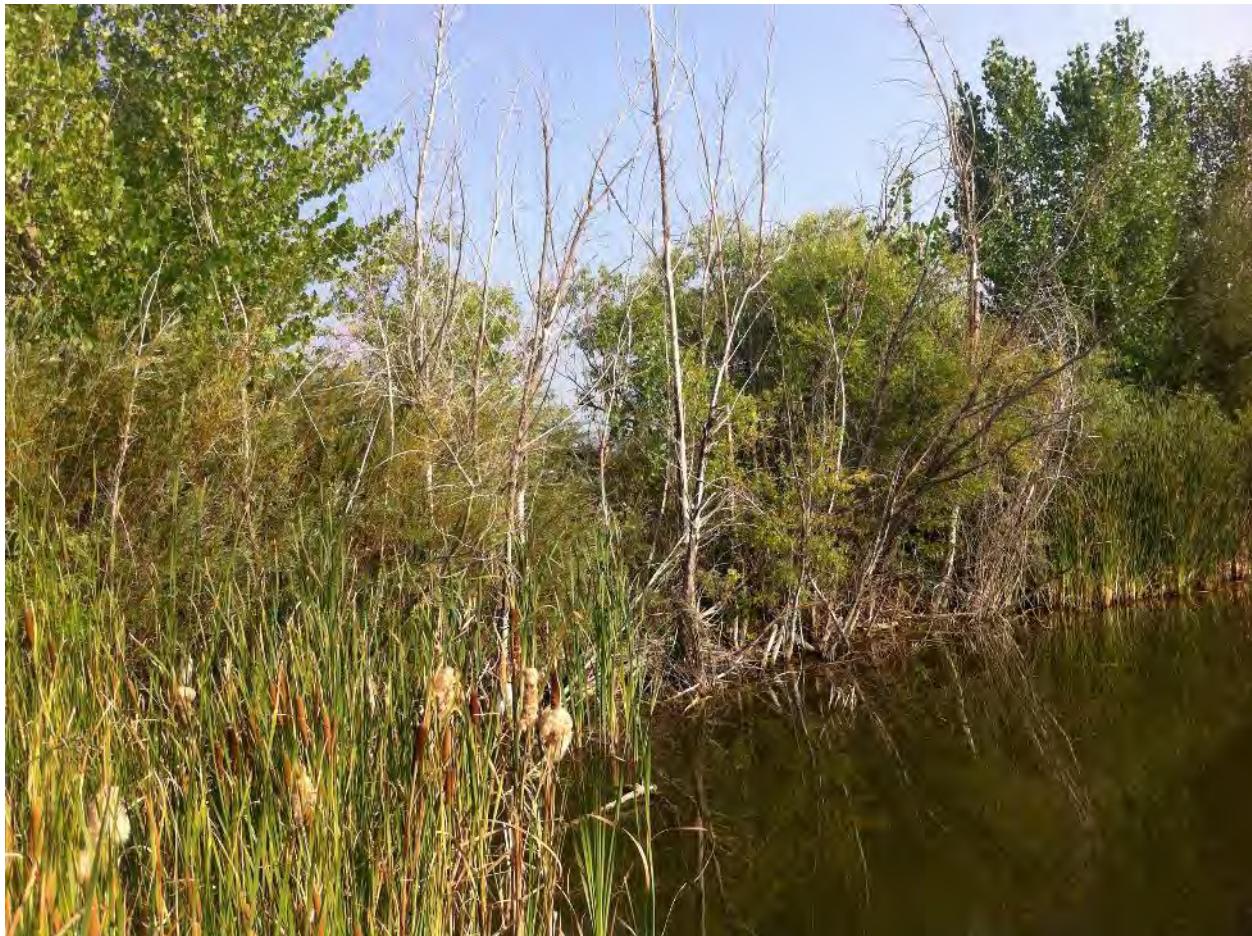
Tamarisk at fishing pier, SE corner

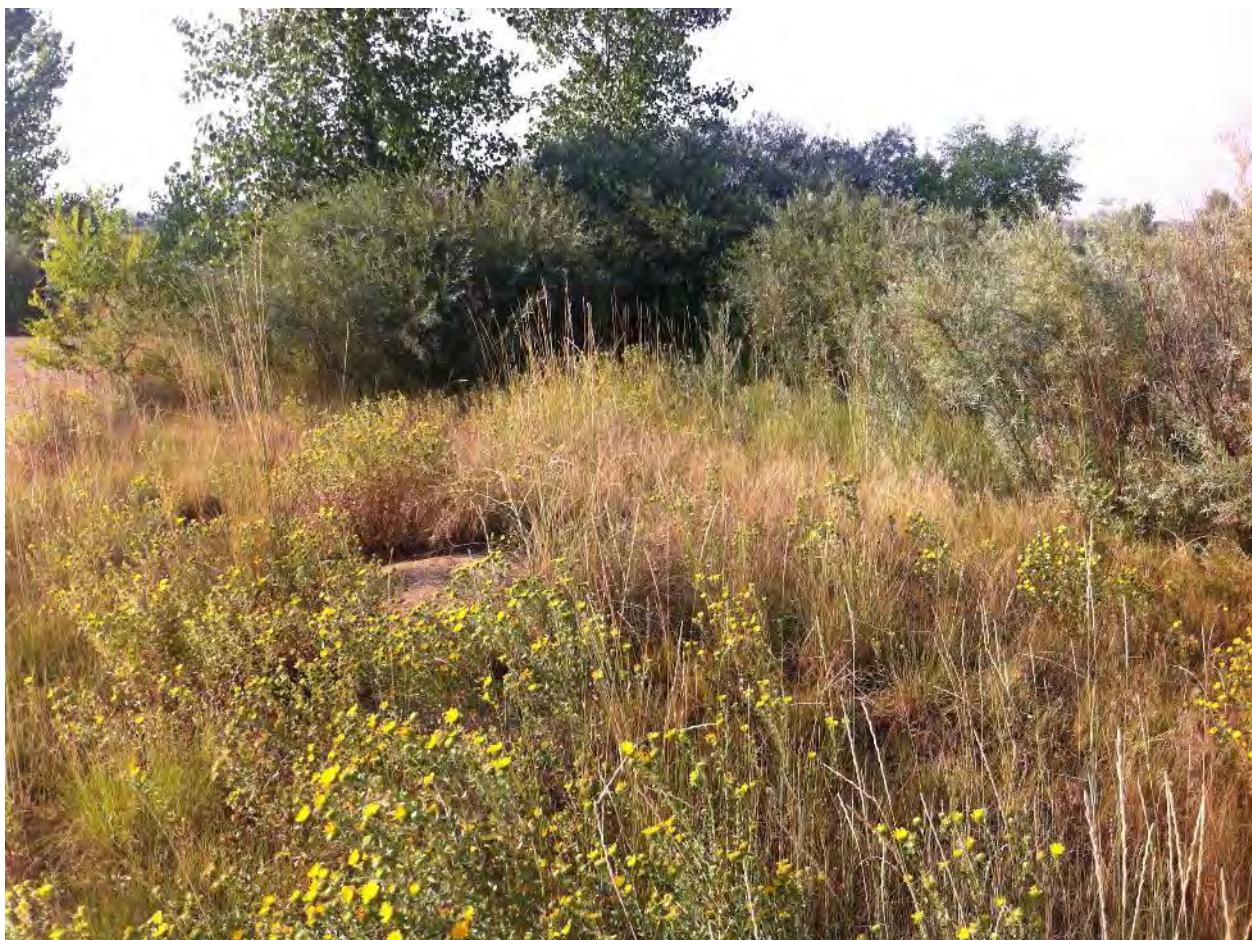
Dense native grass with some cheat grass

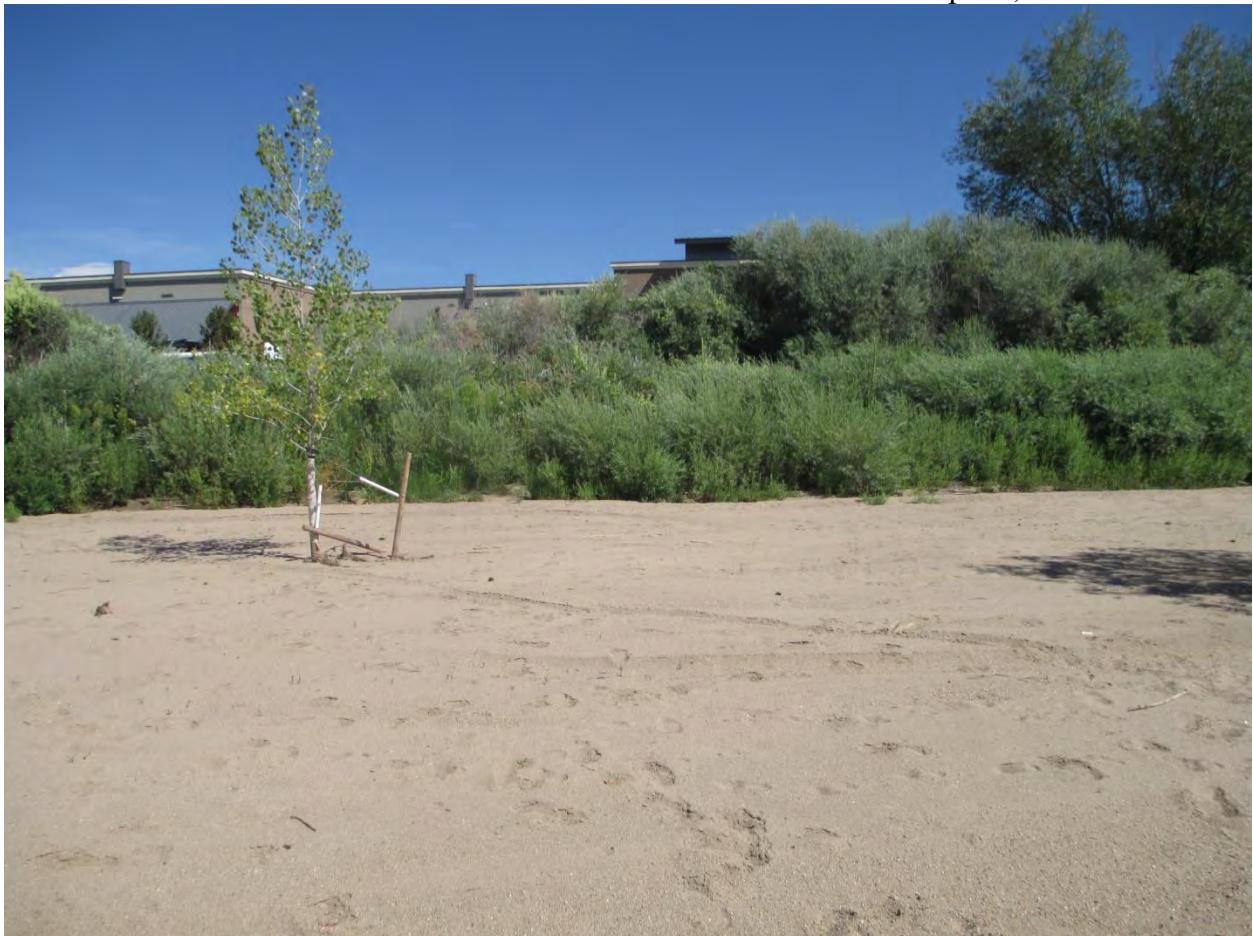
2015. No Russian-olive! Check back as flood recovery proceeds. View to north.

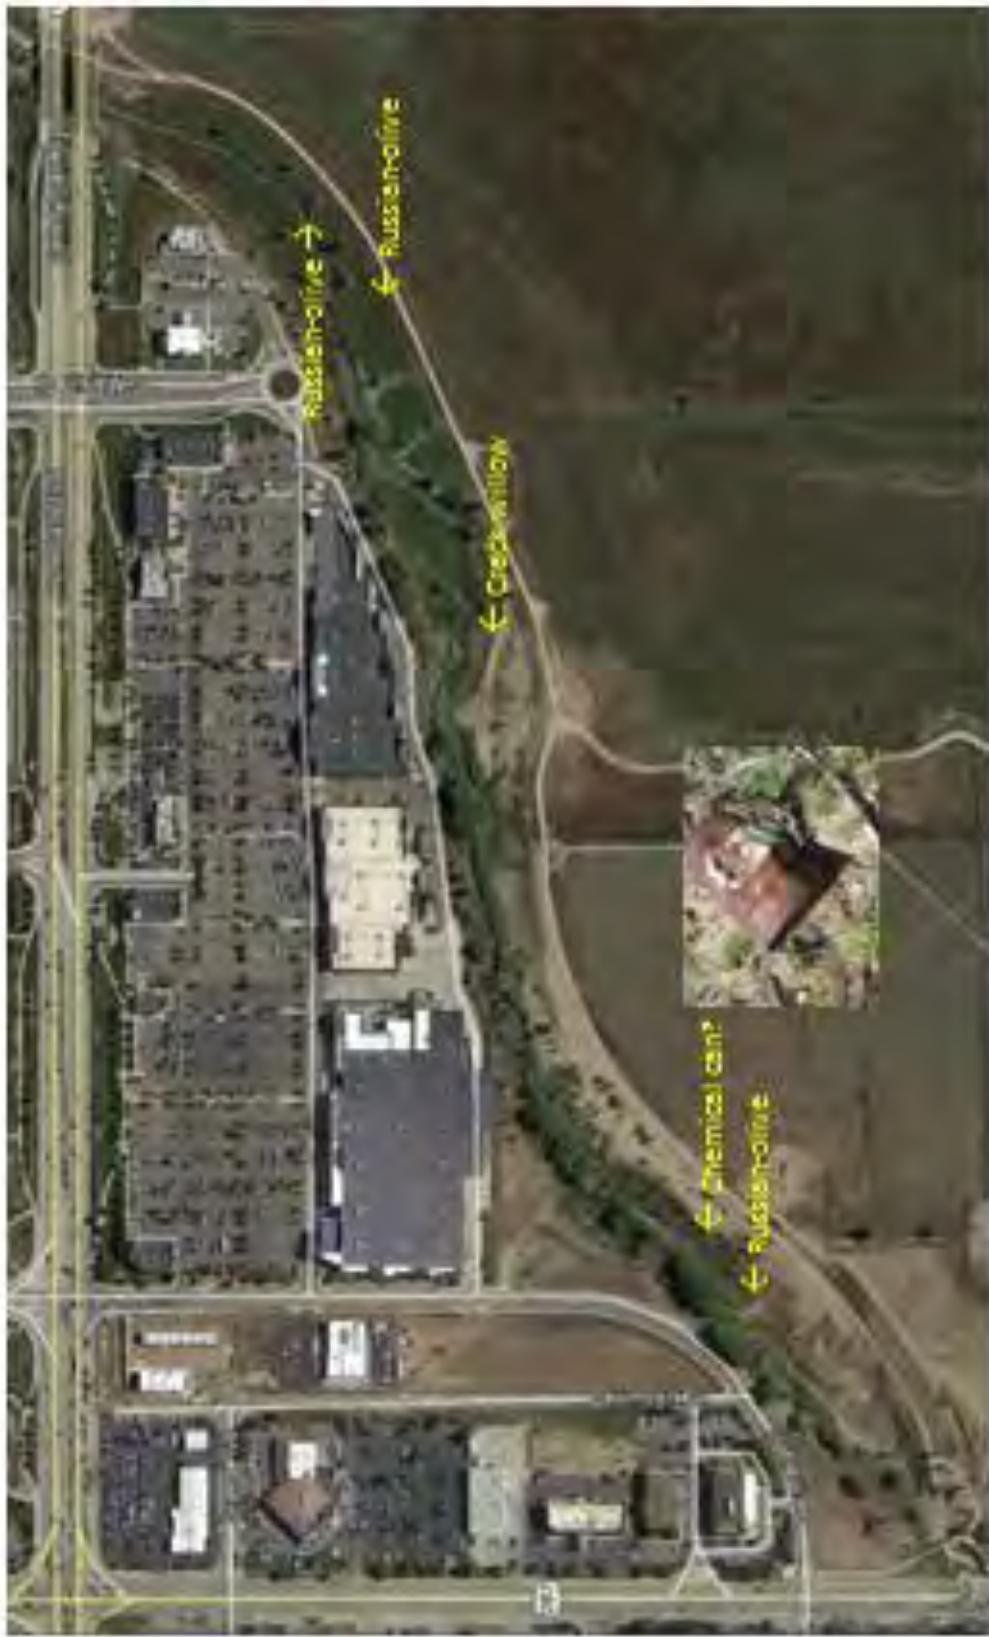
Left Hand Creek south of Ken Pratt Blvd.  
Locations of Russian-Olive, crack willow, and chemical container

Only three Russian-olive were observed and no tamarisk. Several crack willow which were present prior to the road construction project are still present. There are minor infestations of musk thistle, Canada thistle, teasel, and mullein.

Contact the City of Longmont to remove the 3 Russian-olive still present as well as crack willow.
