Wildlands Restoration Volunteers Monitoring Report Summary for Year 2016

Brief Monitoring Project Summaries (date of the original project in parentheses)

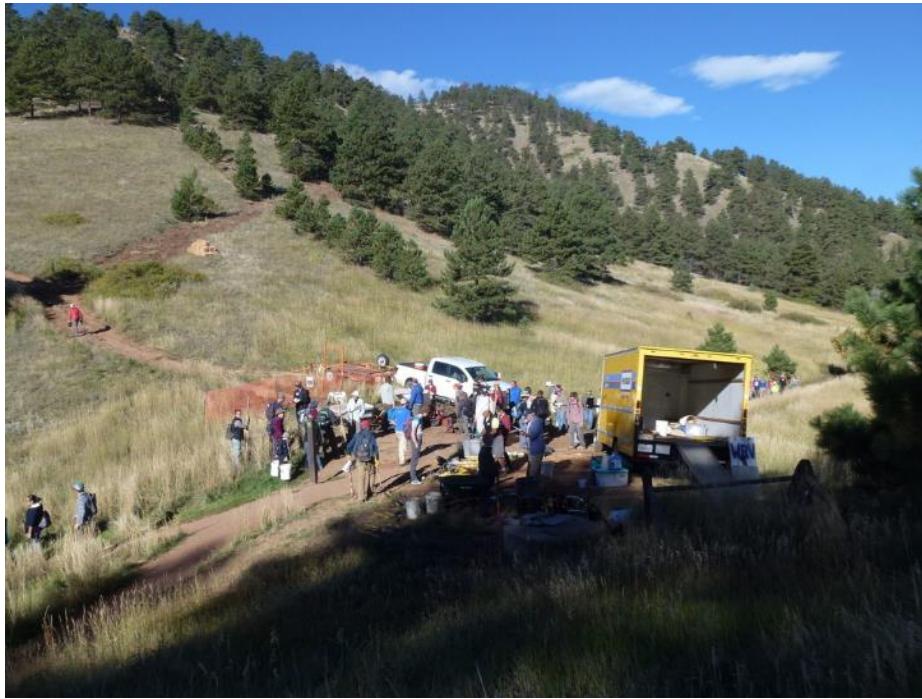
Looking west at the lower portion of the project area, which begins at the turn in the trail just above the human figure in the red jacket. The bare, scarified old roadbed is visible trending uphill. Project day, October 4, 2014

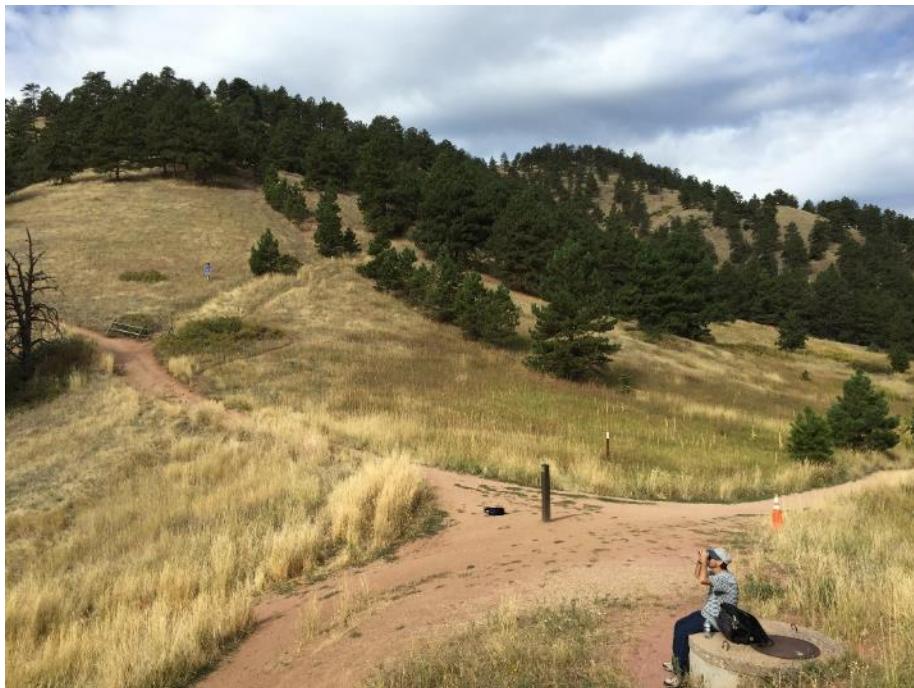
Looking west at the lower portion of the project area. The scarified area visible in the previous photograph is now not visible. September 21, 2016.

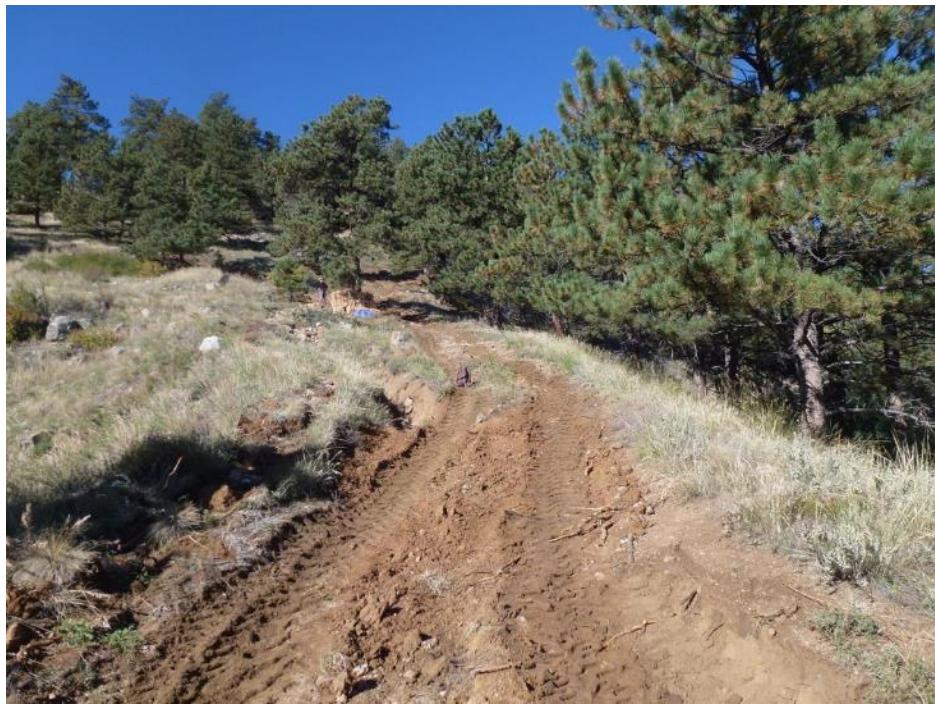
Looking west at the lower portion of the road obliteration project area prior to road obliteration by heavy equipment. October 2014.

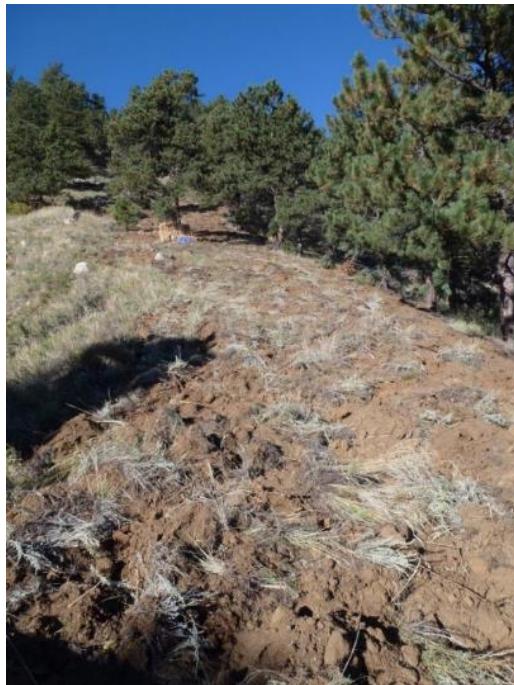
Looking west at the lower portion of the road obliteration project area after road obliteration by heavy equipment. The site is ready for seeding and scattering of course woody debris. Barring excessive human traffic, the restoration would most likely have been successful. October 2014.

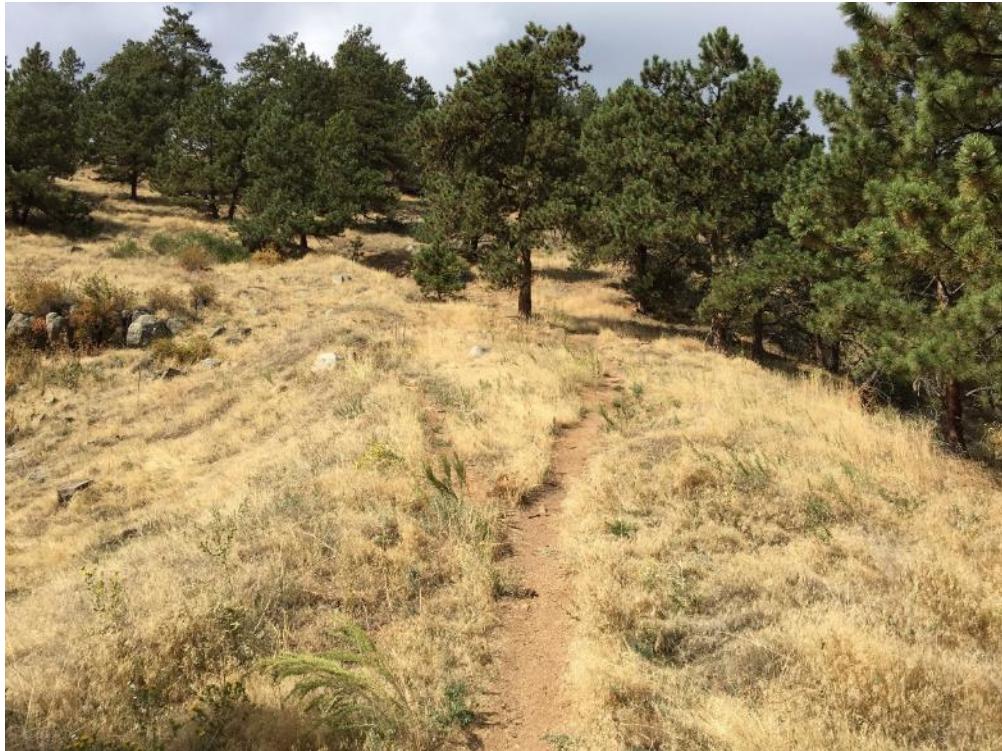
Looking west at the lower portion of the road obliteration project area. Note the drastically reduced amount of bare soil. A social has re-established following the project. September 21, 2016.

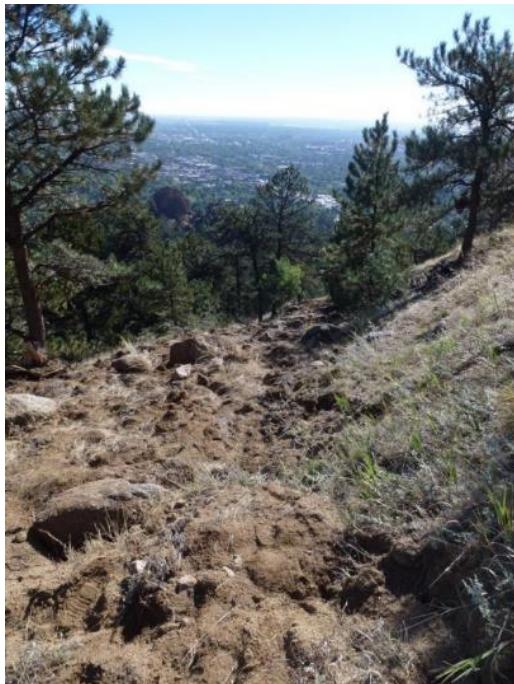
Looking east at the middle portion of the road obliteration project area after road obliteration by heavy equipment. The site is ready for seeding and scattering of course woody debris. Barring excessive human traffic, the restoration would most likely have been successful. October 2014.

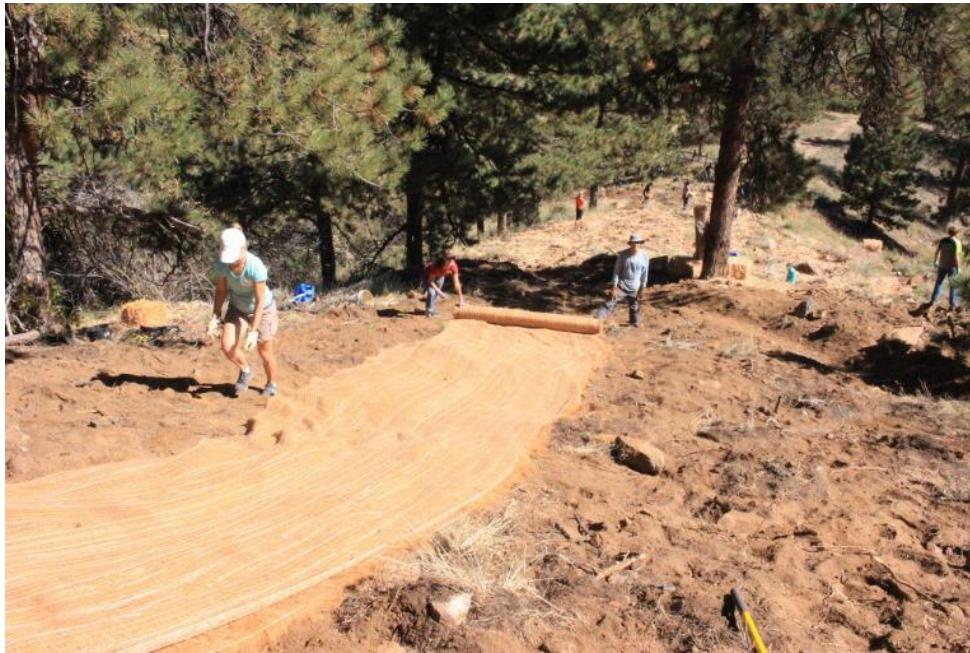
Looking east near the middle of the project area at erosion mat being installed on a particularly steep slope. Project day, October 4, 2016

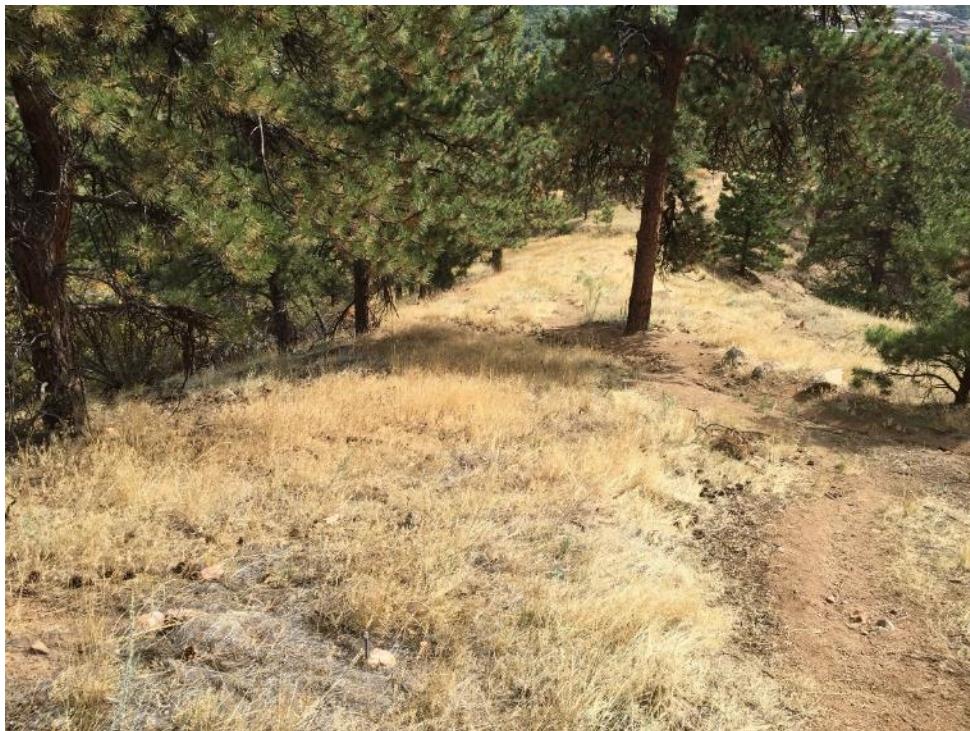
Looking east near the middle of the project. The erosion mat is invisible and the bare soil has largely been revegetated except for the social trail that re-established after the project.

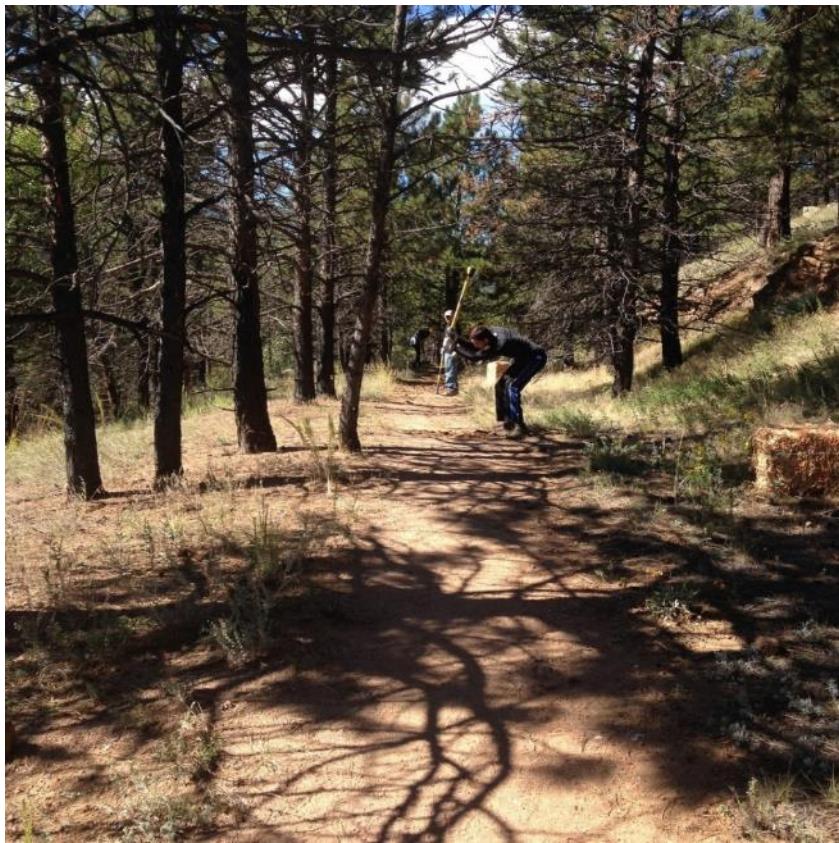
Looking west at a segment of level trail being scarified prior to seeding and application of wood staw.

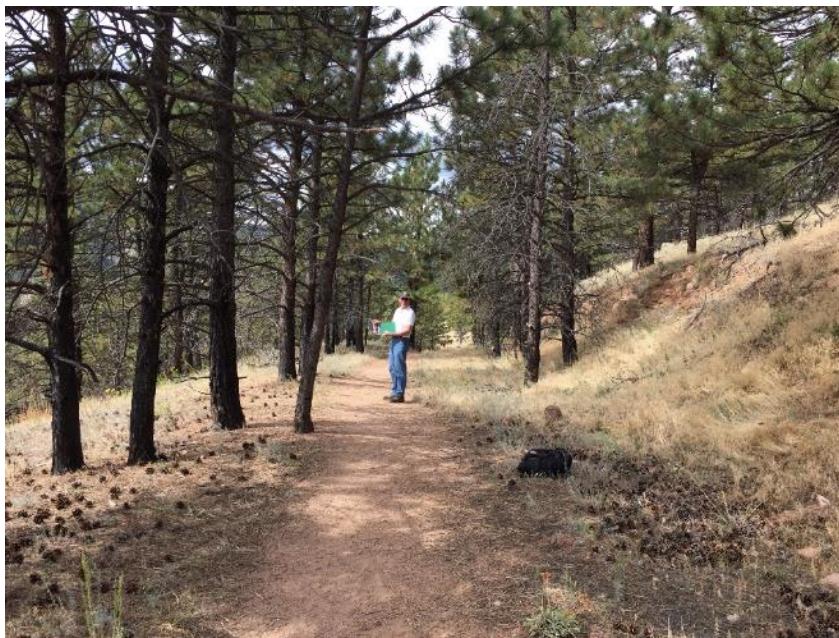
Looking west at a segment of level trail. The restoration was a complete failure due to continued human use. The wood staw is completely gone.

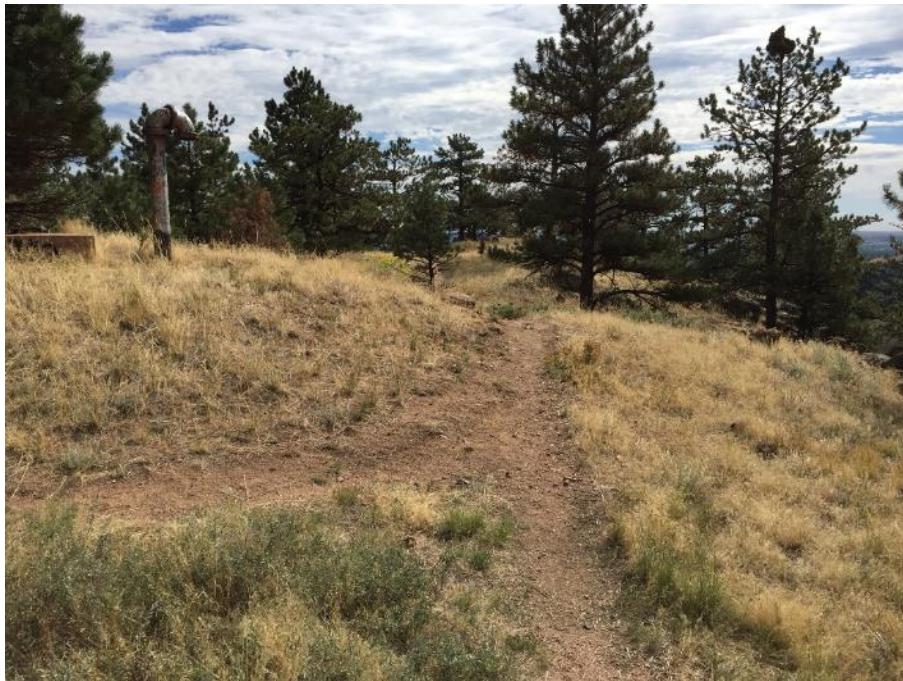
Looking east at the top of the project area. The restoration was unsuccessful due to continued human use of the trail. The wood straw mulch was completely gone.

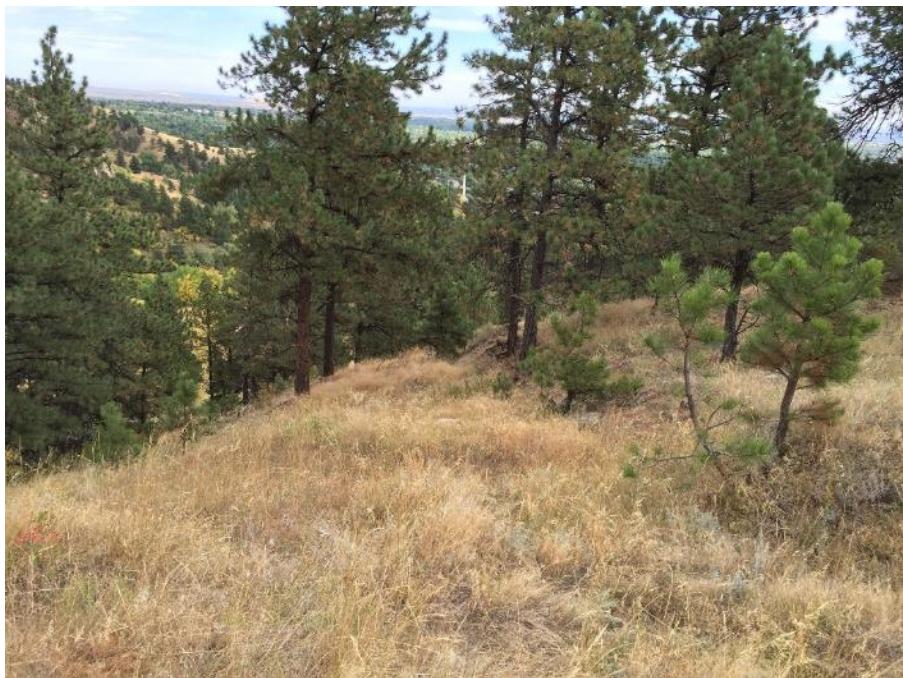
Looking northeast near the top of the project area. The restoration was successful here due to lack of excessive human use post-project. No social trail is visible here.

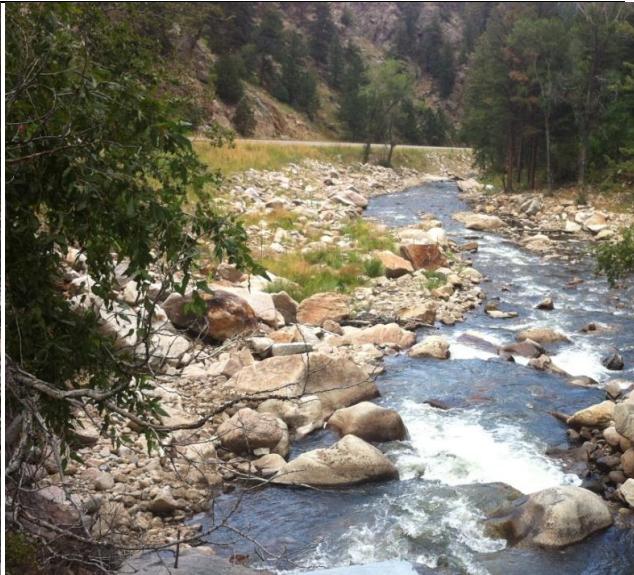
August 19, 2016 - 3 months post-project: note vegetation developing on low floodplain of river left.

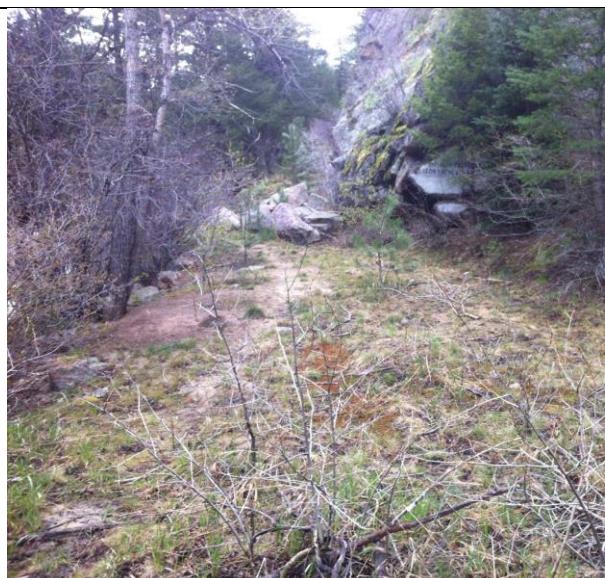
View downstream from bridge

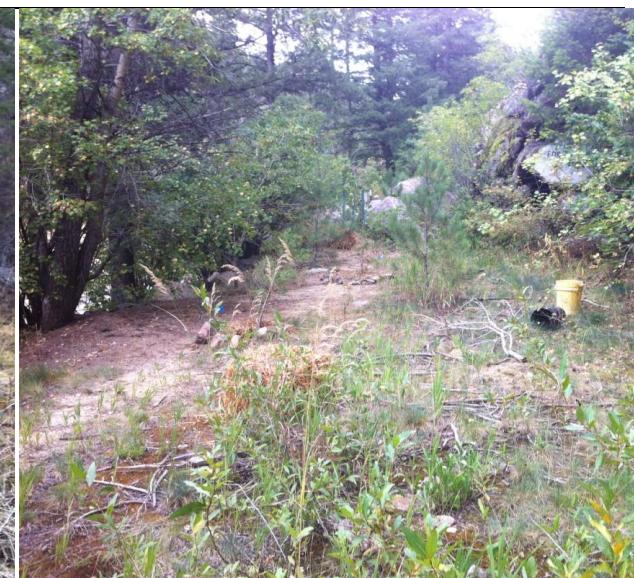
August 2016: Note good growth of planted ponderosa pine that will help block the old jeep trail from vehicle use.

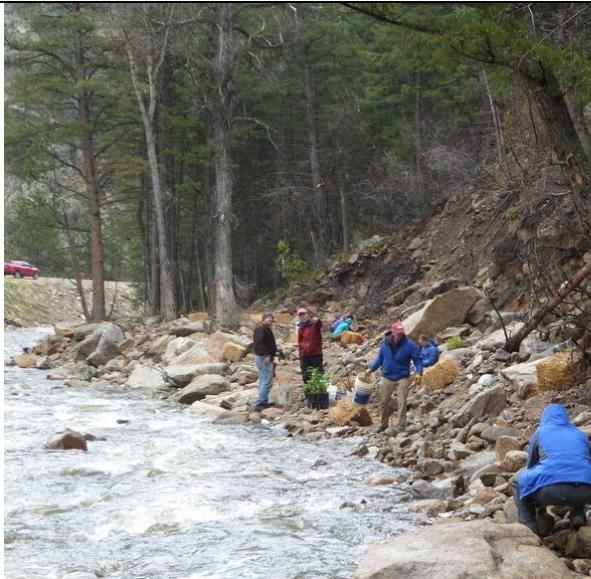
May 2016: Note high water covering low floodplain.

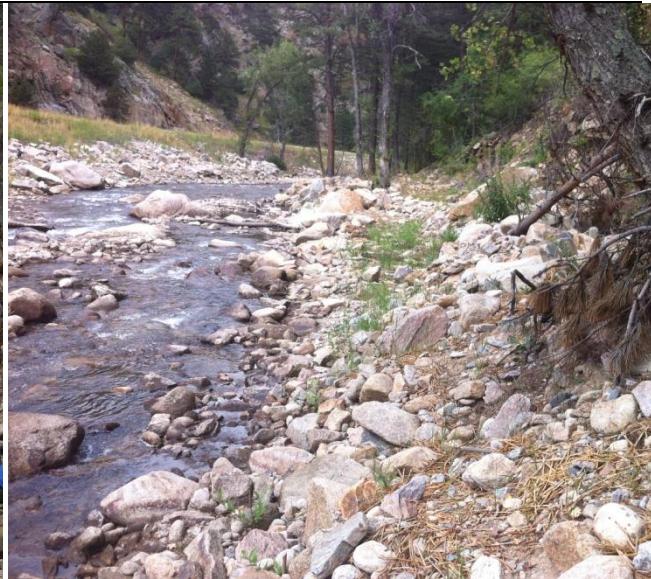
August 2016: Note good vegetation growth in exposed cobbles of low floodplain.

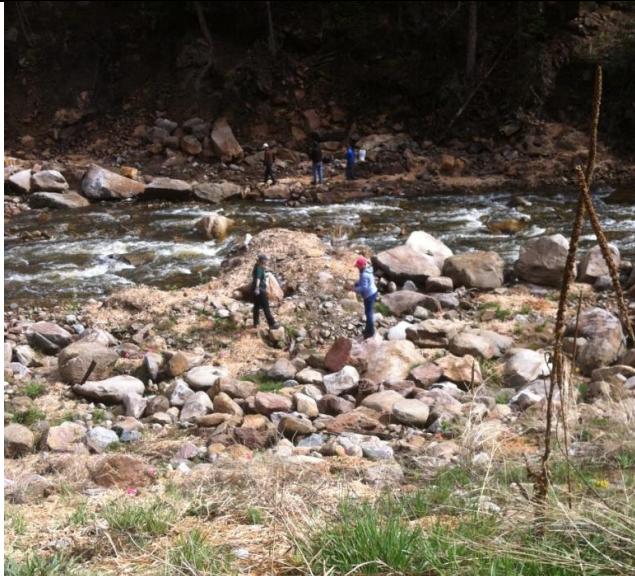
May 2016, upstream end of Section 2 in center of photo. Note tall stalks of weedy mullein.

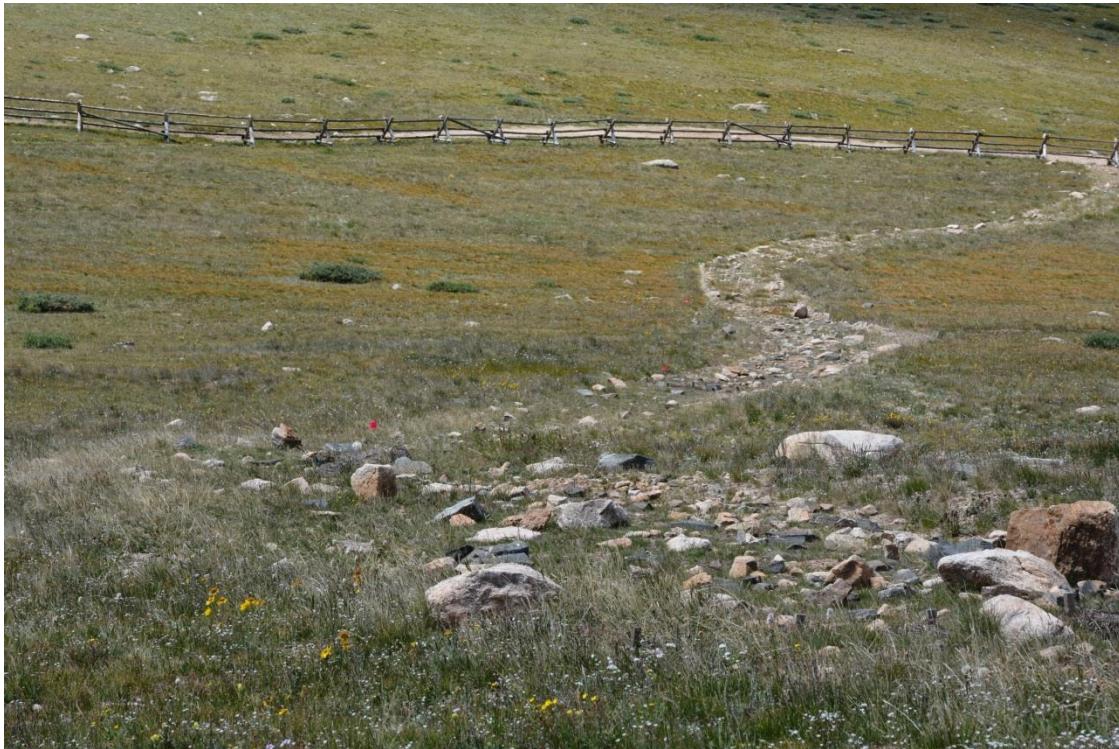
2016: Rock cover area in foreground shows old road blending into existing vegetation. You can still see the outline of the road in lower sections but it is largely vegetated at this point.

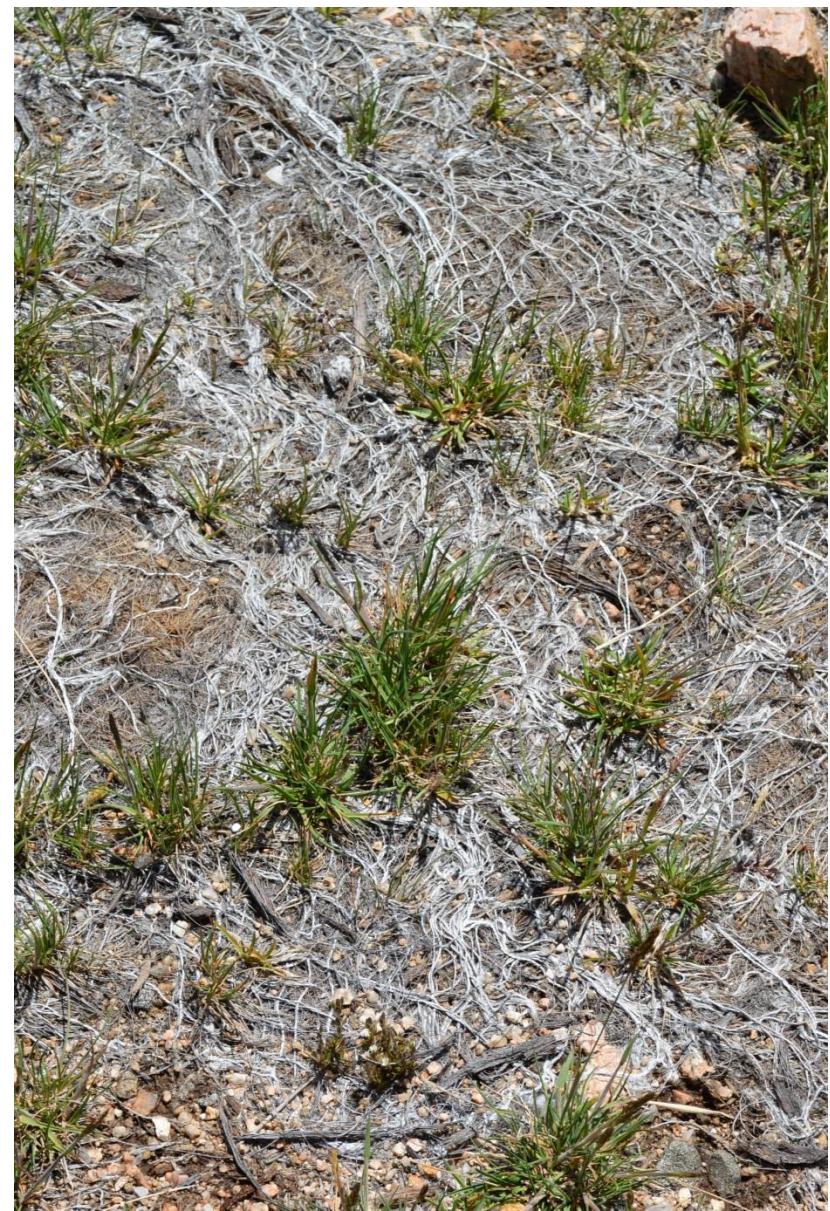
2016: Close up of erosion matting 4 years after installation at elevation ~ 11,500ft. It is largely decomposed but still providing some structure. Tufts of vegetation are from seeded species and natural recruitment.

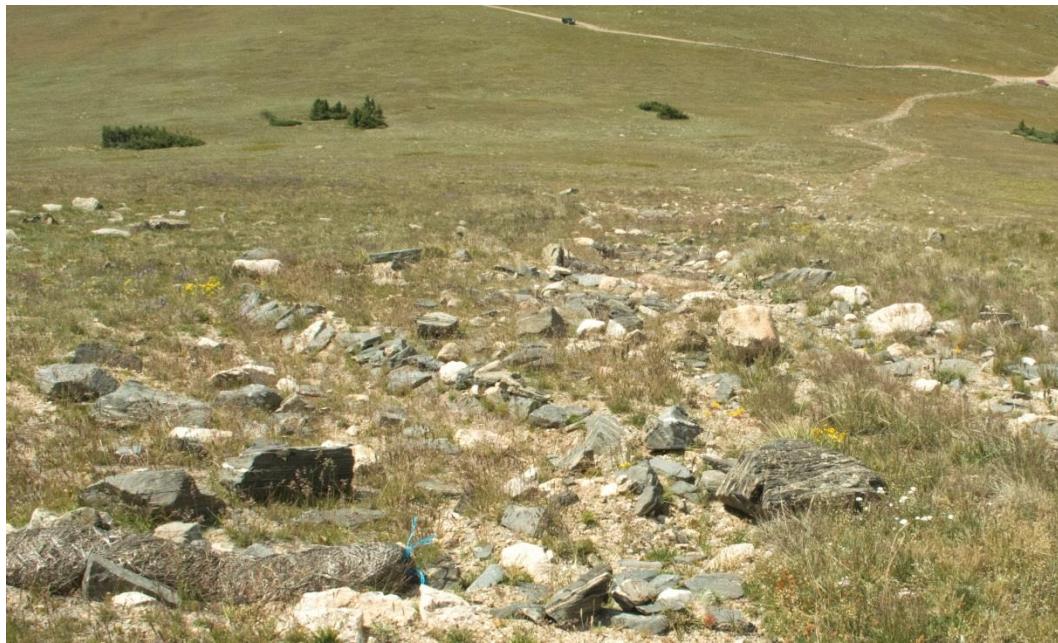
2015: Note undulations and rock cover

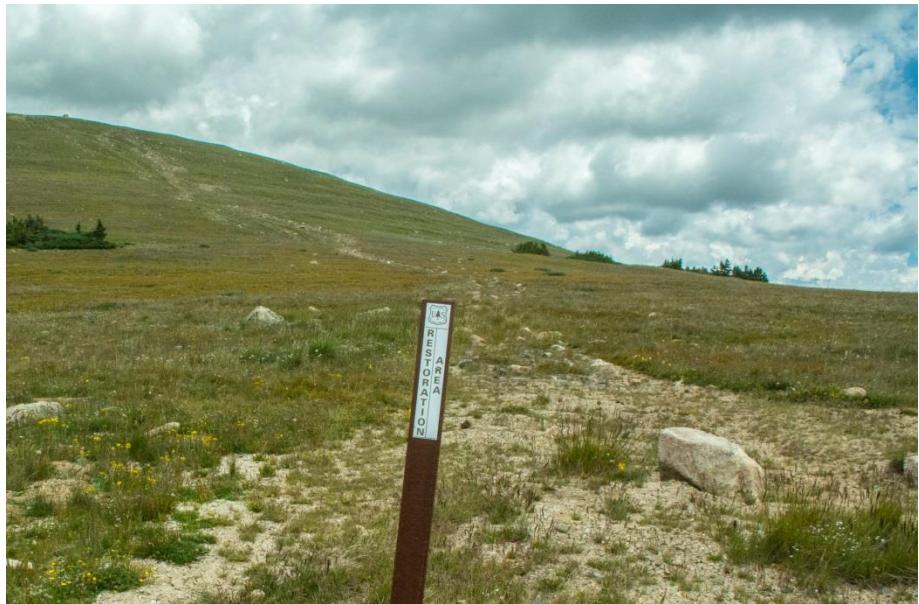
2011: Year prior to project.

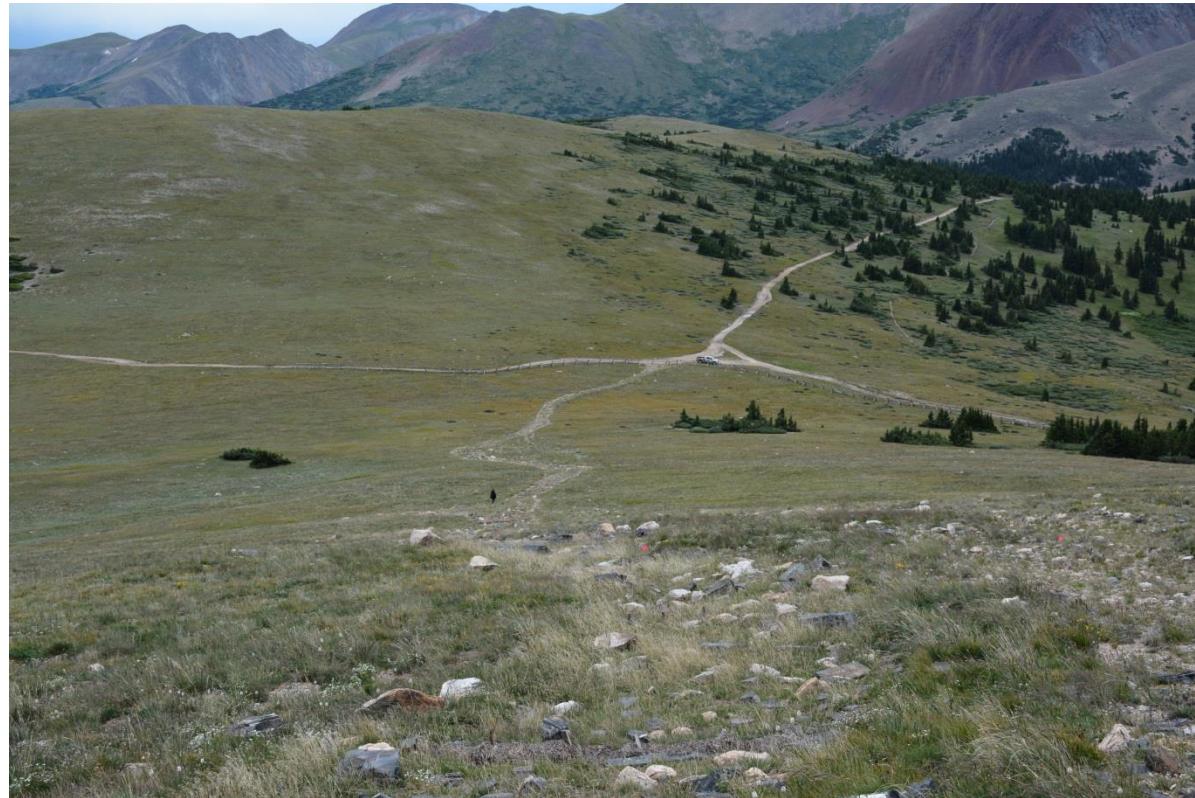
2016: Erosion matted area up higher that is doing very well. Note there is still some rock cover on top of the matting and you can see a straw wattle at the very bottom of the photo.

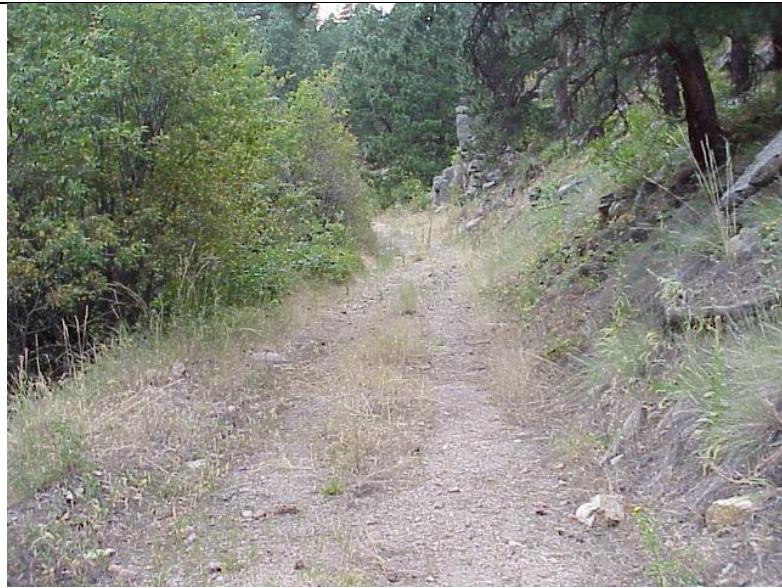
2001: Note double track road, the project revegetation target.

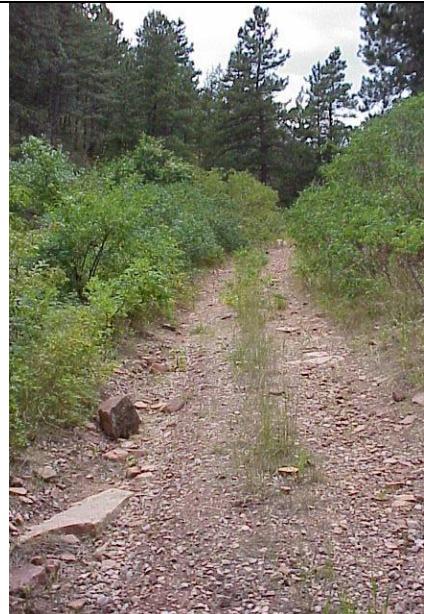
2001: Note shallow ruts and vegetation only in center of road.

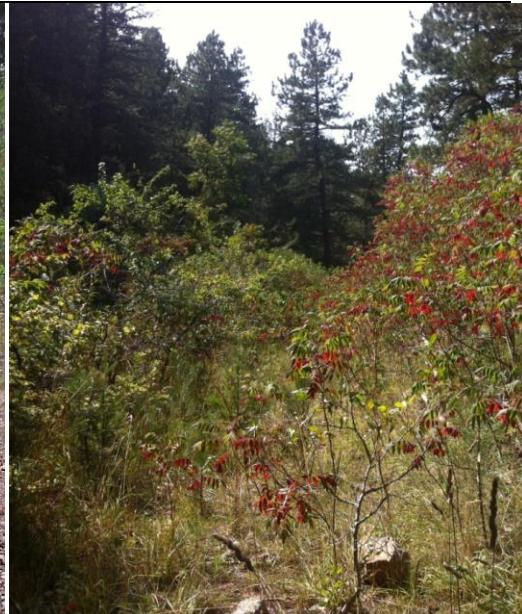
2016: Note that old road surface is densely vegetated with grasses and volunteer sumac.

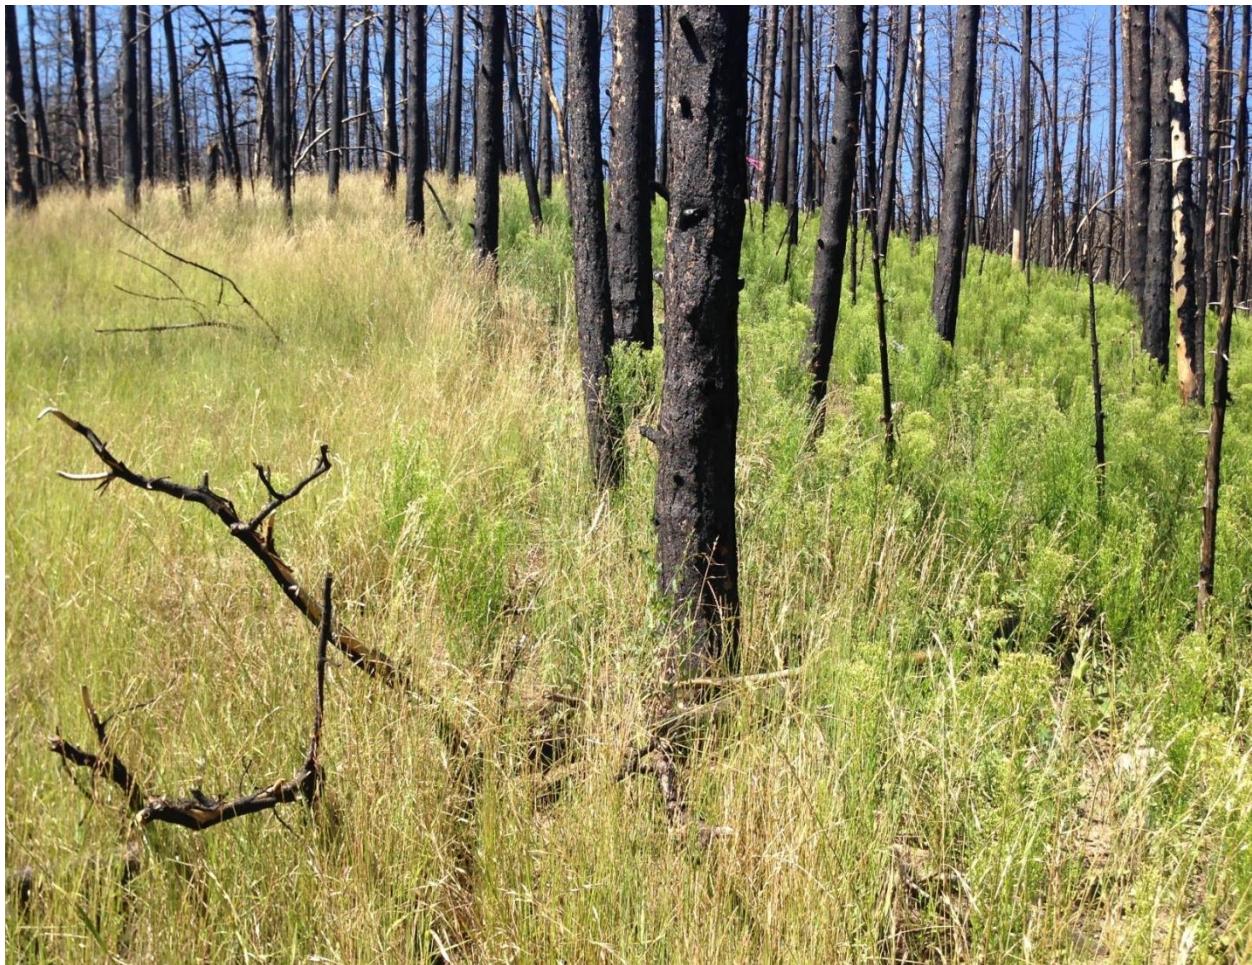
The left side of this photo was seeded and mulched; the right side was a control (do nothing) plot. Note the high abundance of grasses on the left side and the abundance of horseweed (*Conyza canadensis*) on the right side.

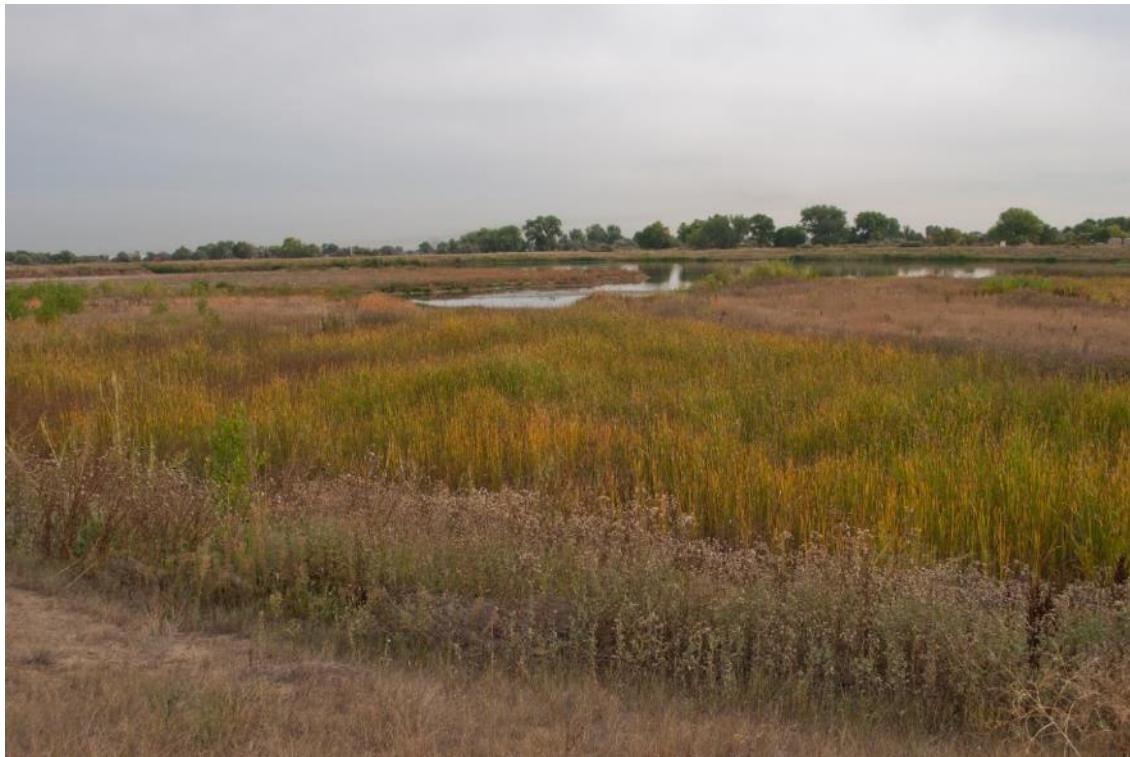
Looking northeast across Area #2; wetland dominated by narrow-leaf cattail; photo taken 9/20/16.

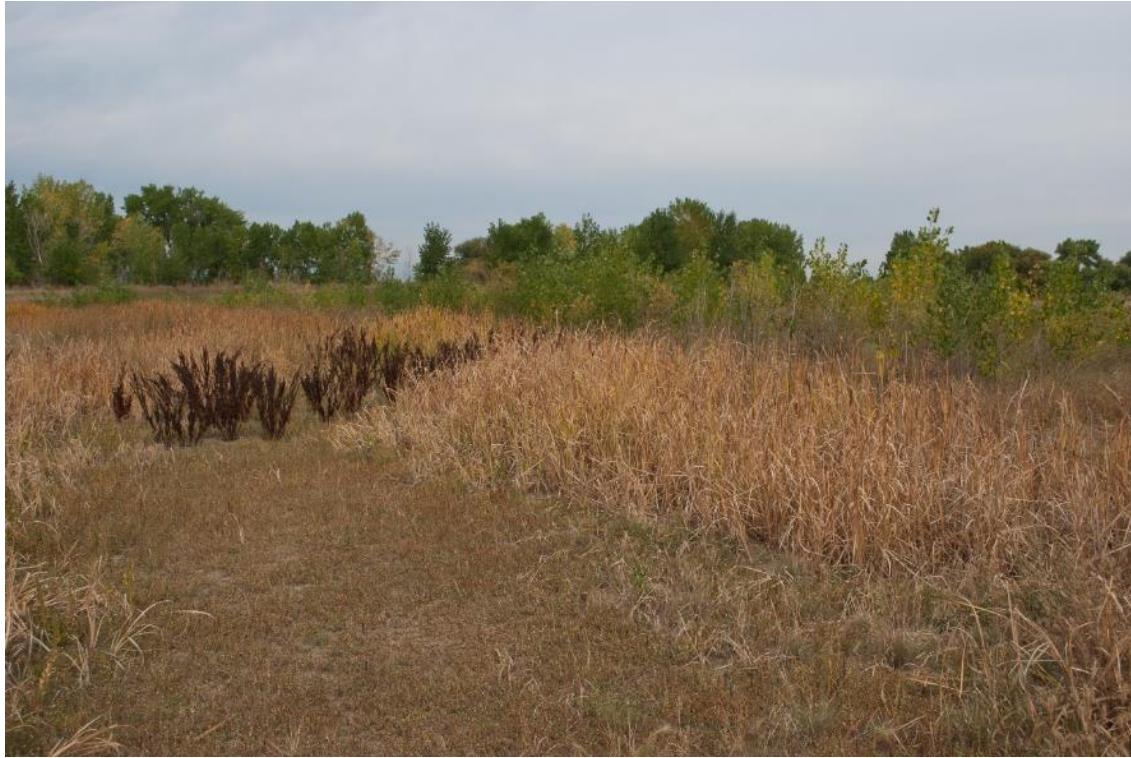
Looking east along the edge of water in Area #1 (?); the green bunches are spikerush; a few American three-square plants present; photo taken 9/20/16.

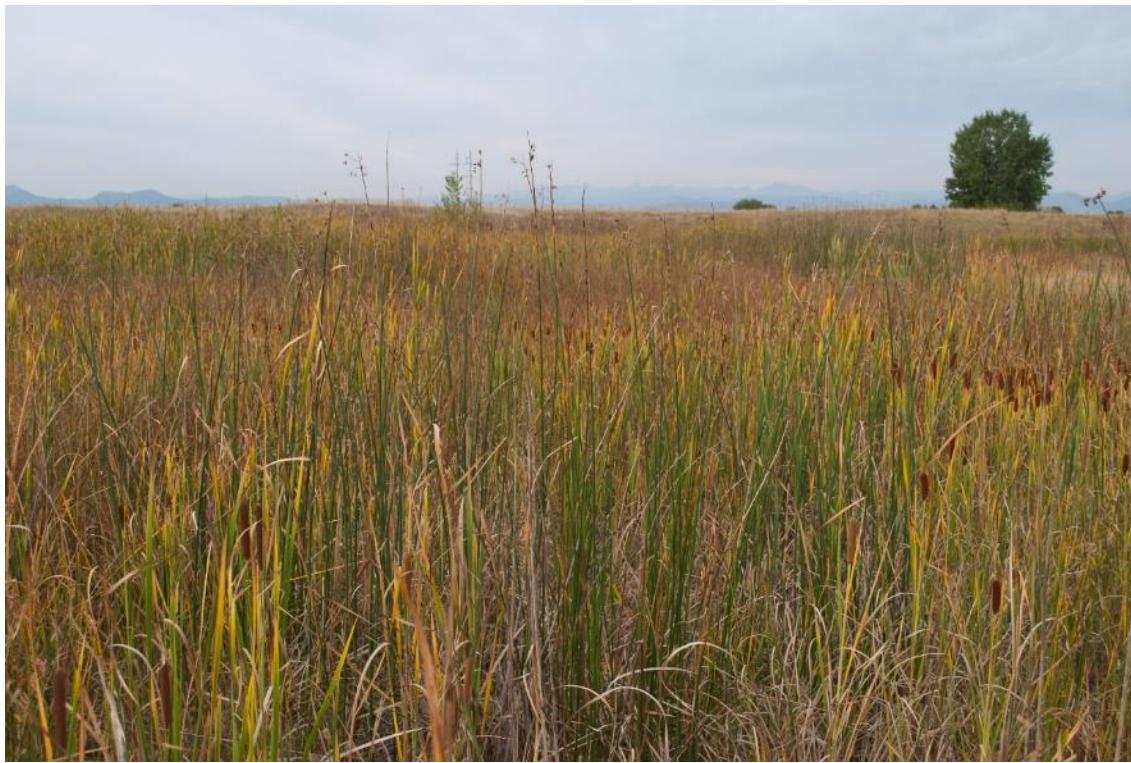
Looking west at bulrush plants and cattails in Area #1 (?); photo taken 9/20/16.

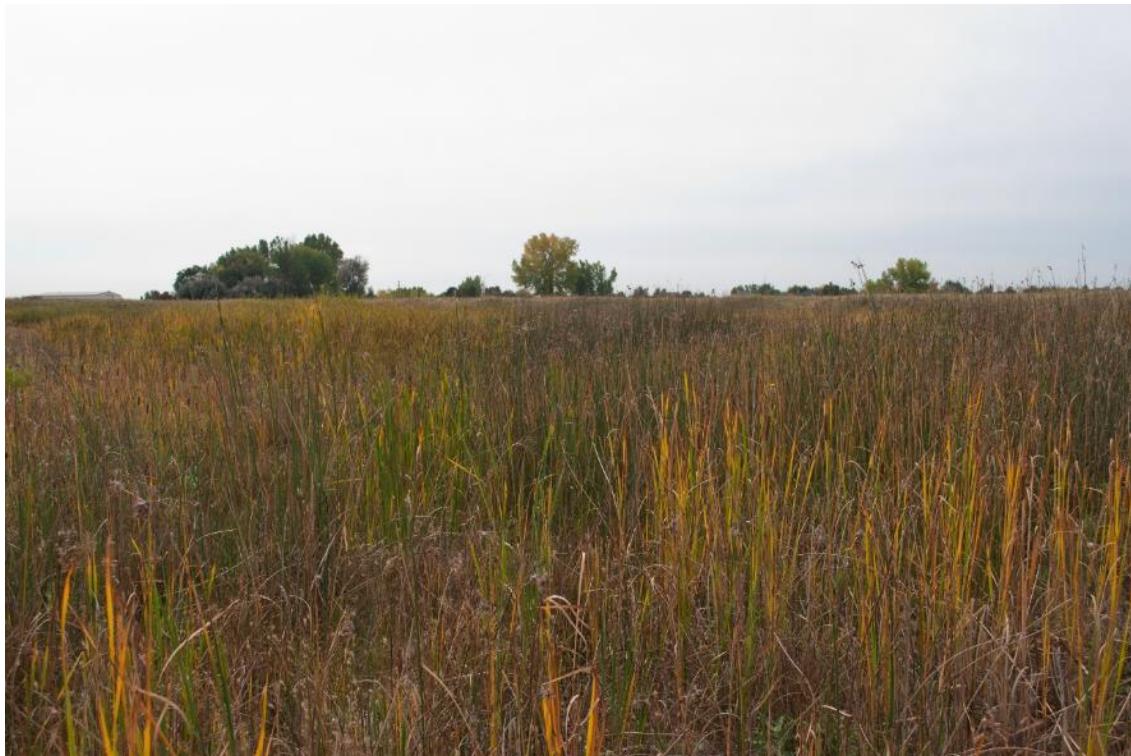
Looking east at bulrush plants at southern edge of Area #3 (?)

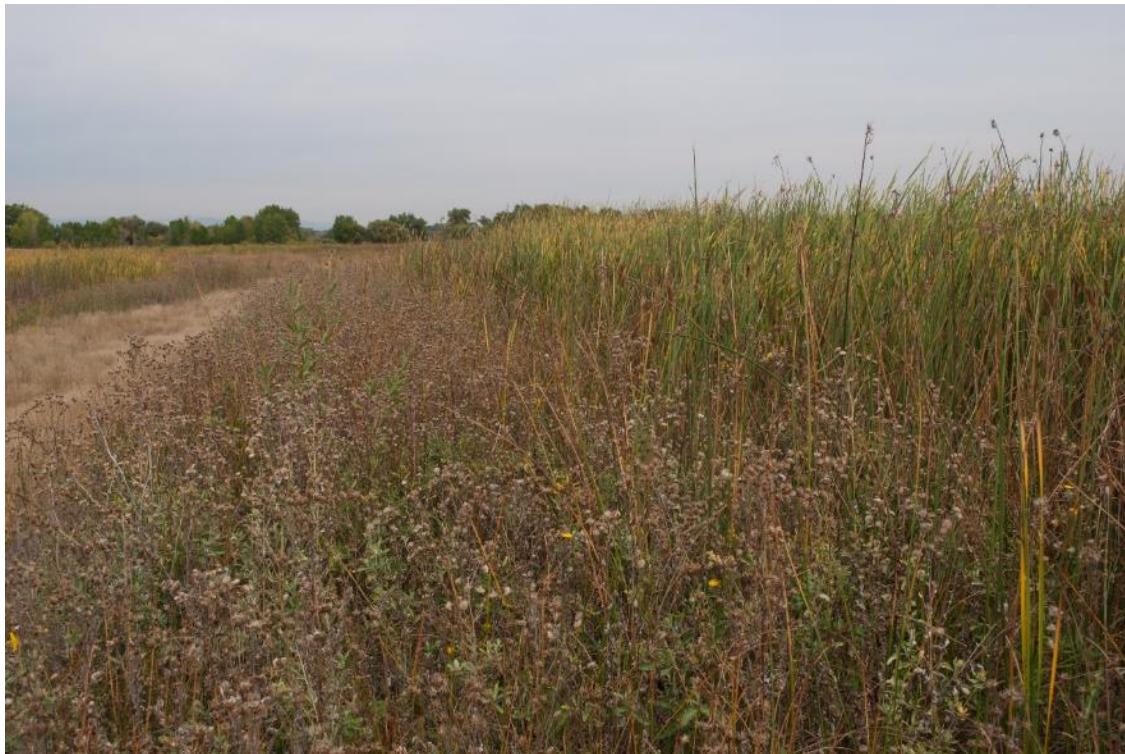
Looking north-northwest at bulrush along western edge of Area #10; abundant Canada thistle plants; photo taken 9/20/16.

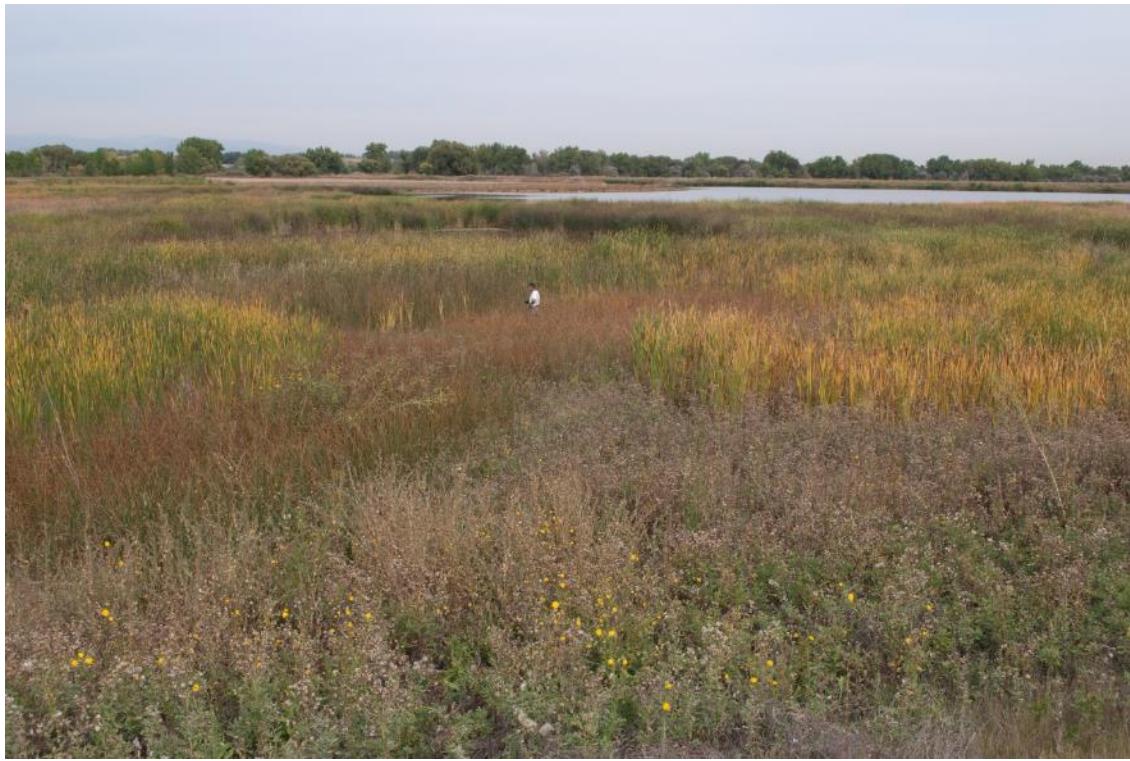
Looking north at dense stand of American three-square at southern edge of Area #10; photo taken 9/20/16.

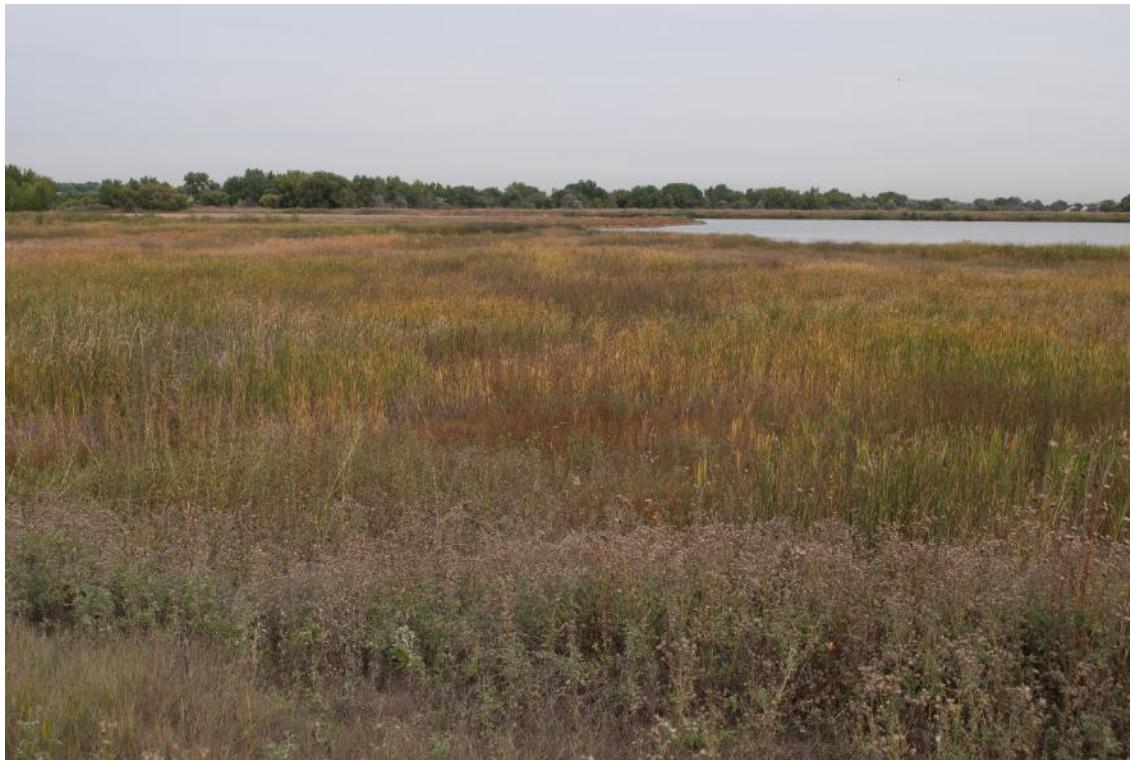
From hill top, looking north at dense stand of American three-square and bulrush a southern edge of Area #10; photo taken 9/20/16.
