Wildlands Restoration Volunteers Monitoring Report Summary for Year 2016

Brief Monitoring Project Summaries (date of the original project in parentheses)

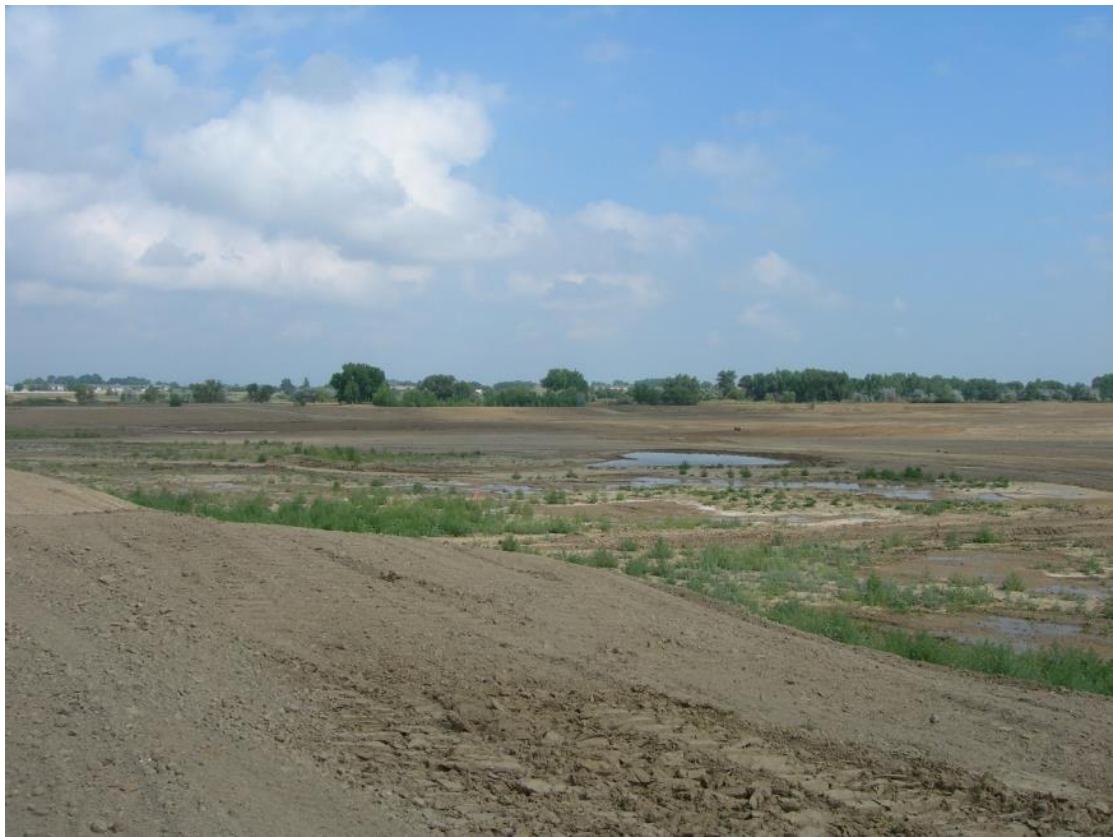
Kenosha wetland – Spring 2008. Looking northwest across the project site prior to planting. Note the abundance of bare ground and sparse vegetation. The cover of native wetland plant species is vastly greater now than it was prior to the project. Unfortunately, most of that cover comes from cattails.

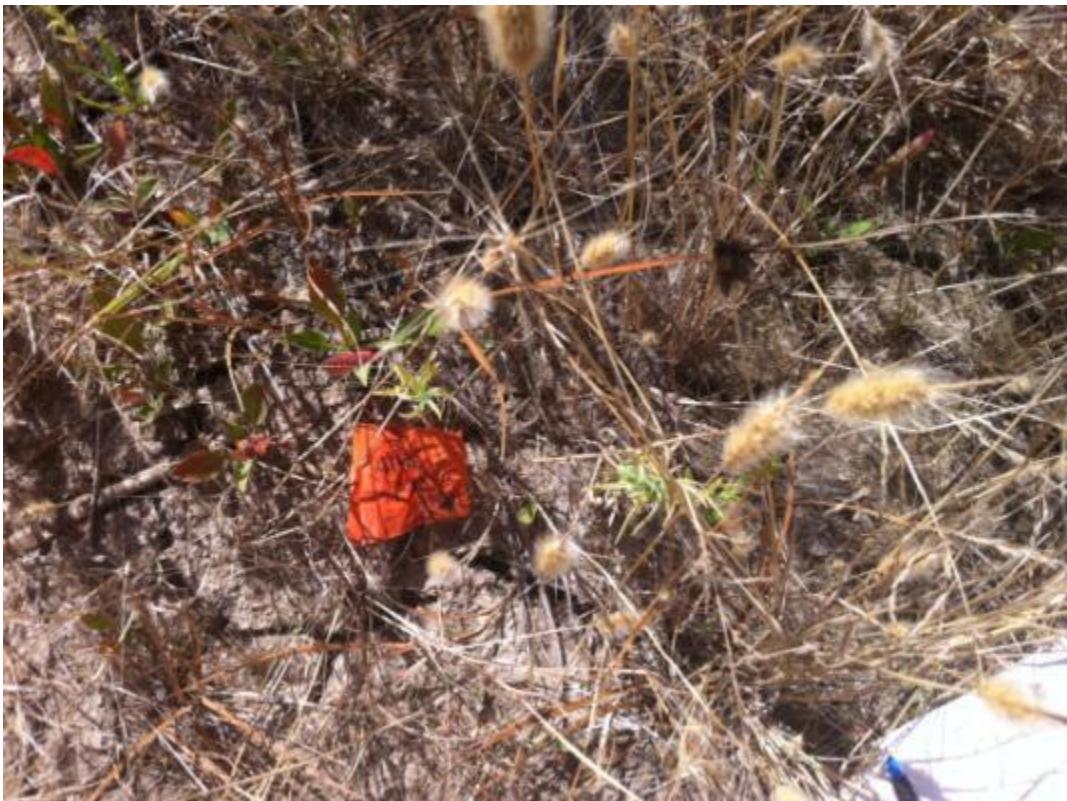
Stunted plantings of alkali bulrush among rabbitfoot grass in Zone 6. Note cracked soils.
August 17, 2016

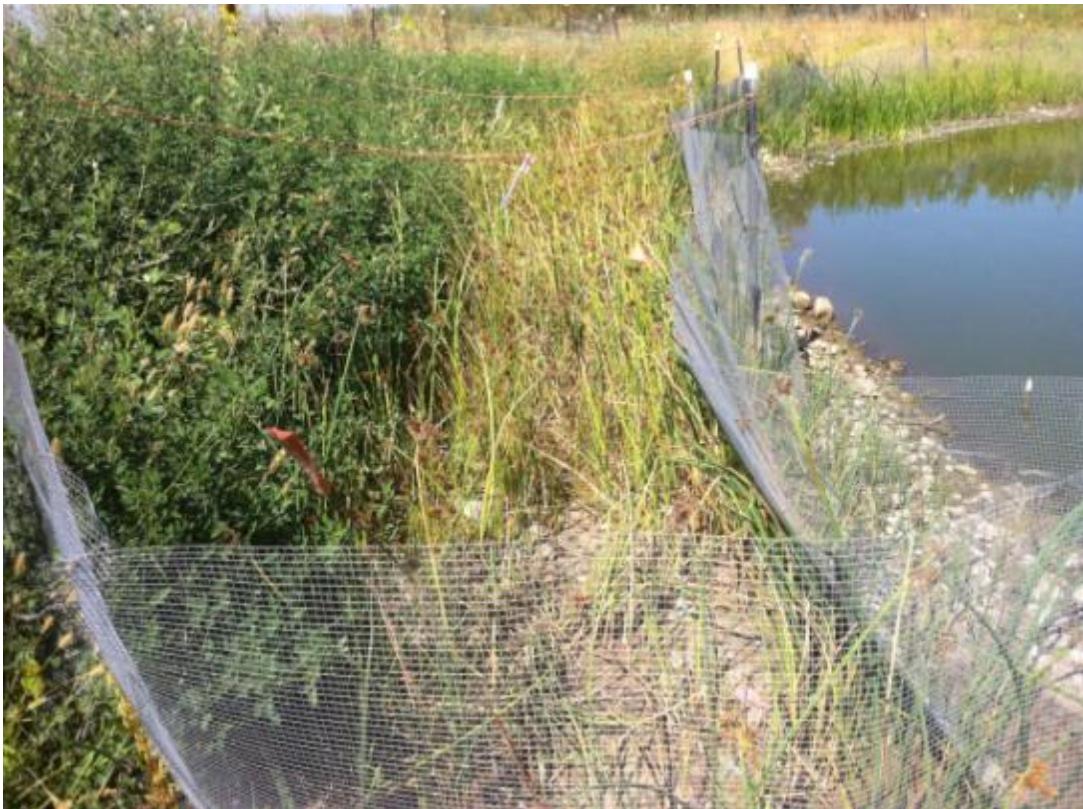
Western Zone 3 at left dominated by alfalfa and Zone 2 at right
with poorly developing plantings of softstem bulrush. August 17, 2016

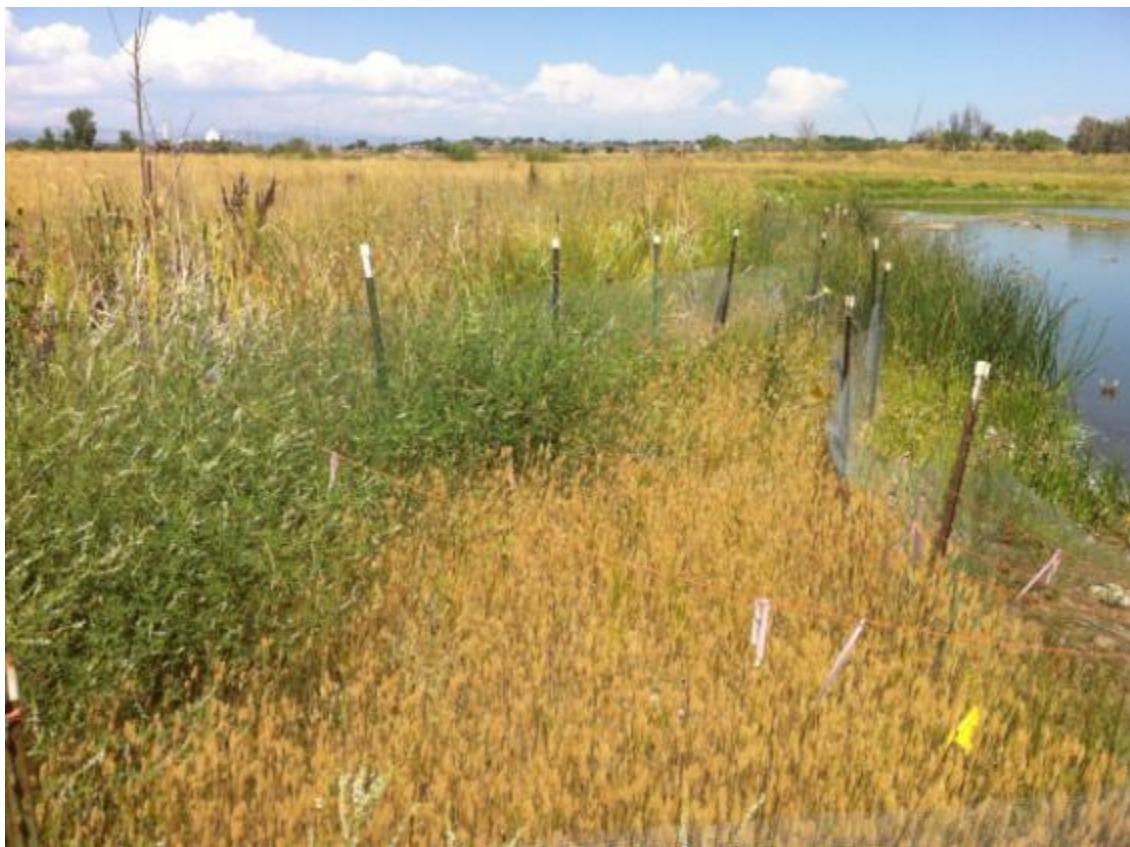
Torrey's rush developing in sedge planting area. August 17, 2016

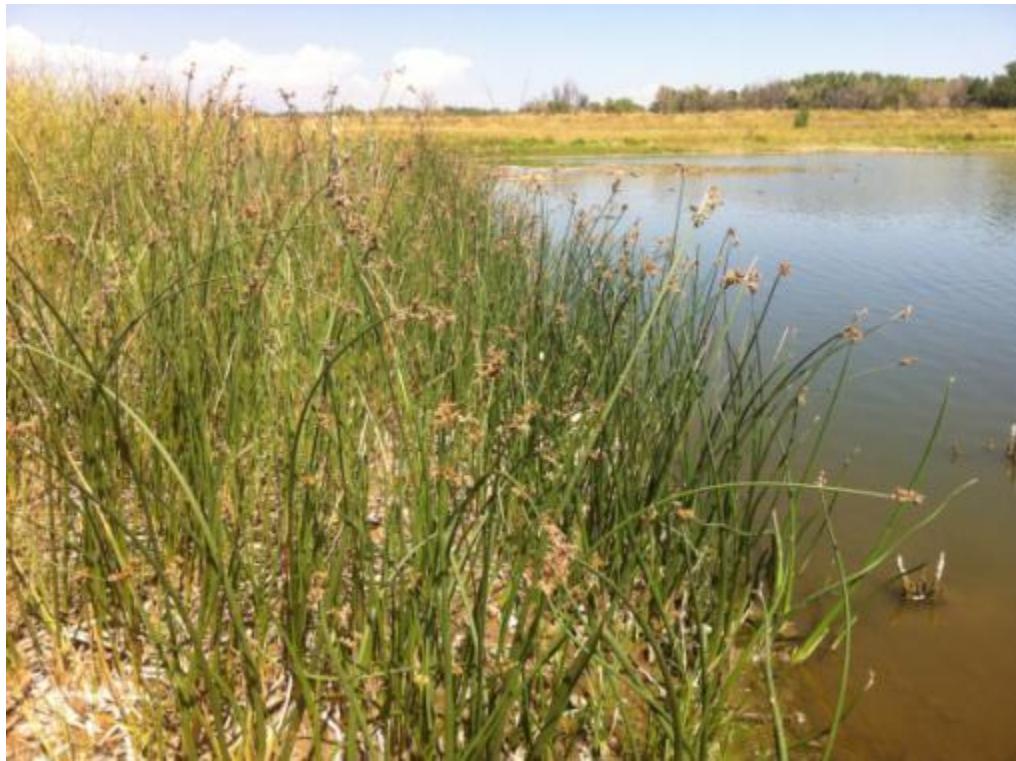
Possibly Zone 7, Baltic rush understory in rabbitfoot cover. August 17, 2016

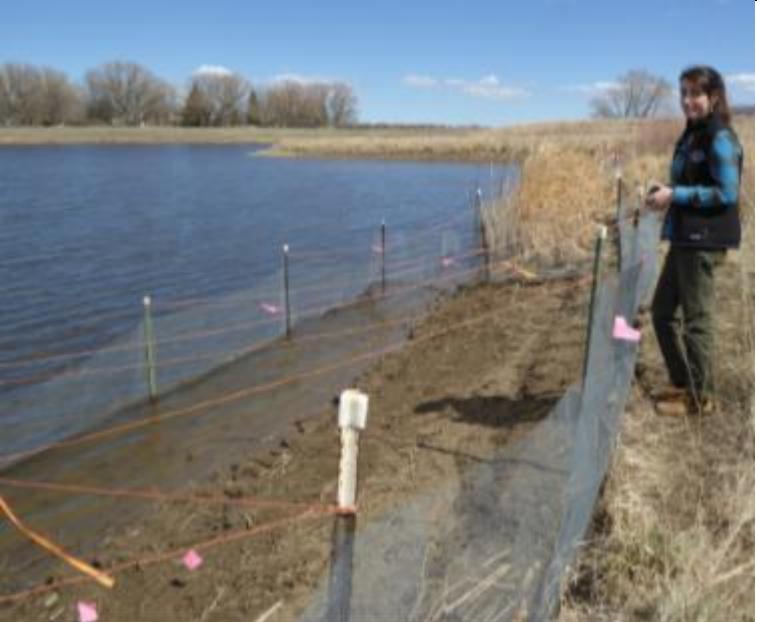
Zone 7 softstem bulrush planting area. The bulrush probably have rooted from the planting area out into the standing water. August 17, 2016

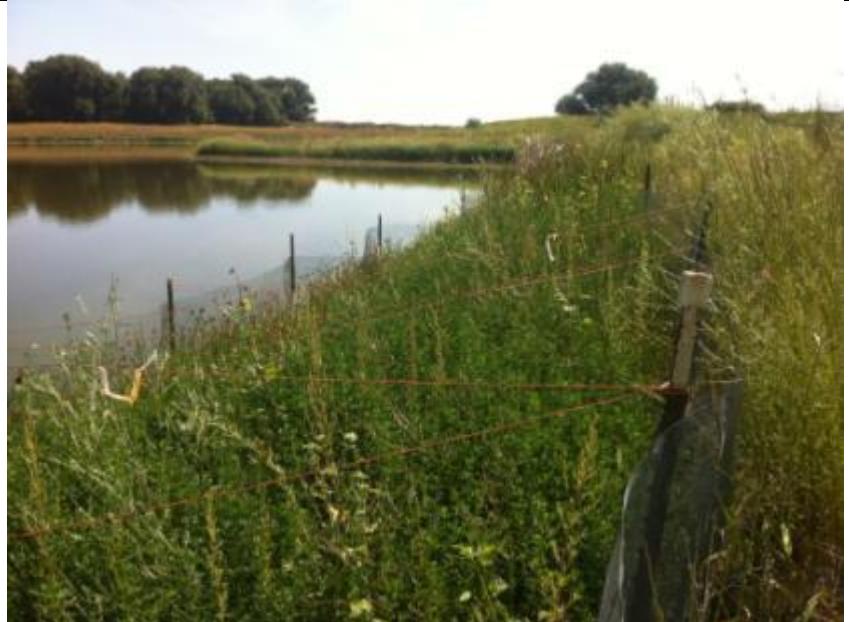
August 17, 2016 - end of 1st growing season. Note minor plantings of softstem bulrush at edge of water and dominance of non-native alfalfa in upper area.

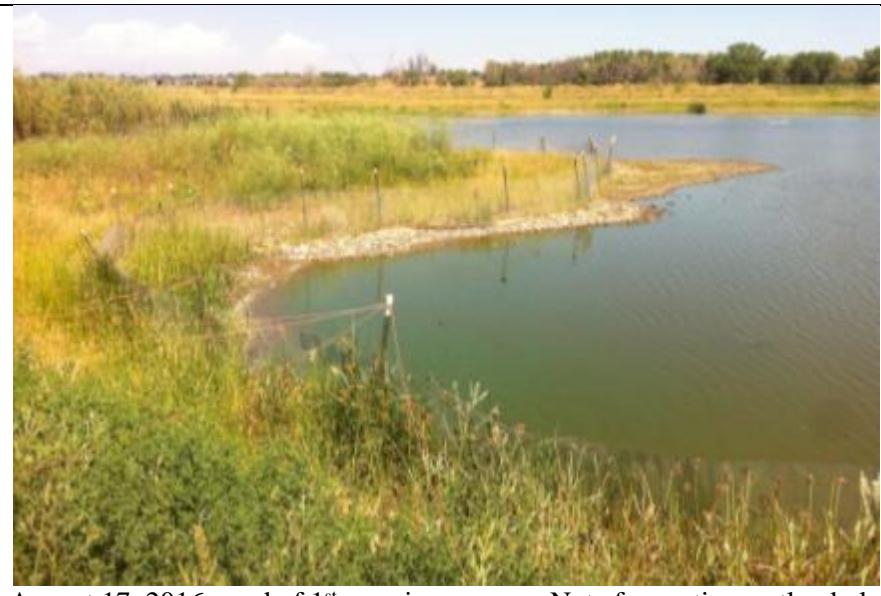
August 17, 2016 - end of 1st growing season. Note few native wetland plants are visible.

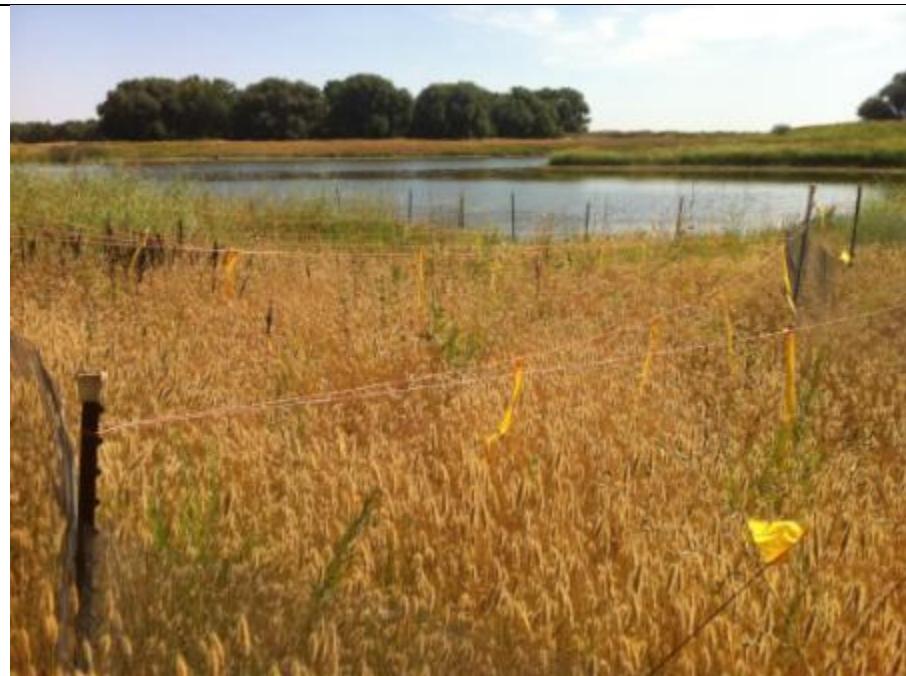
August 17, 2016 - end of 1st growing season. Note dominance by non-native rabbitfoot grass in alkali bulrush planting area.

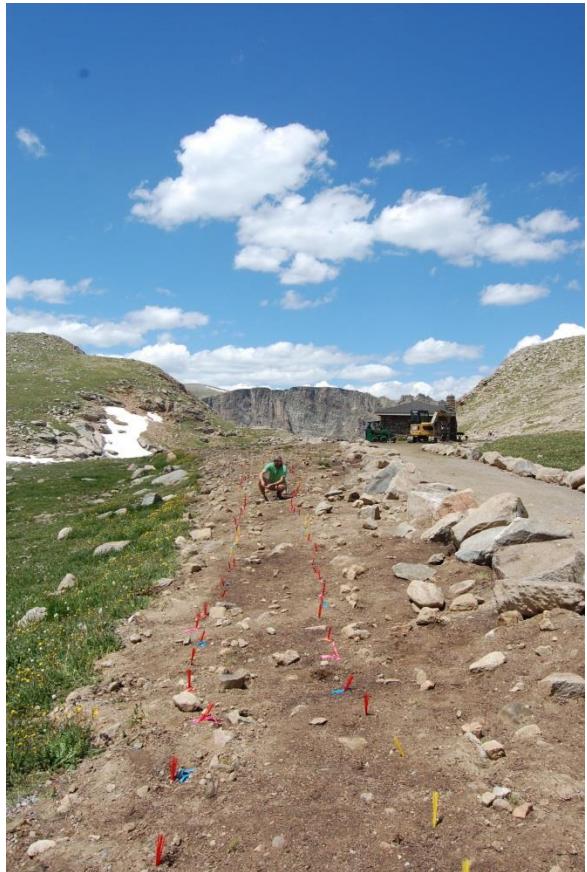
2011: Bare ground after planting and seeding. Note the disturbed ground is a slight slope from the rock lined trail on the right to the natural vegetation on the left.

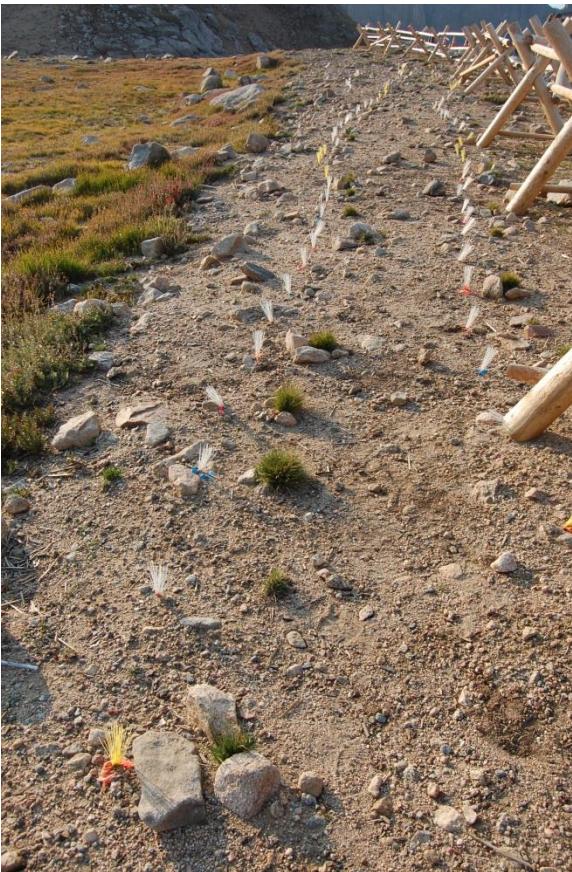
2012: One year later. Note the growth of some of the plugs (offset slightly to the right from the flags in this photo. There is minimal natural recruitment. The fence is now in place.

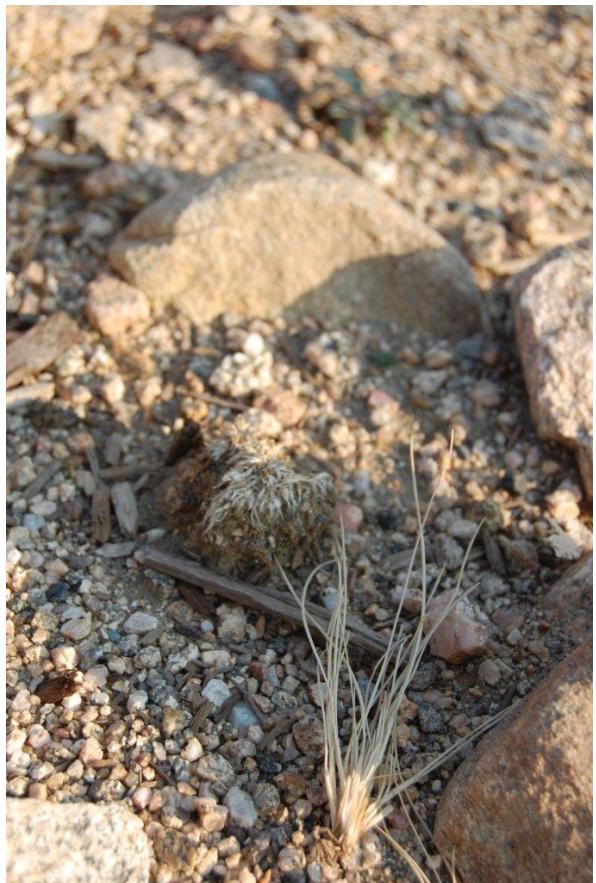
Plug that did not survive. Note that it is ~1 inch above ground level. Either freeze thaw or erosion cause this.

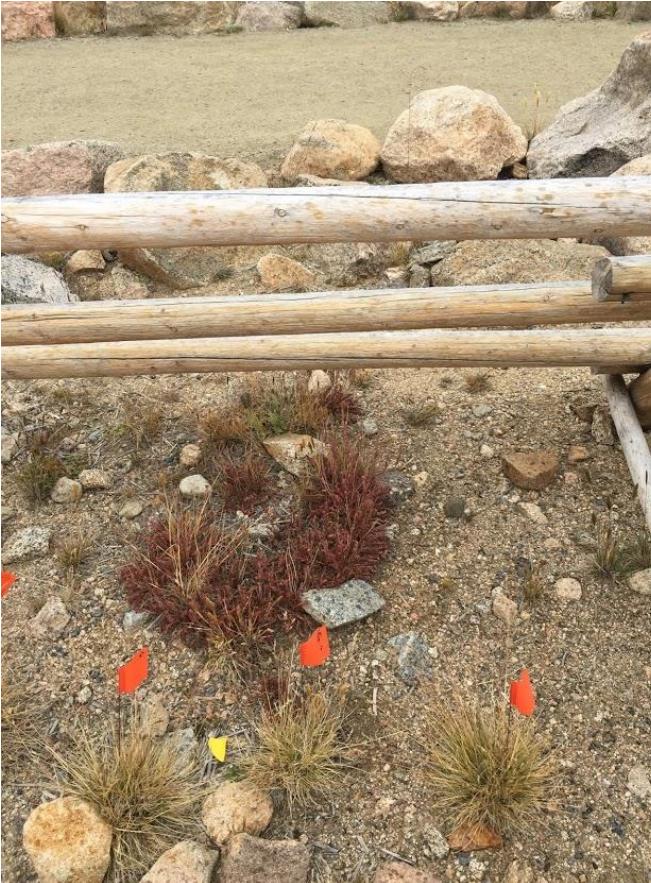
Large plug from backhoe above three planted plugs that had rock cover (marked with orange flags). Note the growth of the plugs and how they have filled the area between placed rocks.
