Wildlands Restoration Volunteers 2017 Site Monitoring Report: A Glimpse of Successes, failures and potential futures.

February 24, 2018.

Project Name: Rock Creek Restoration Project Date: June 15, 2005

Project Name: Left Hand Canyon Restoration

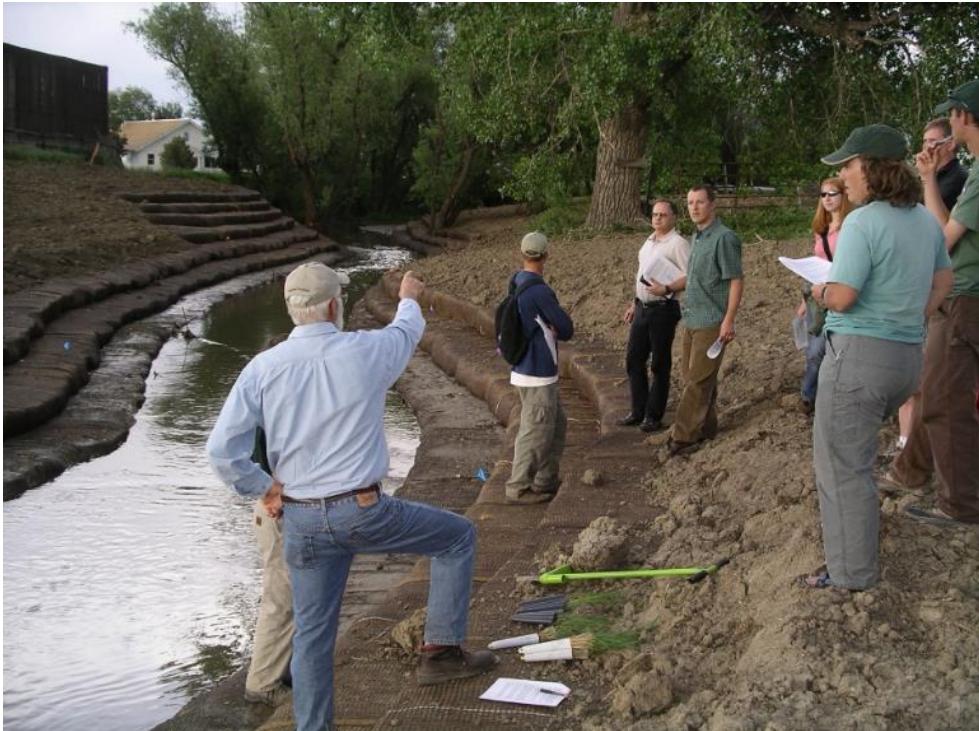
Photo 1, Pre-project 2005: View east-northeast (67 degrees) up Rock Creek. Note zero riparian vegetation on the soil lifts. Photo taken during crew leader orientation.

Monitoring 2017: No site comparison photo due to dense coyote willows obscuring the riparian area.

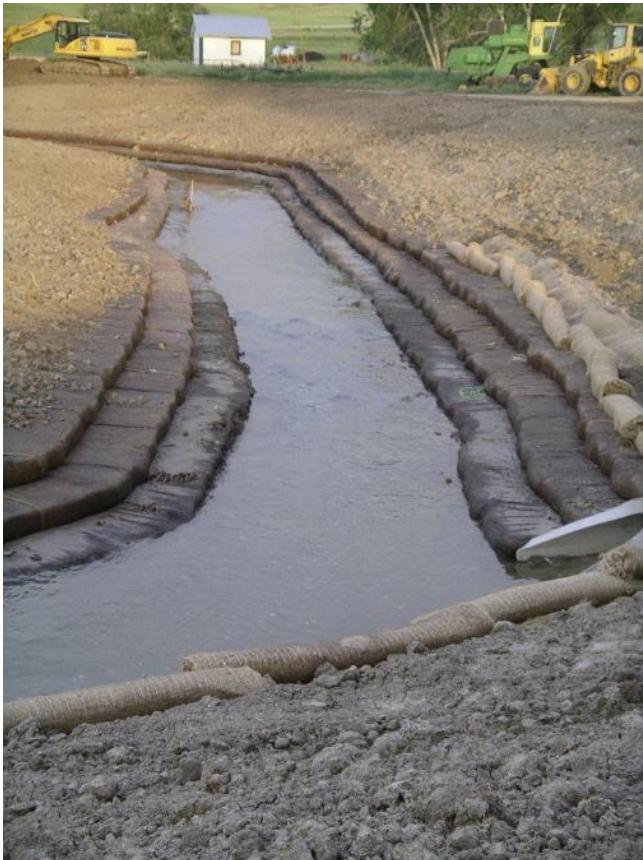
Photo 2a, Pre-project 2005: View to southeast (117 degrees) up Rock Creek just downstream from bend in channel. Note soil lifts with no riparian vegetation, channel wide and shallow.

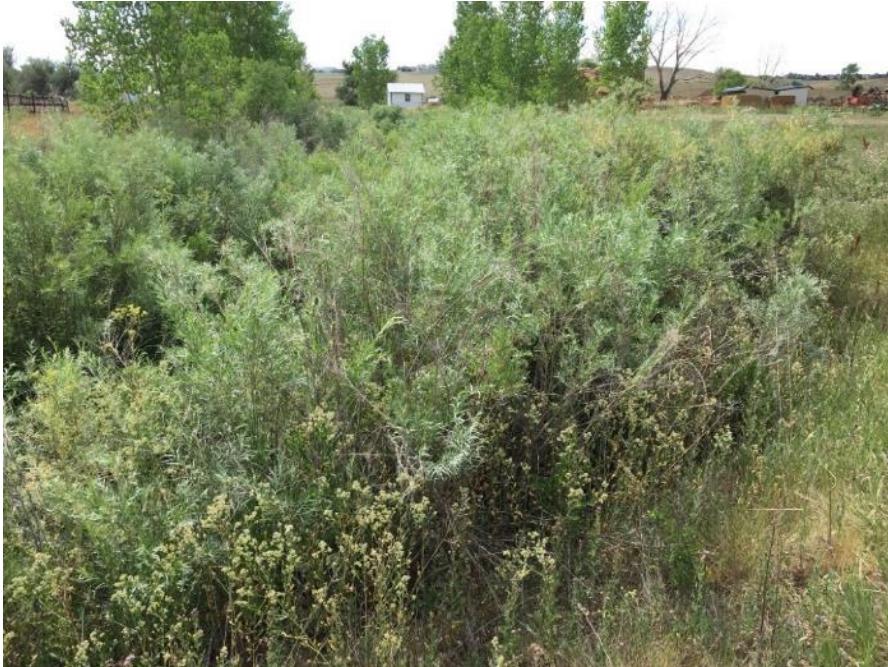
Photo 2b: Monitoring 2017: Same view with small white structure in background. Note that creek is not visible due to dense thicket of coyote willow and planted plains cottonwoods. Channel narrow and shallow.

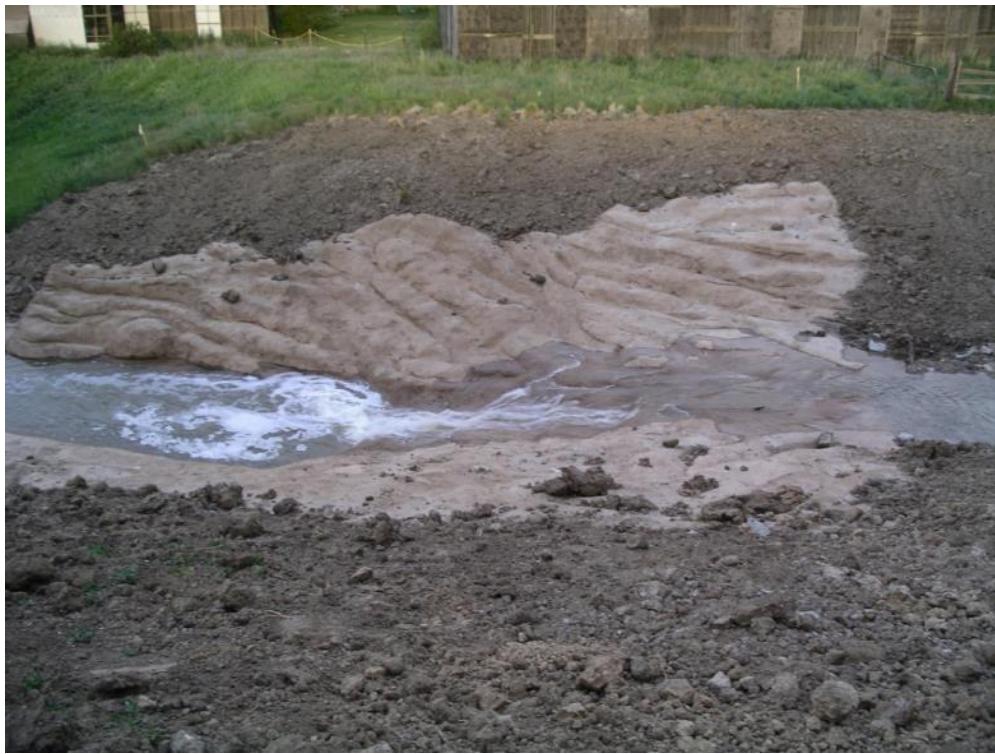
Photo 3a, Pre-project 2005: View to southeast (144 degrees) across Rock Creek of concrete apron at upper end of the project area with raptor rehab cages in the background. Note lack of riparian vegetation.

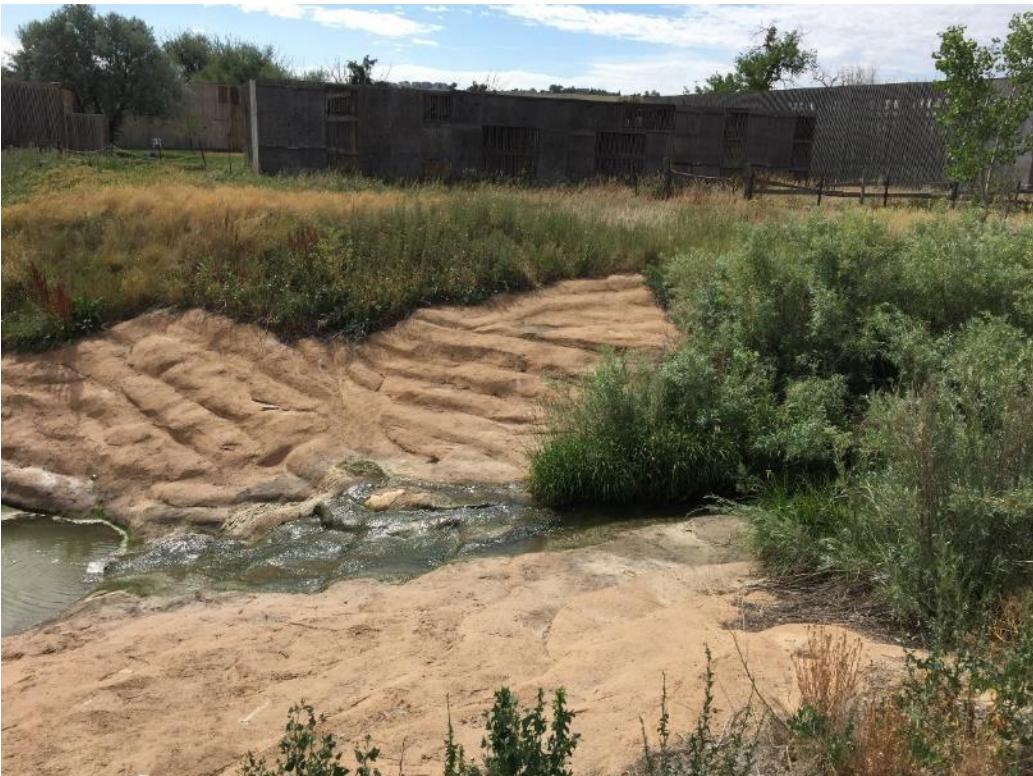
Photo 3b, Monitoring 2017: Same view. Note thick coyote willows along creek.

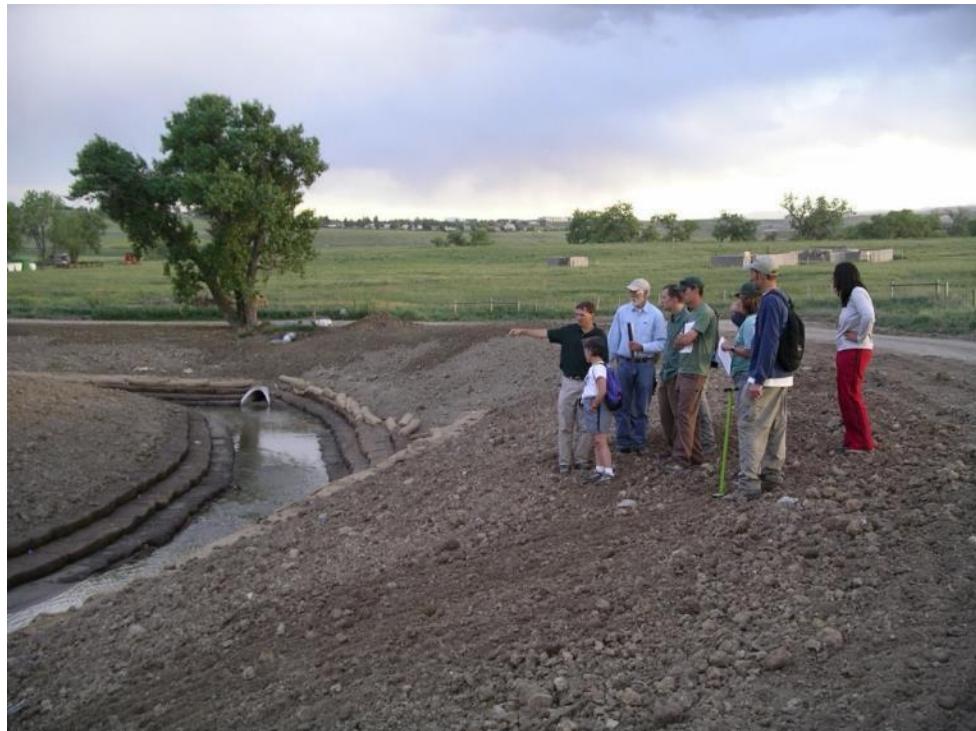
Photo 4a, Pre-project 2005: View to southwest (207 degrees) up Rock Creek from bottom end of project area. Note the soil lifts and the lack of riparian vegetation except for a lone mature plains cottonwood.

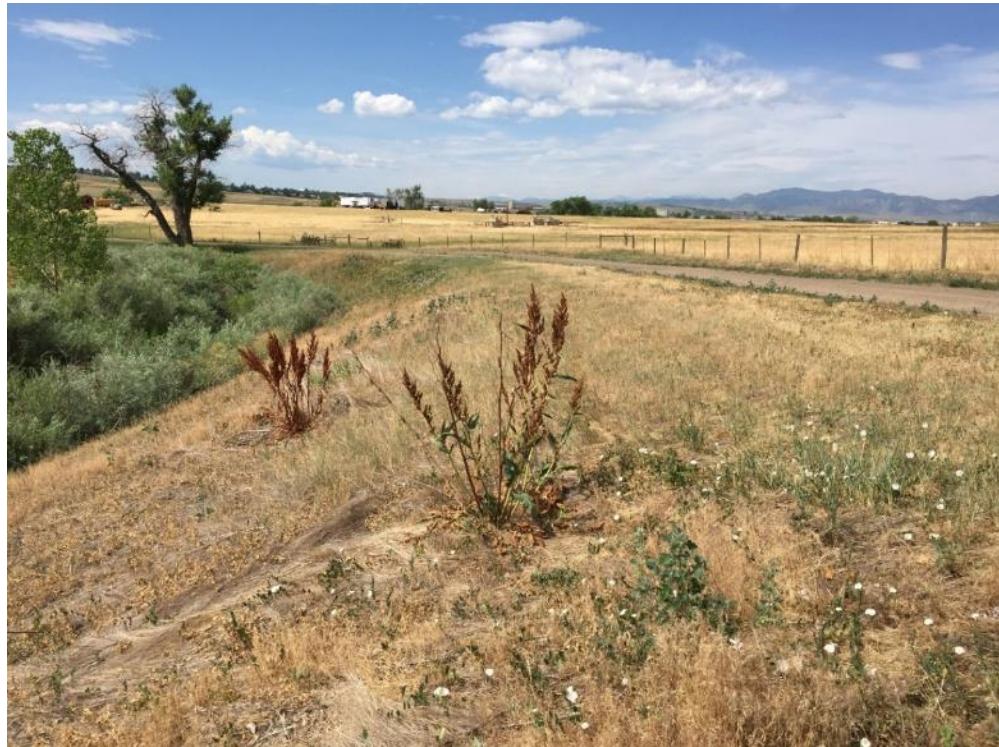
Photo 4b, Monitoring 2017: Same view. Note the planted plains cottonwood to the left of the mature plains cottonwood. Coyote willows dominate the thick riparian vegetation.

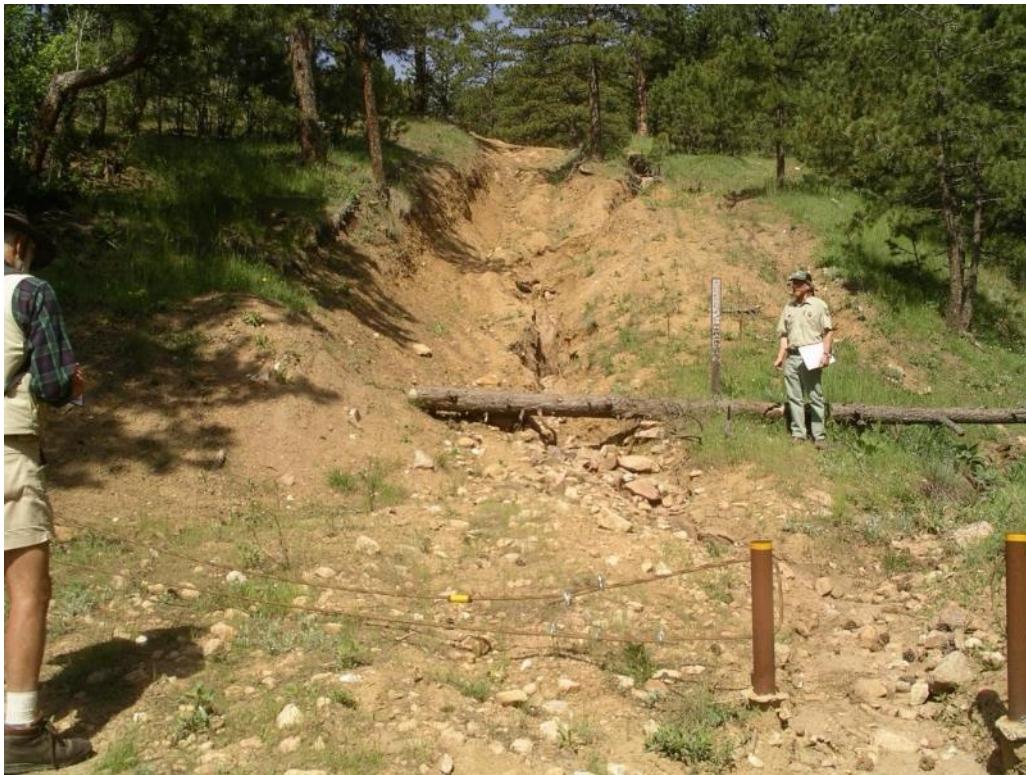
1a, Pre-project 2007: View to (265 degrees) up steep slope at Area A0. Note deep, eroding gulley.

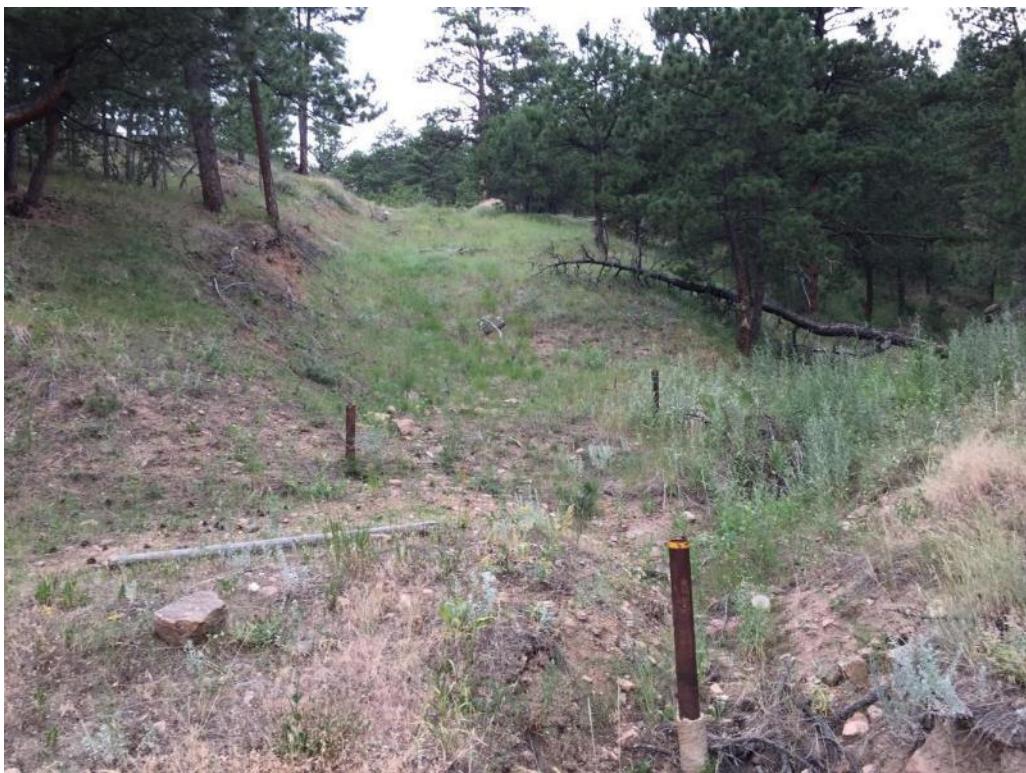
1b, Monitoring 2017: Same view. The regraded gulley is covered with native plant species (sedge, hairy goldenaster, scurfpea). A patch of Canada thistle lies in the drainage in the right side of the photo. Despite the 2013 flood, the slope is now stabilized with no signs of erosion or vehicle use.

Treat a small patch of Canada thistle in Area A0 with herbicide.

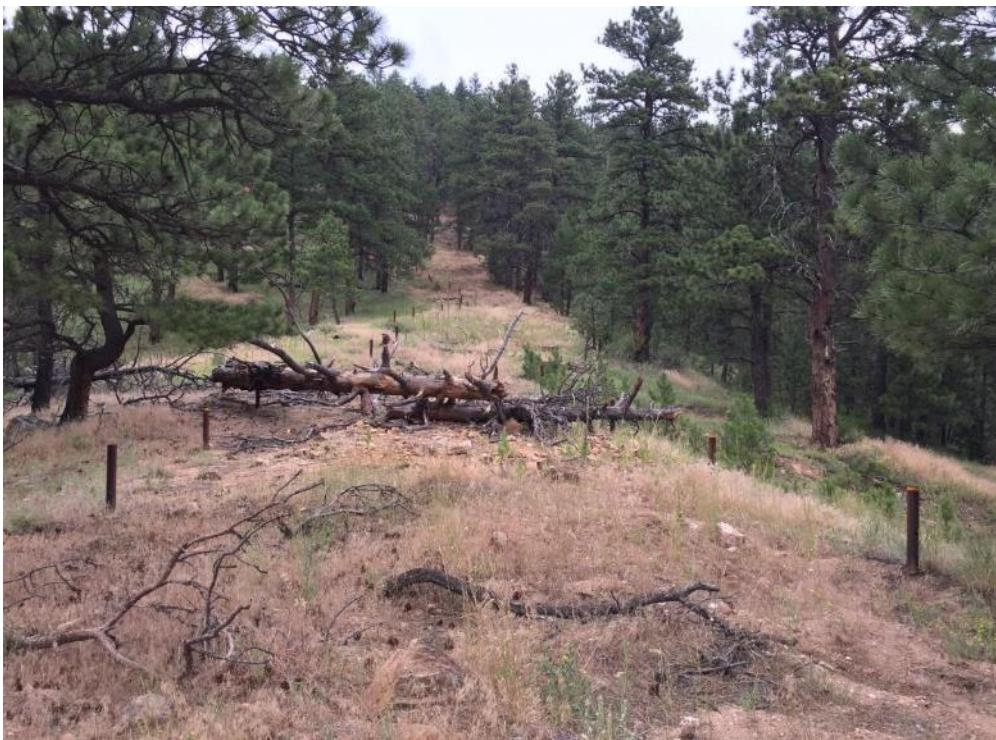
Photo 2, Pre-project 2017: View to northwest (294 degrees) up old Forest Road 286C and Area A2. Abundant cheatgrass, plus the land surface is rough. The crests of small mounds have minimal native vegetation. Native plant species are sparse, mostly slender wheatgrass and hairy goldenaster. However, there was no significant soil erosion. It's unclear why the land surface is so lumpy. Based on other restored area nearby, a smoother surface would have been easier to revegetate with native species

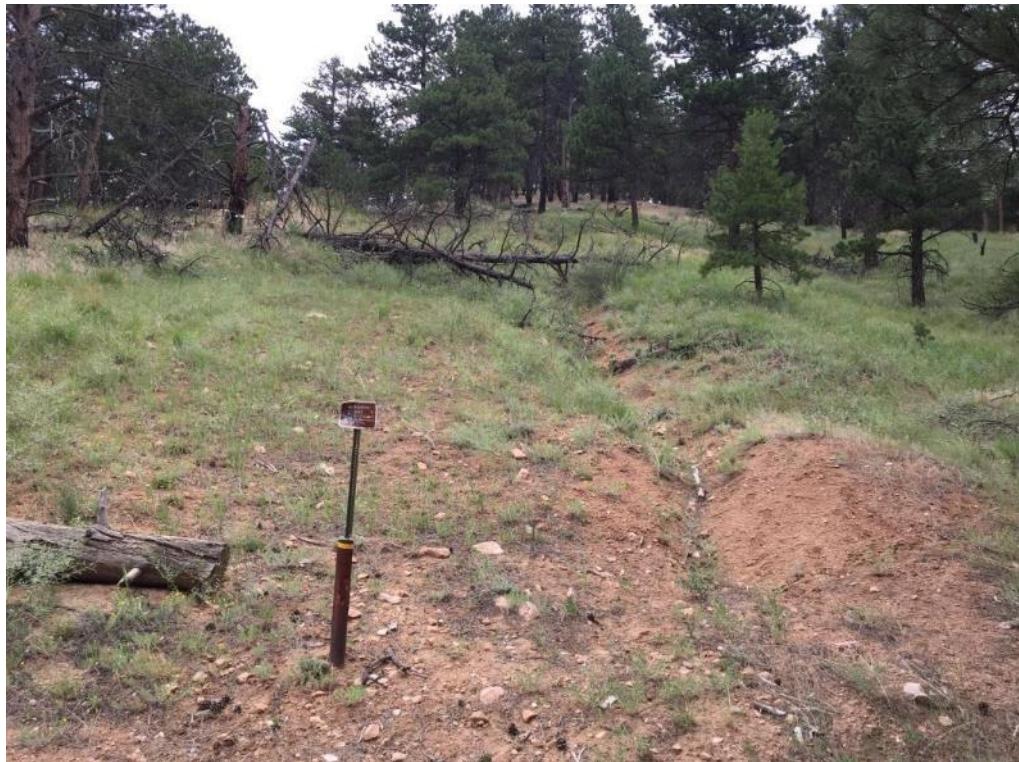
Photo 3, Monitoring, 2017: View to northwest (292 degrees) up a steep slope possible along Area A9. The restored slope is well vegetated with native plant species including hairy goldenaster and scurfpea. Minimal signs of soil erosion at bottom left of photos; no signs of vehicle use. The erosion mat helped vegetation establishment on this steep, southeast-facing slope.

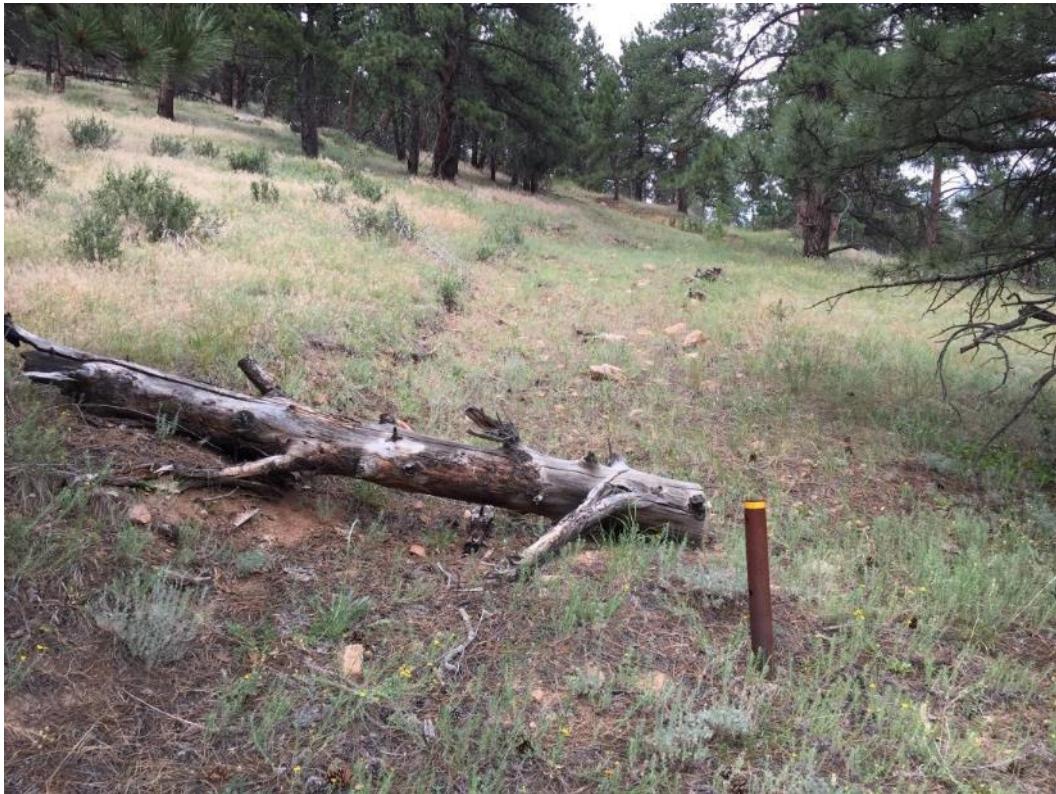
Photo 4, Monitoring, 2018: View to north (359 degrees) up a steep slope along Area A12. The restored slope is well vegetated with native hairy goldenaster, western wheatgrass, sand dropseed, needle-and-thread. No signs of soil erosion or vehicle use. The erosion mat helped vegetation to establish on this steep, south-facing slope.

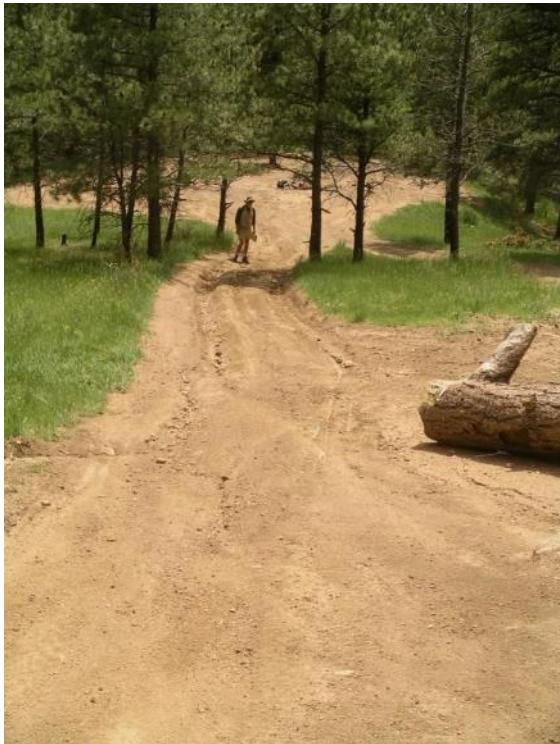
Photo 5a, Pre-project: View to south (173 degrees) down a steep slope at Area A13 toward a camping area. The vehicle way is eroding.

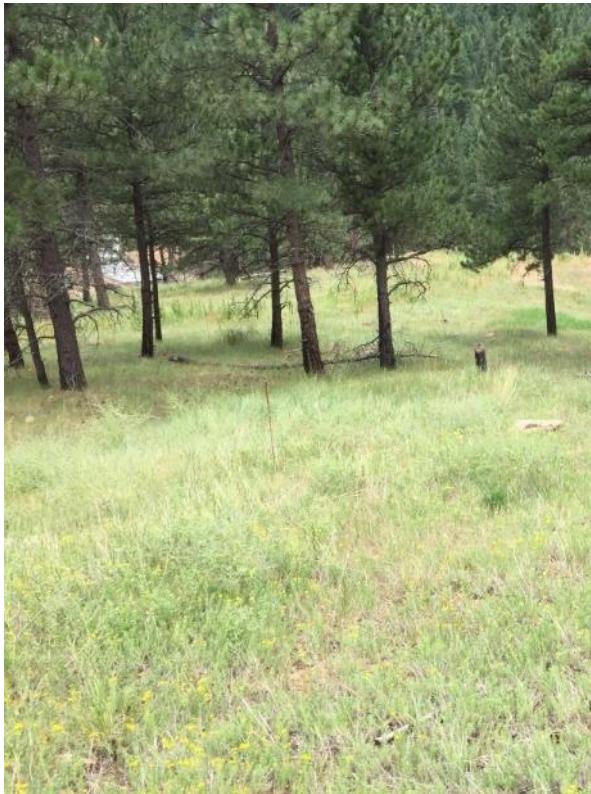
Photo 5b, Monitoring 2017: Same view, now well-vegetated with native hairy goldenaster, scattered slender wheatgrass and other native grasses. The erosion matting was effective. No signs of soil erosion or vehicle use. Common mullein is abundant in the flat camping area below. A fire swept through this site about five years ago.

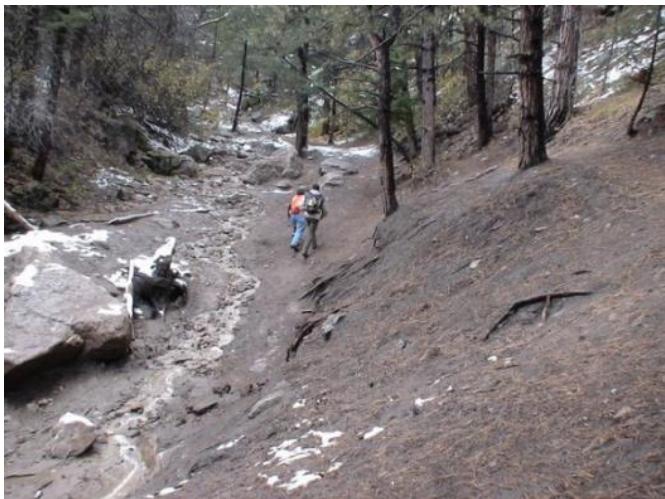
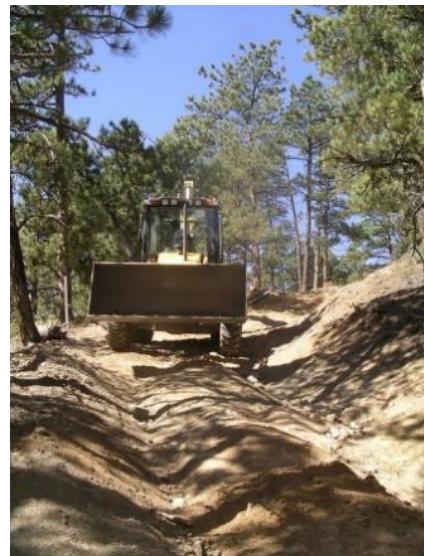
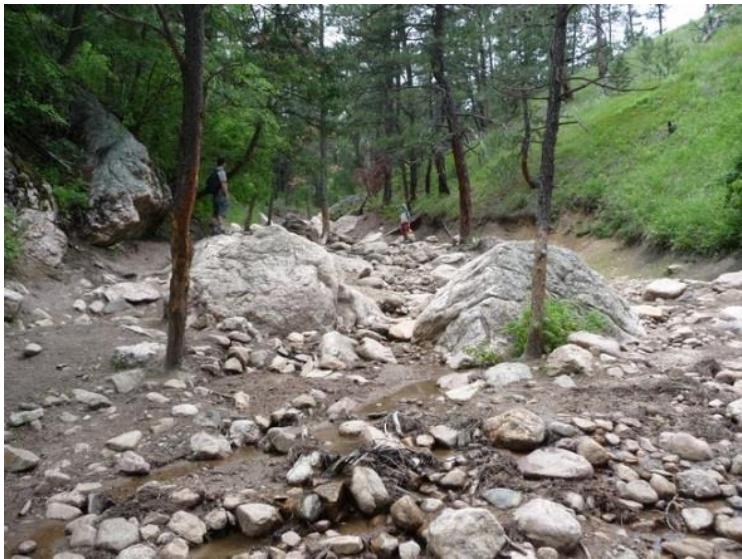
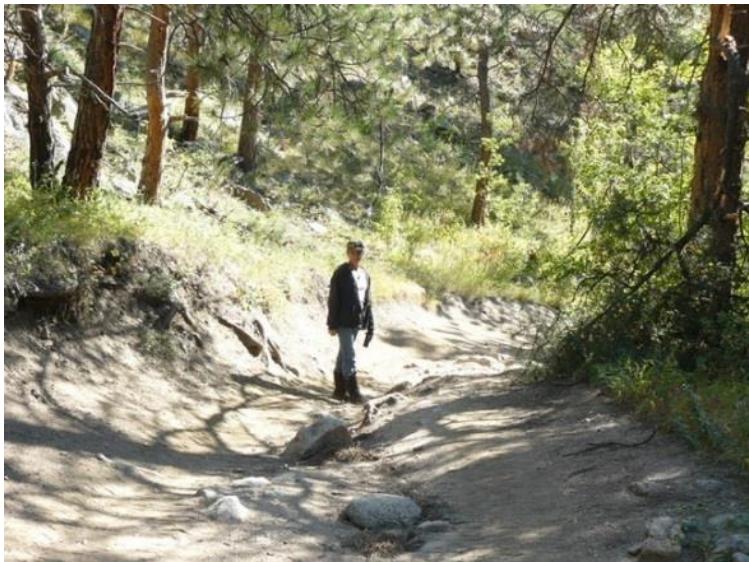
2008, Pre-project: Numerous areas contributed to water run-off and severe erosion.

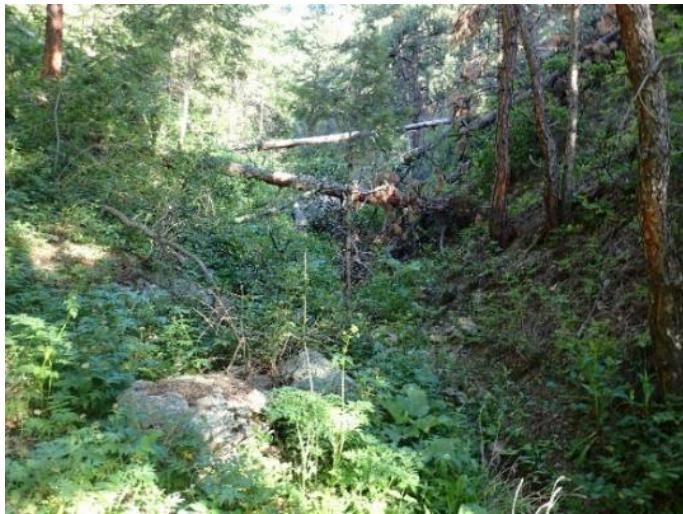
Steep canyon areas are plugged with flood debris, but have completely revegetated.

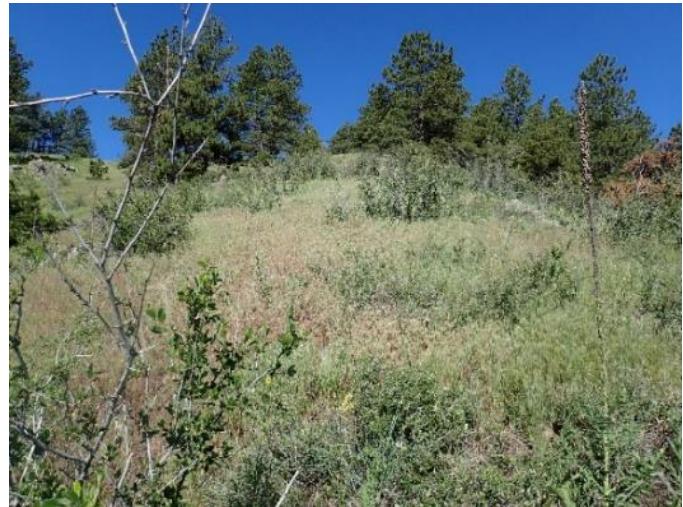
A south-facing hillslope shows no signs of a previous road, and is a mix of native vegetation with some cheatgrass.

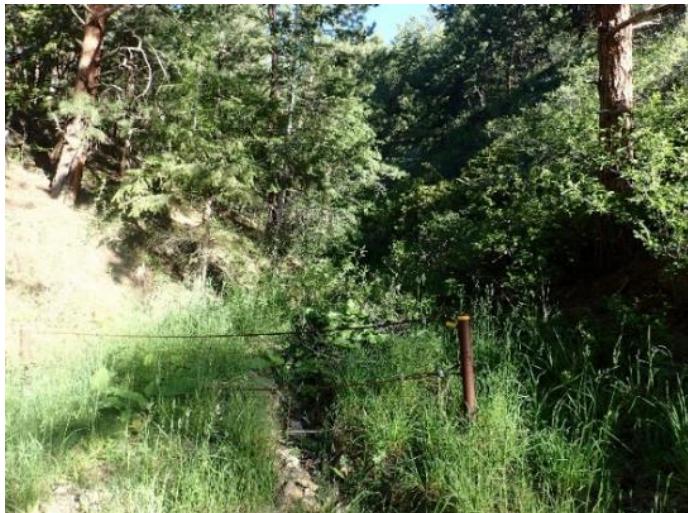
Metal post and cable structures for vehicle exclusion remain in place.

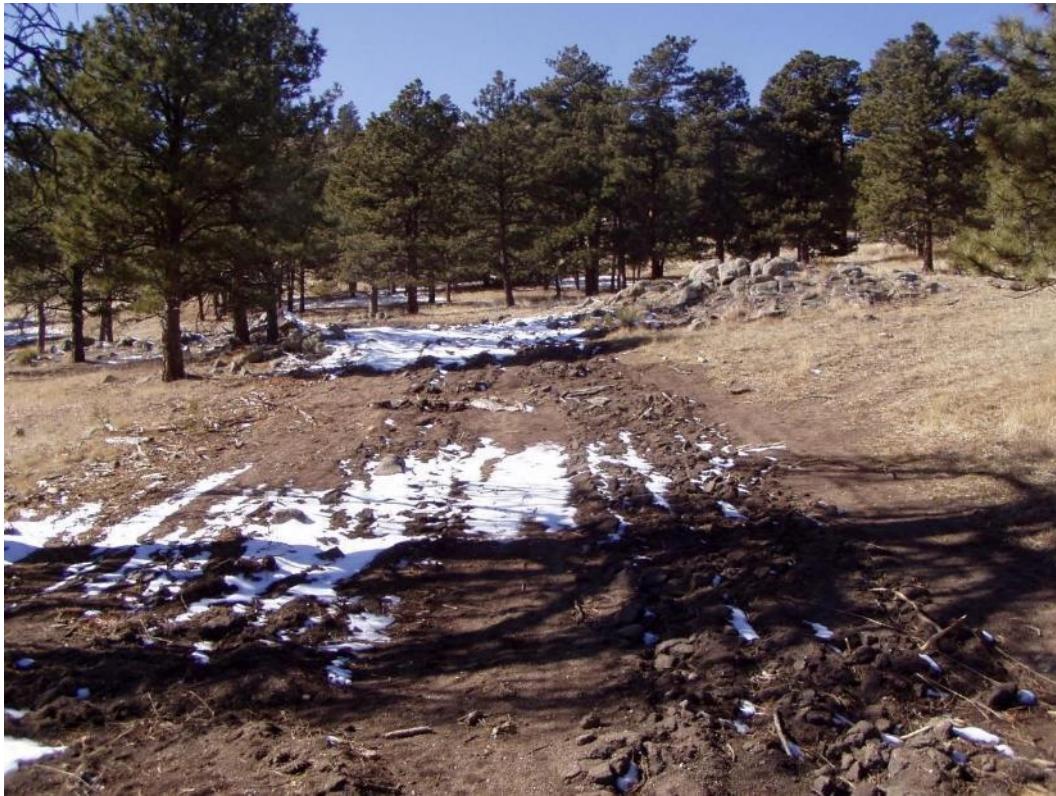
1a, Pre-project, March 2009: View to southwest (240 degrees) along first part of de-vegetated skid trail just west of Area J.

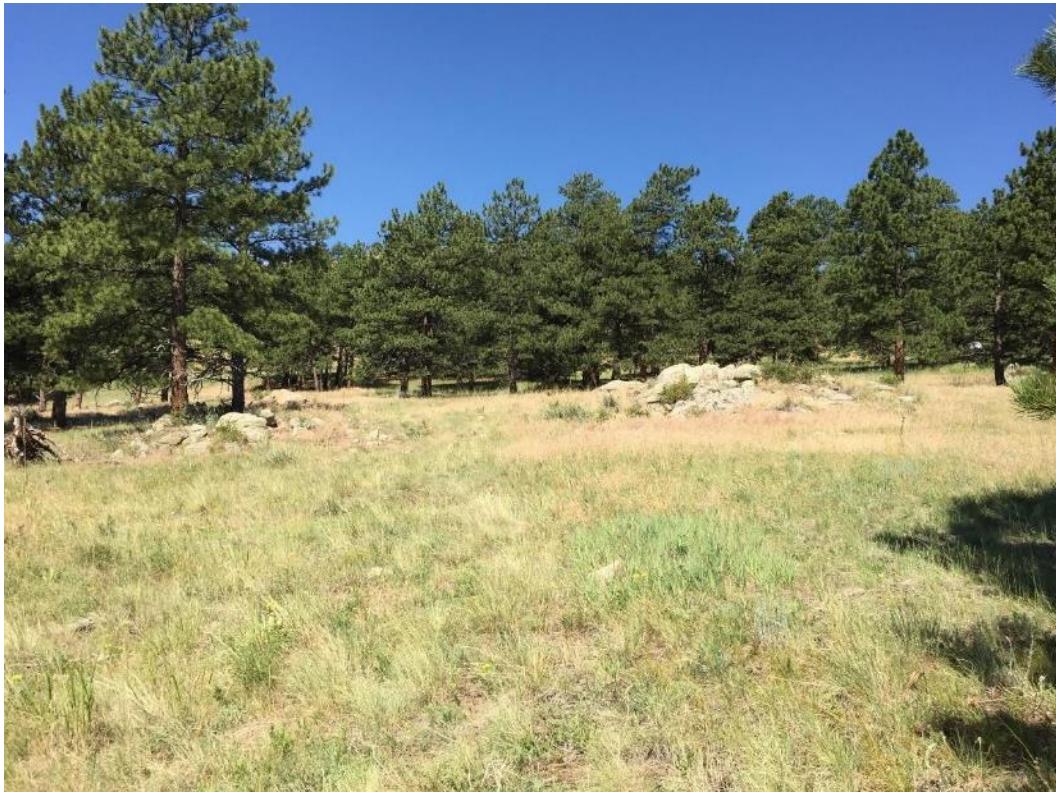
1b, Monitoring, 2017: Same view. Note excellent establishment of native plant species, including mountain muhly, hairy goldenaster, wild buckwheat, and daisy fleabane. Non-native cheatgrass common. Skid trail largely invisible. No signs of erosion. Soil surface ~ 35% bare ground.

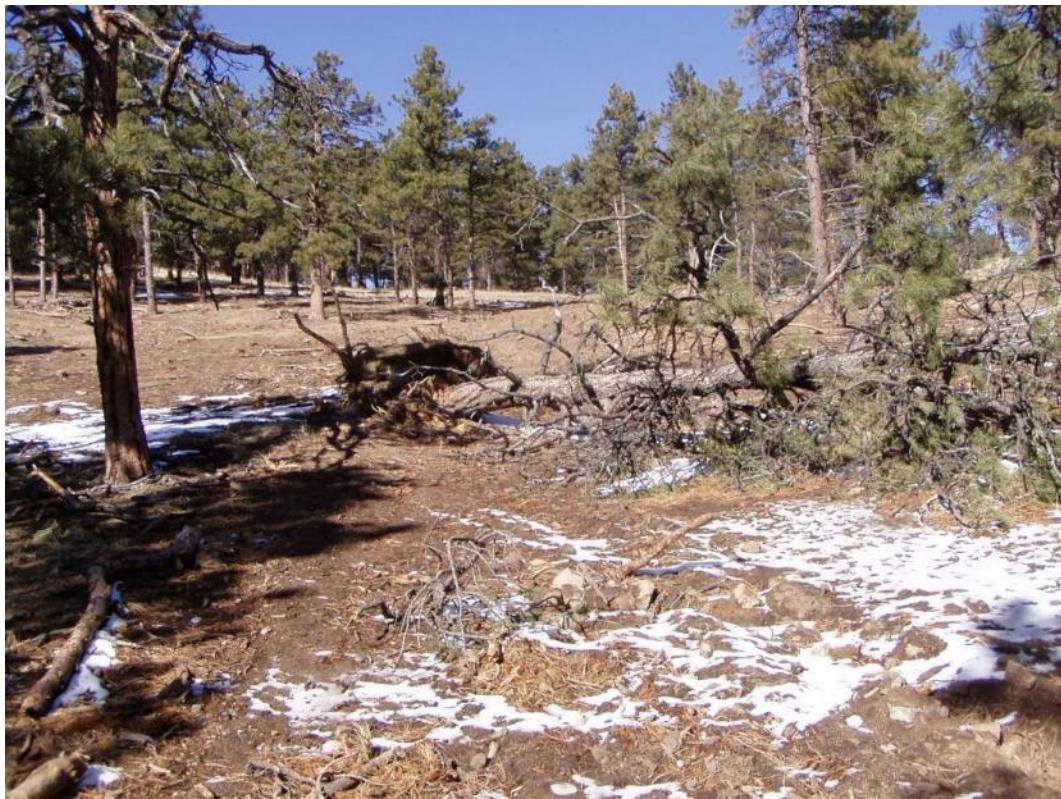
2a, Pre-project, March 2009: View to northeast (30 degrees) up Area A of de-vegetated skid trail at fallen tree.

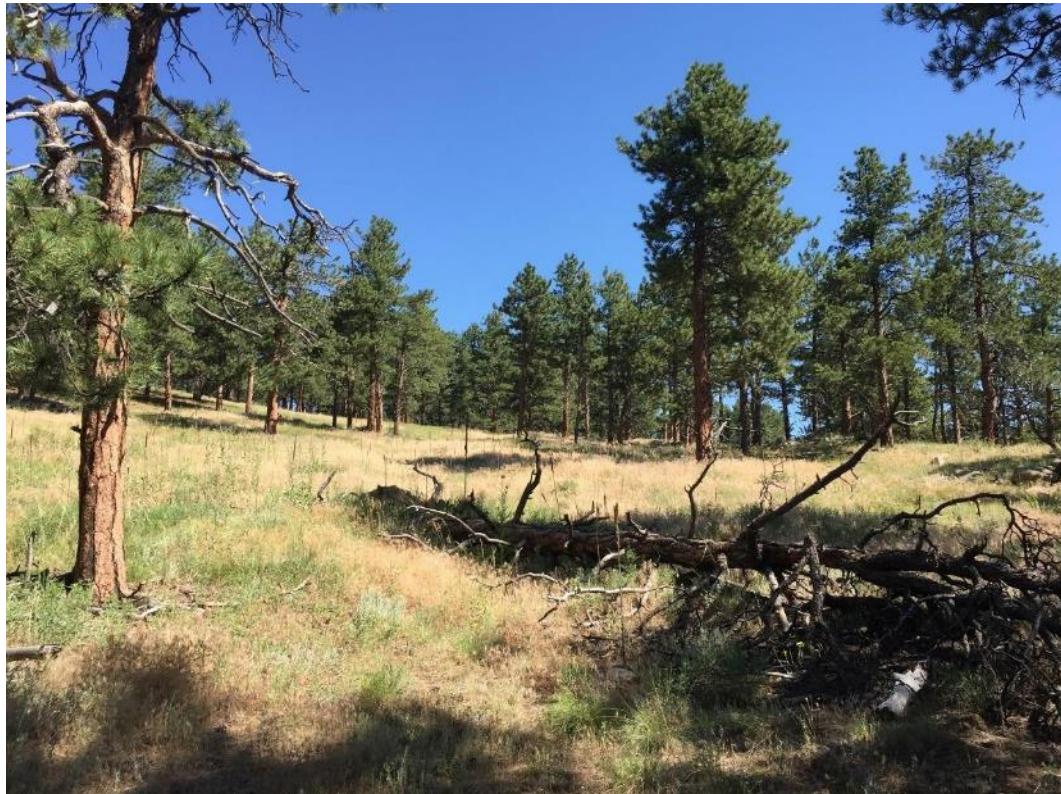
2b, Monitoring 2017: Same view. Note skid trail largely invisible. No signs of erosion. Soil surface ~ 10% bare ground. Non-native cheatgrass common. Common native plant species include mountain muhly, ragwort, wild buckwheat, and buckbrush.

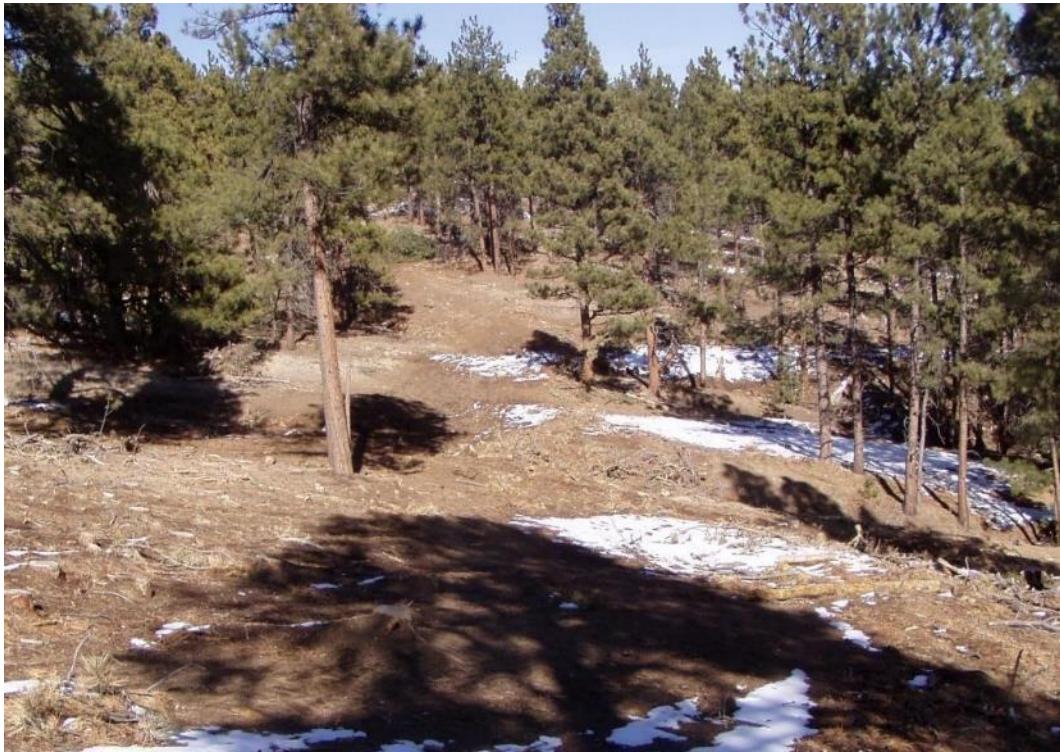
3a, Pre-project, March 2009: View to north-northwest (344 degrees) of de-vegetated skid trail down Area F toward junction of Areas B and H.

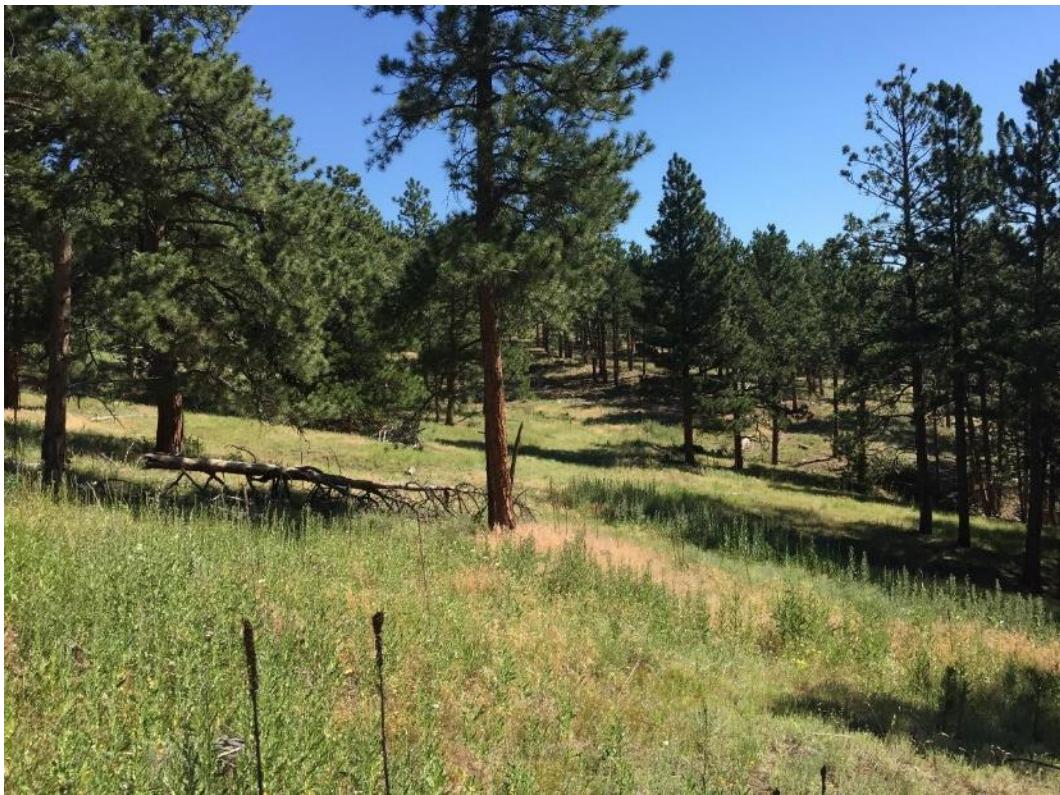
3b, Monitoring 2017: Same view. Note: skid trail largely invisible. No signs of erosion. Soil surface ~ 10% bare ground. Canada thistle prevalent. Common native plant species include sun sedge and hairy goldenaster.

Spot-treat patches of Canada thistle with herbicide.

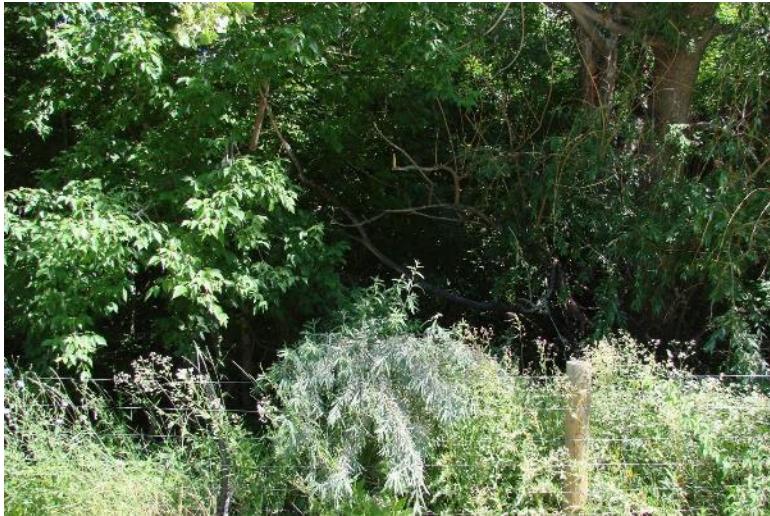
Comparison Photos, PS 1 North, N 40° 01.561; W 105° 13.406

Pre-project, June 2010: Note dense understory Canada thistle.

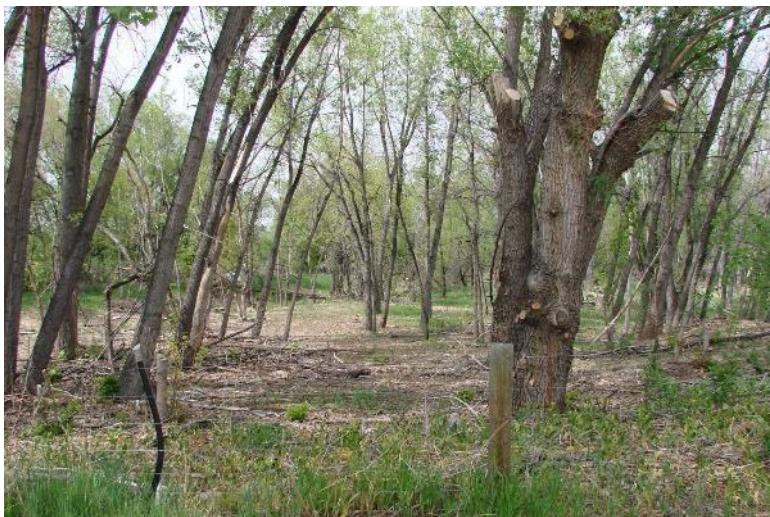
Post-project, first phase, June 2011: Note open understory.

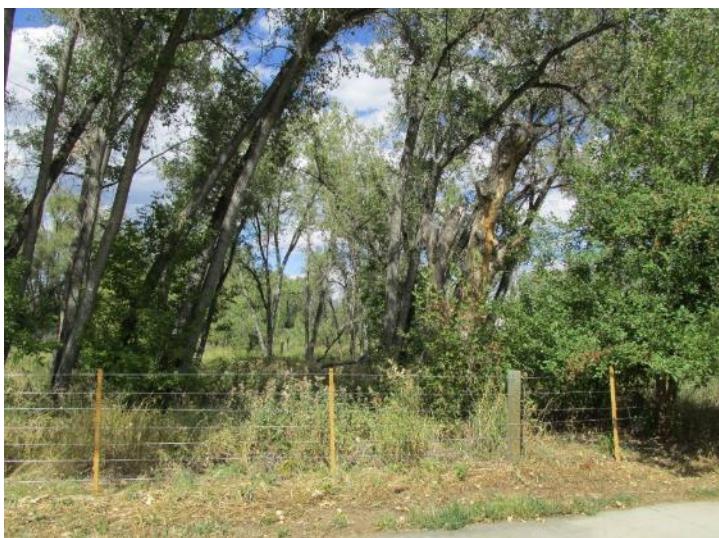
Monitoring, September 2017: Note developing understory, Canada thistle at fence line.

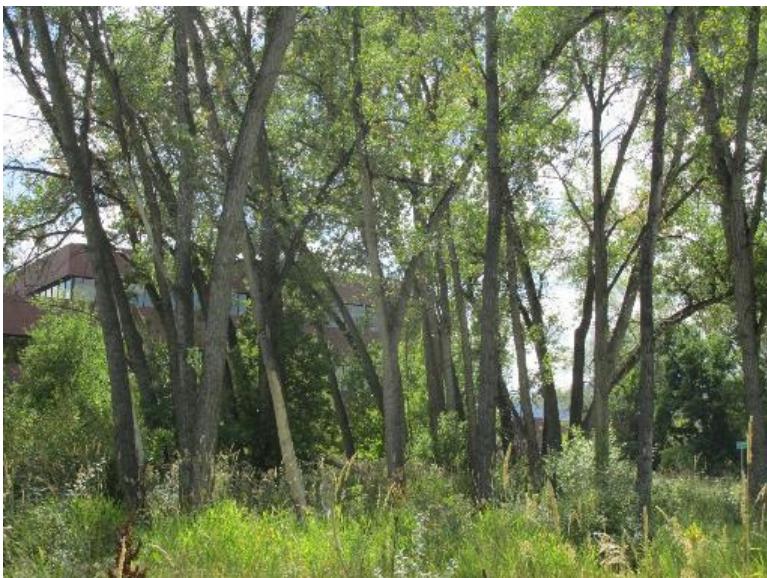
Comparison Photos PS 5 S, N40° 01.587; W 105° 13.391

Monitoring, September 2017, approximate location. Note increase of understory shrubs.

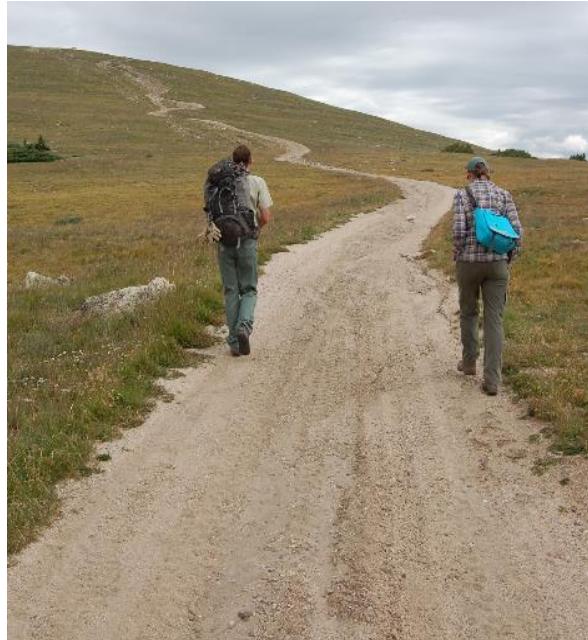
Pre-project 2011. Note bare ground on road.

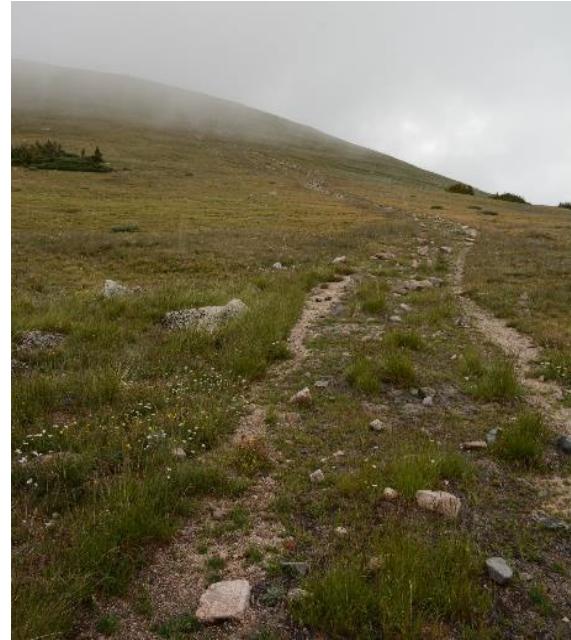
Post-project 2014. Note advanced revegetation on road.

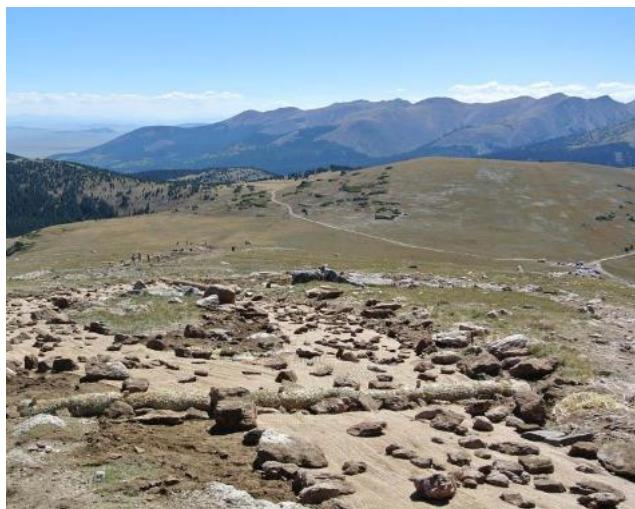
Immediately post-project 2012: Erosion matting treatment

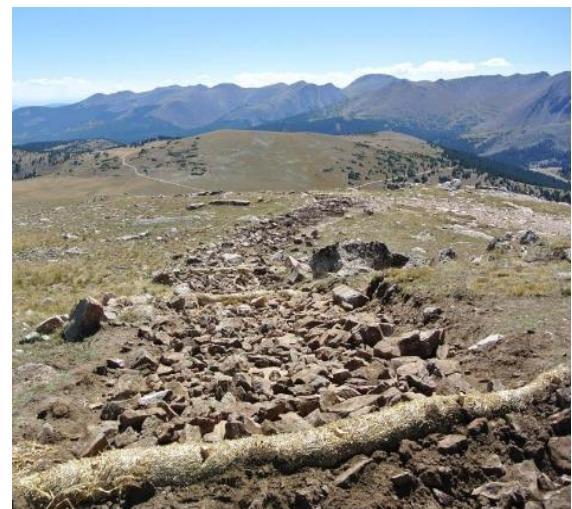
Immediately post-project 2012: Rock cover treatment

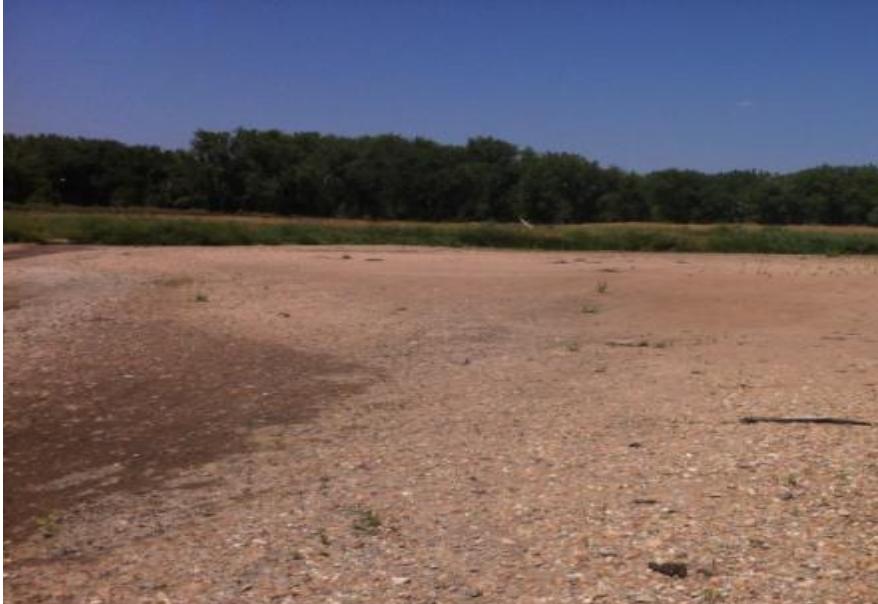
2016, Pre-project: View to north of sand and cobble bar. Note very sparse, mostly weedy vegetation.

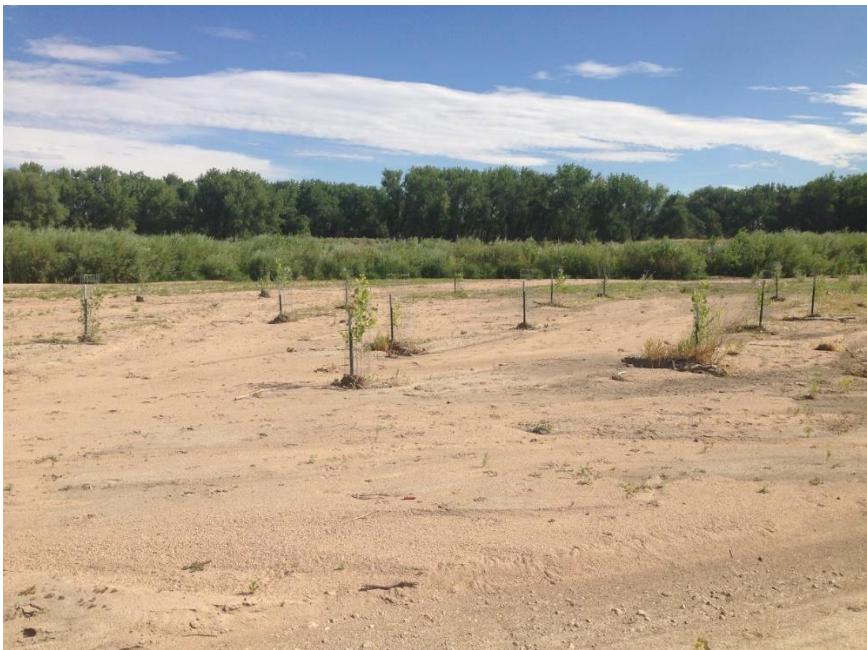
2017 – Monitoring: Same view. Note vigorous cottonwood and willow plantings, development of additional vegetation.
