Wildlands Restoration Volunteers 2017 Site Monitoring Report: A Glimpse of Successes, failures and potential futures.

February 24, 2018.

Project Name: Rock Creek Restoration Project Date: June 15, 2005

Project Name: Left Hand Canyon Restoration

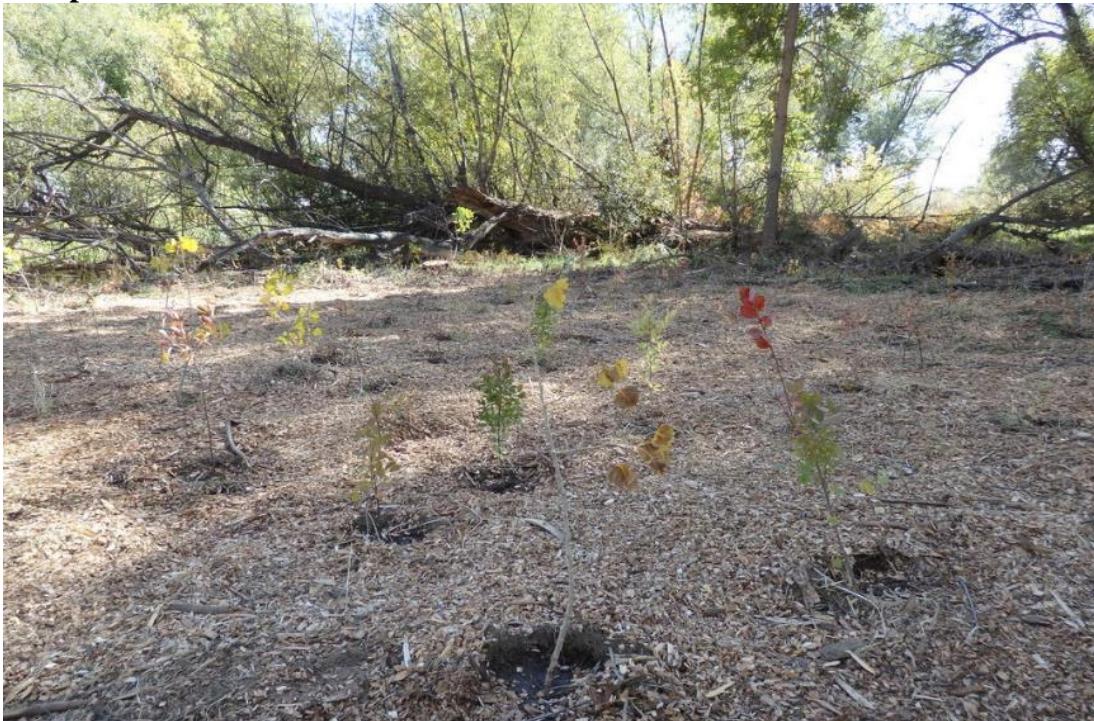
2016 Immediate post-project: Cottonwood container planting interspersed with shrub and herbaceous plantings.

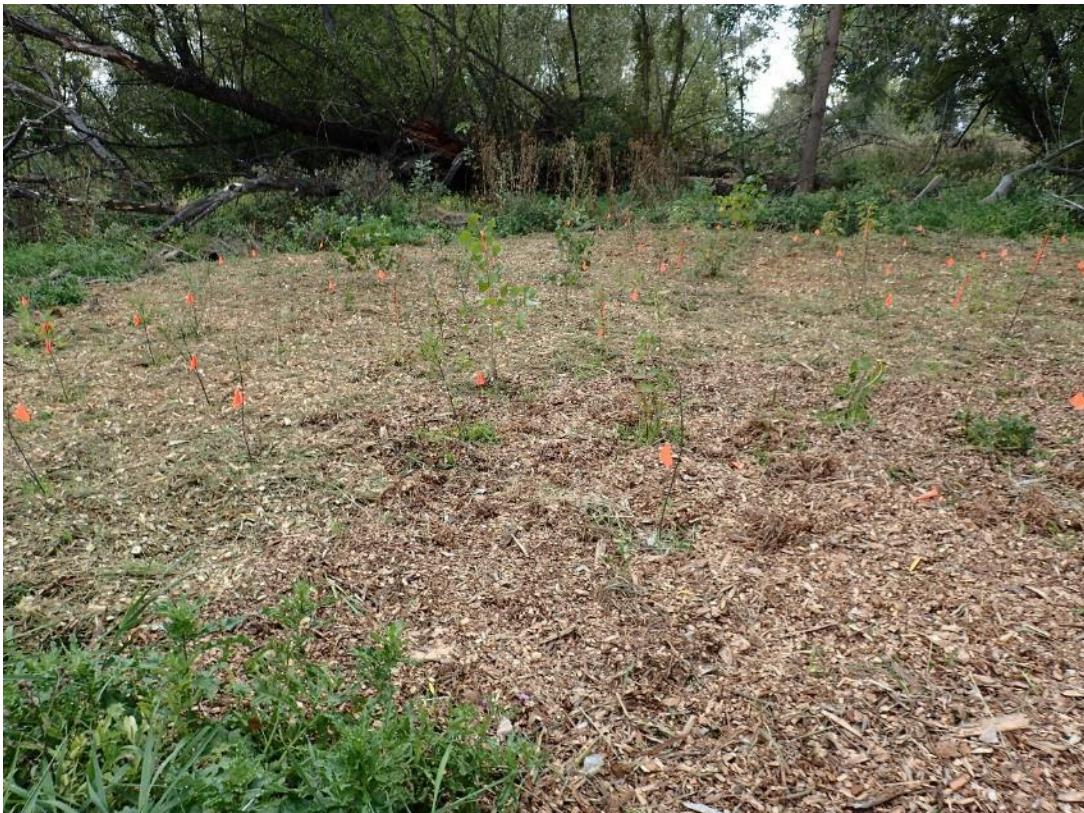
2017 Monitoring: Note good condition of plantings, few weeds due to wood chip mulch.
