2018 WILDLANDS RESTORATION VOLUNTEERS MONITORING REPORT

The Monitoring Group of Wildlands Restoration Volunteers presents the 2018 Monitoring Report compiled by our monitoring volunteers who visited past project sites to evaluate success. We include a summary of important lessons learned from monitoring completed in 2018, detailed project site monitoring forms, and project site photographs. See page 2 for a complete list of projects assessed in this report. By providing project feedback, our findings support the hard work of volunteers, staff, agencies, and donors.

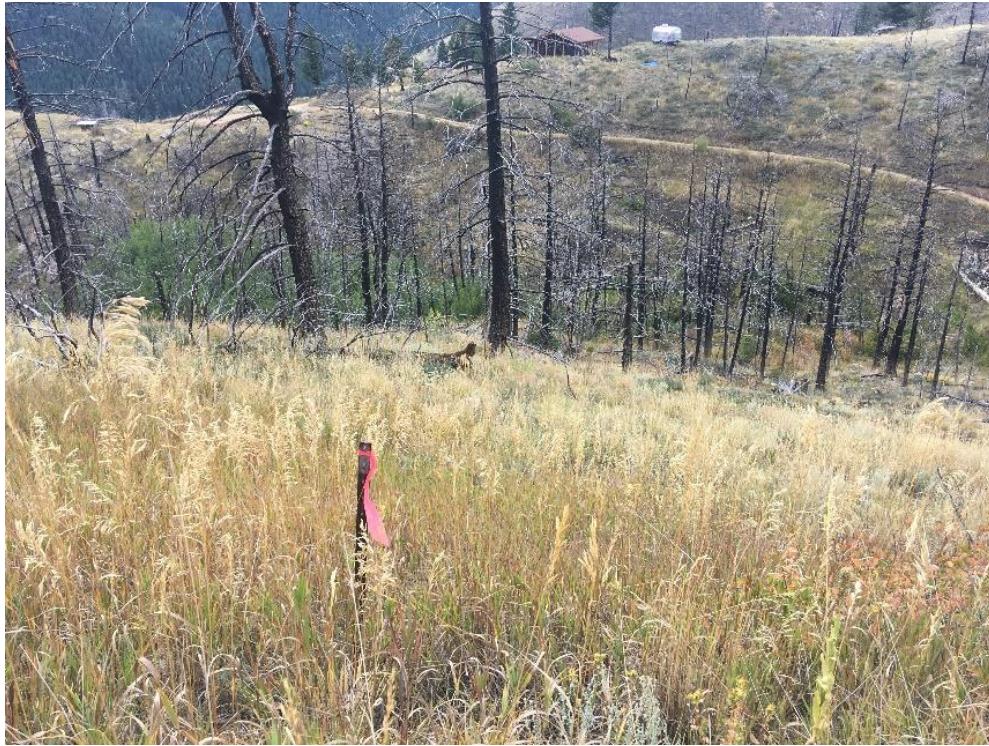
September 8, 2018, view to southwest from side road to 724 Emerson Gulch. Note dominance by smooth brome, lack of conifer regeneration.

Corrective or Maintenance activities needed: Because smooth brome is so well-established, seeding or planting of ponderosa pine, Douglas fir, and spruce likely will be necessary to re-establish a forest.

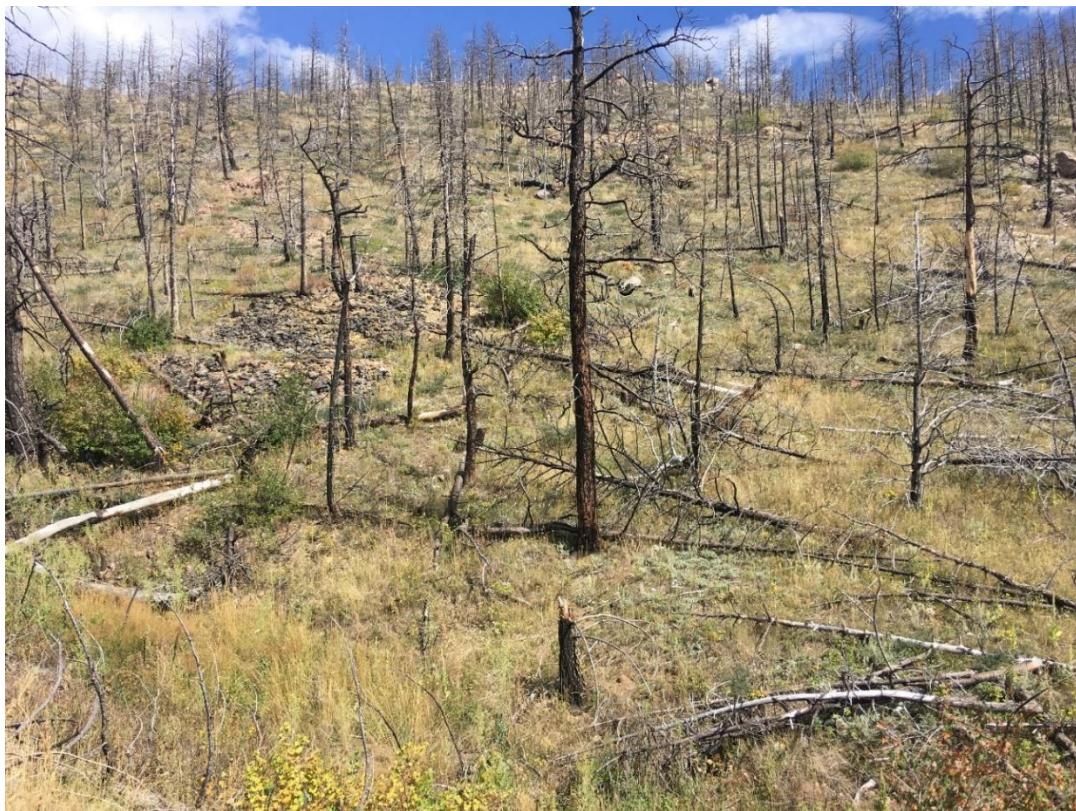
September 8, 2018, view to northeast from side road to 724 Emerson Gulch. Note grasses and some forb and deciduous shrub regeneration.

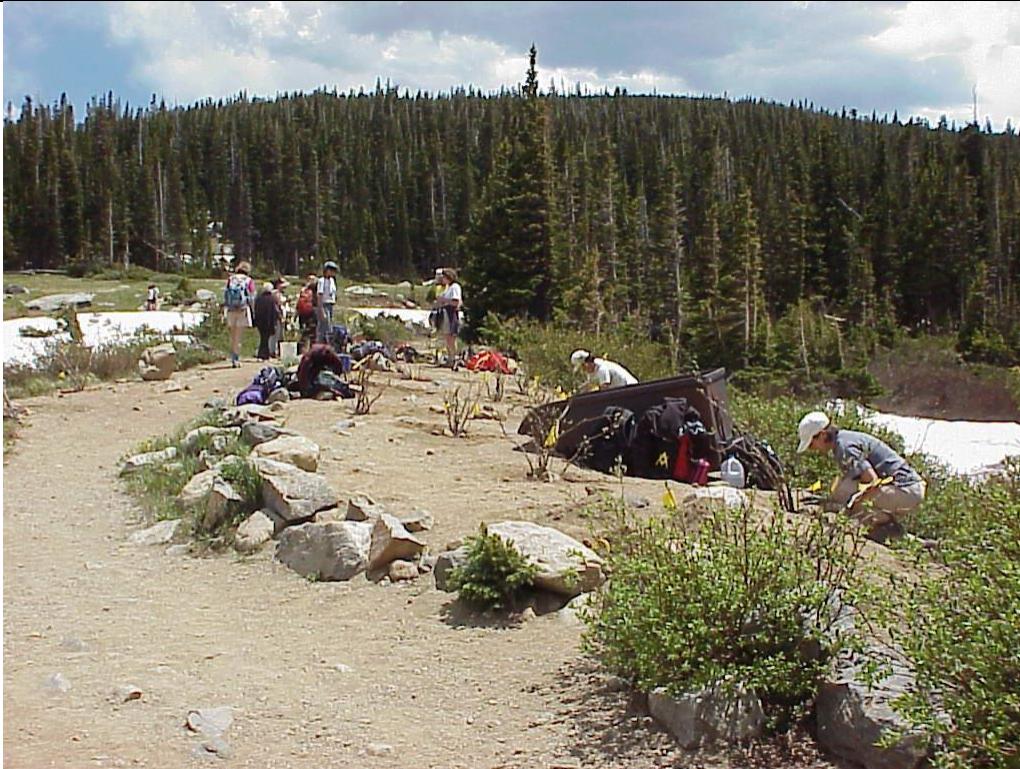
September 14, 2001. Note: newly planted willows and bog birch to right of boulders and intended trail to left. The planting area was devoid of woody vegetation prior to the project. Note the old metal bucket in center of photograph.

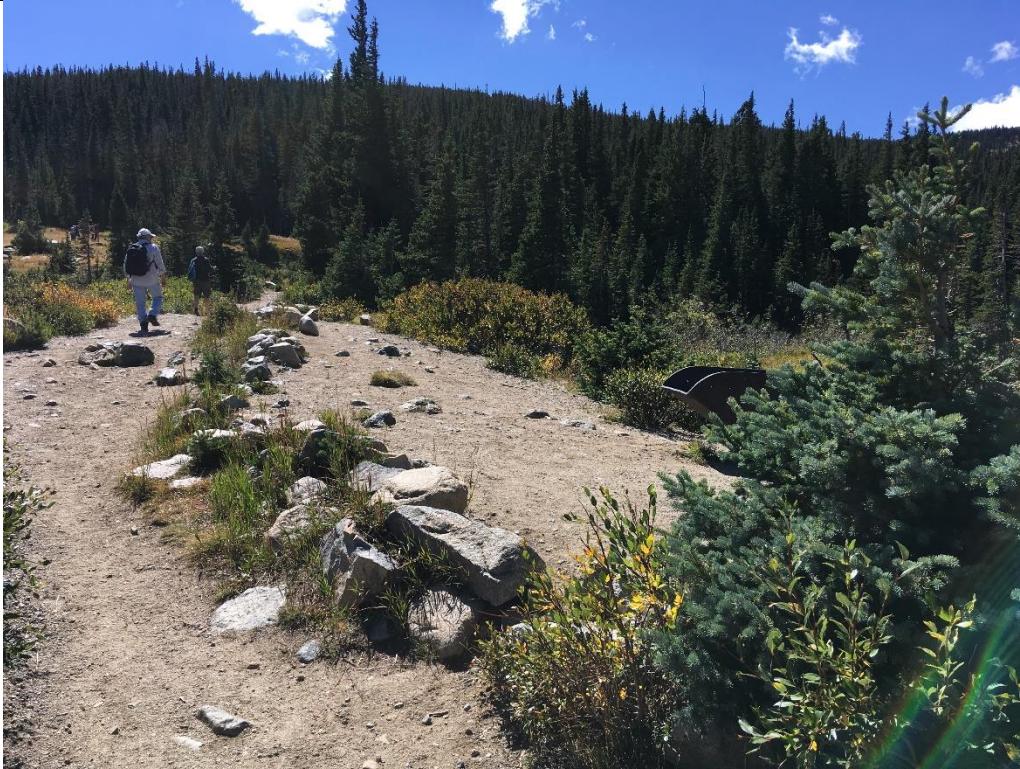
To view Long Lake and peer inside an old metal bucket, hikers walked through the plantings on the west side of the intended trail resulting in high willow mortality. See Figure 1: Long Lake Berm Plantings. Probably, as plantings failed to survive or died, more people walked through the planting area.

September 7, 2018. Note: Both the planting area and the intended trail are used by hikers. The antique metal bucket has been moved slightly down the slope of the berm. Some surviving willows are present along the margins of the bare areas. Spruce have grown.

Formally construct the trail through the west side lake view area with old metal bucket. Add a bench and plaque with history of the site. In the area of the 2001 intended trail, plant plane-leaf willows. Add an “Area Closed for Revegetation” sign and woody debris.

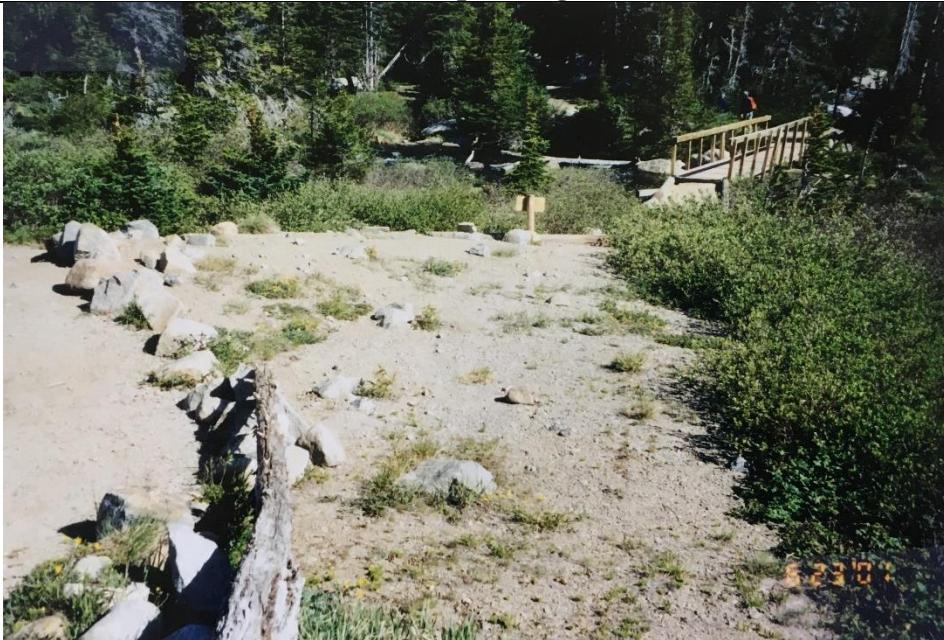
June 23, 2001. Note: very sparsely vegetated area, back of "Closed for Restoration" sign at the far end, and boulder/log barrier marking the right side of the trail. This area was closed, but not planted.

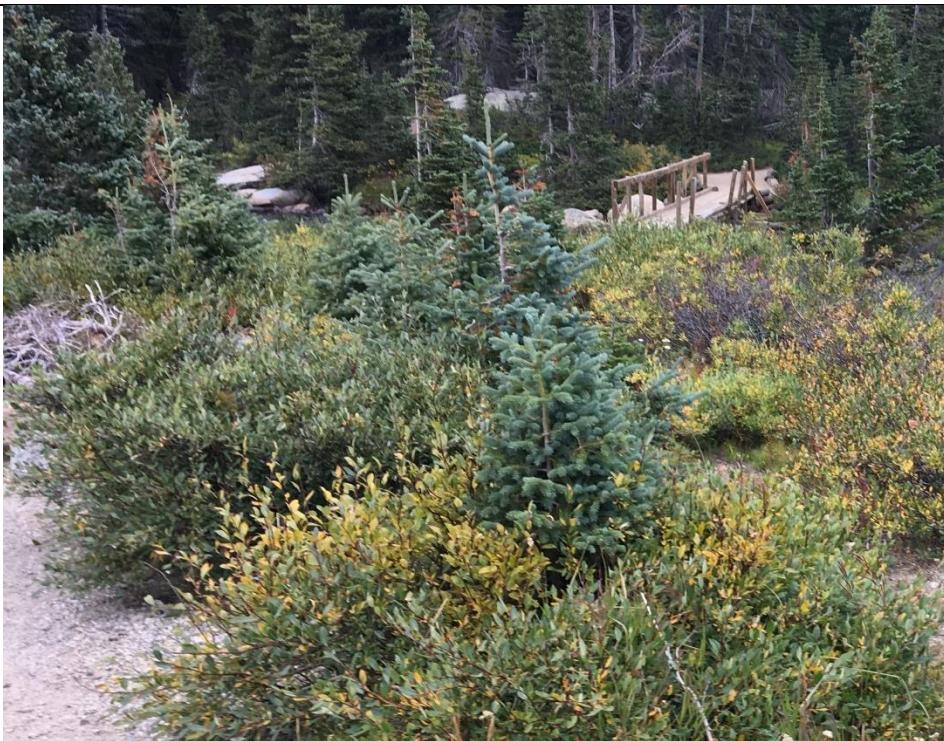
In contrast, on the unplanted northeast portion of the berm which had an “Area Closed for Revegetation” sign and scattered woody debris, volunteer plant growth had proceeded well, and there is no evidence of visitor trampling.

September 6, 2018. Note: Vigorous growth of volunteer spruce and willow, likely due to a clearly closed area.

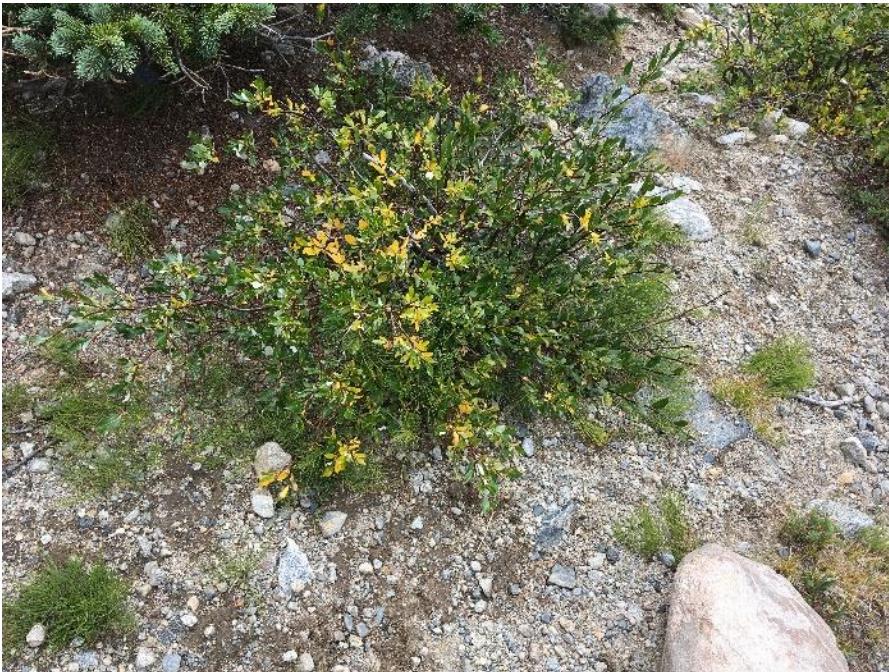
Volunteer grasses spreading out from willow planting #31

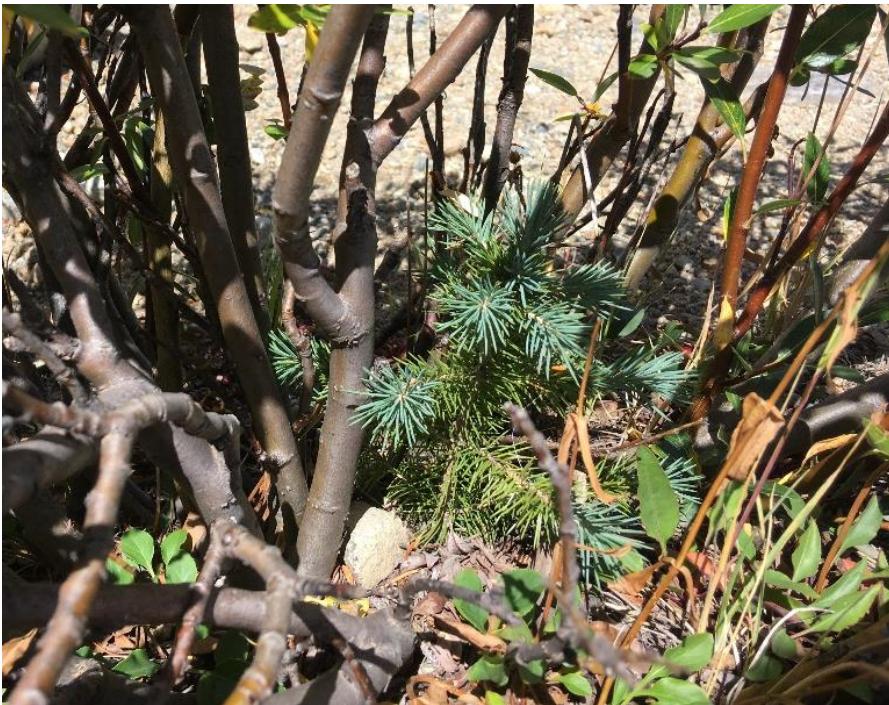
Small Engelmann spruce in shelter of plane-leaf willow planting #20

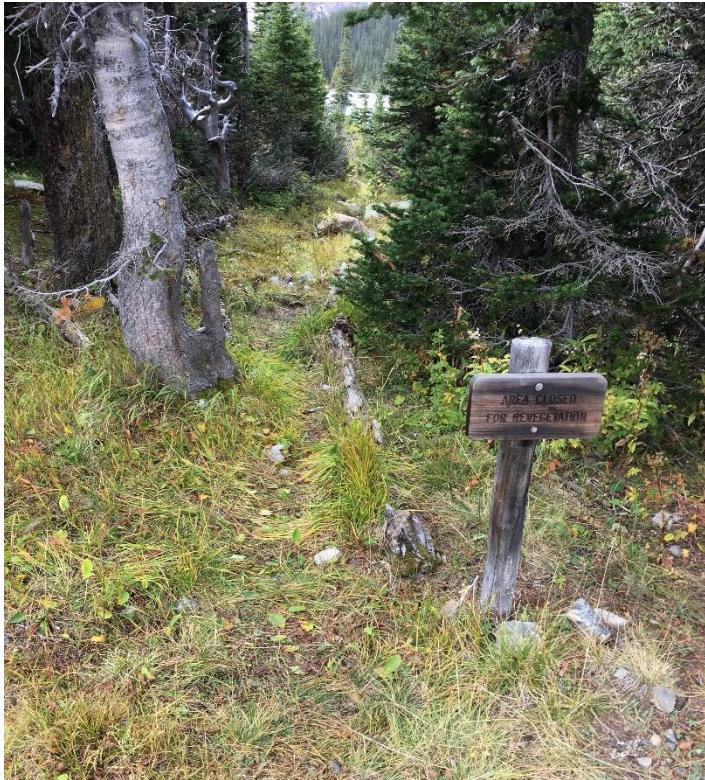
Three of the four willows planted on the wet social trail to the south were surviving, but showed only minor growth. Despite a closed sign, the trail appears to get some use.

Closure sign at entrance to wet social trail with one of the #33 willow plantings in middle ground

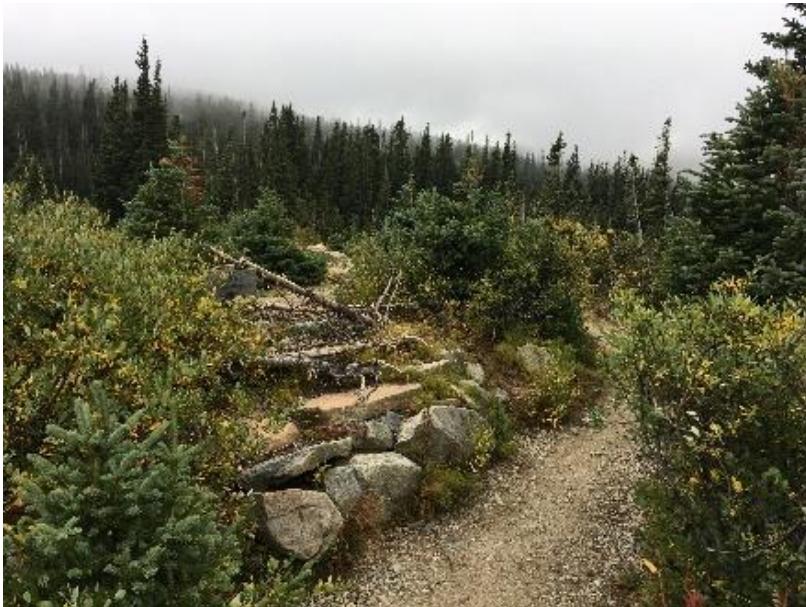
Posted “Area Closed for Restoration” sign (barely visible near left end of slanted log) at the north end of the east side; the volunteer plant growth here was much more successful than the west side. Scattered woody debris also contributed to maintaining the closure.

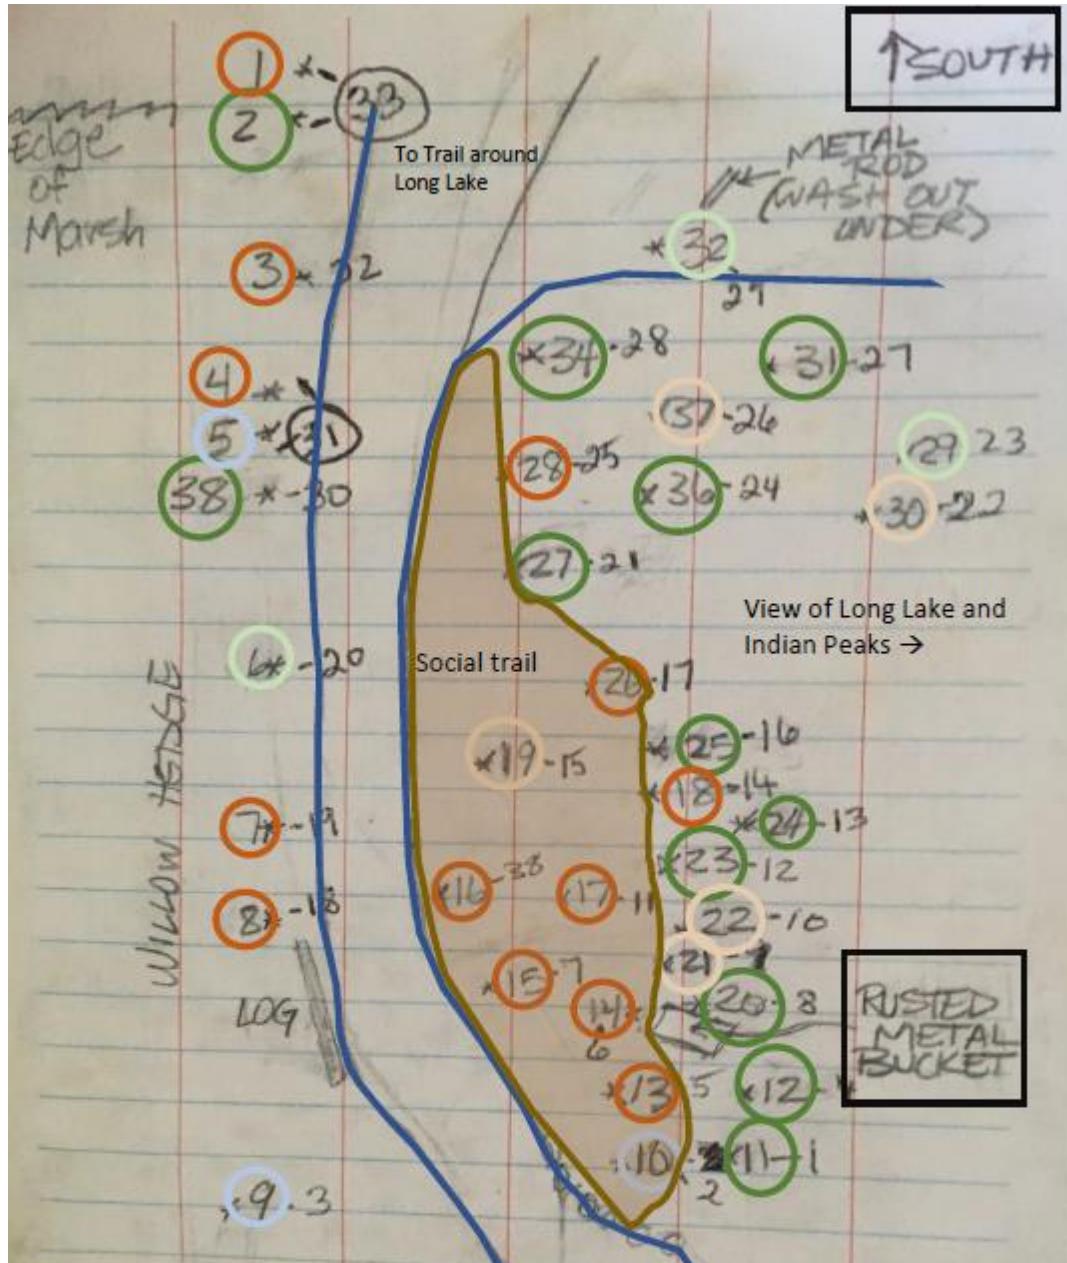
Figure 1. Long Lake Berm Plantings
6-23-2001

Did the project meet the goals? Although project survivor rates for all species and project areas had been very high in the first few years post-project, I observed mixed success 17 years after the project. Approximately 1/3 of the plane-leaf willow plantings survived; these were nearly all in locations furthest from the intended trail and from social trails. None of the planted upland willows or bog birch survived to 2018.

Tan circles = missing birch

Blue circles = missing upland willows

Orange circles = missing plane-leaf willows

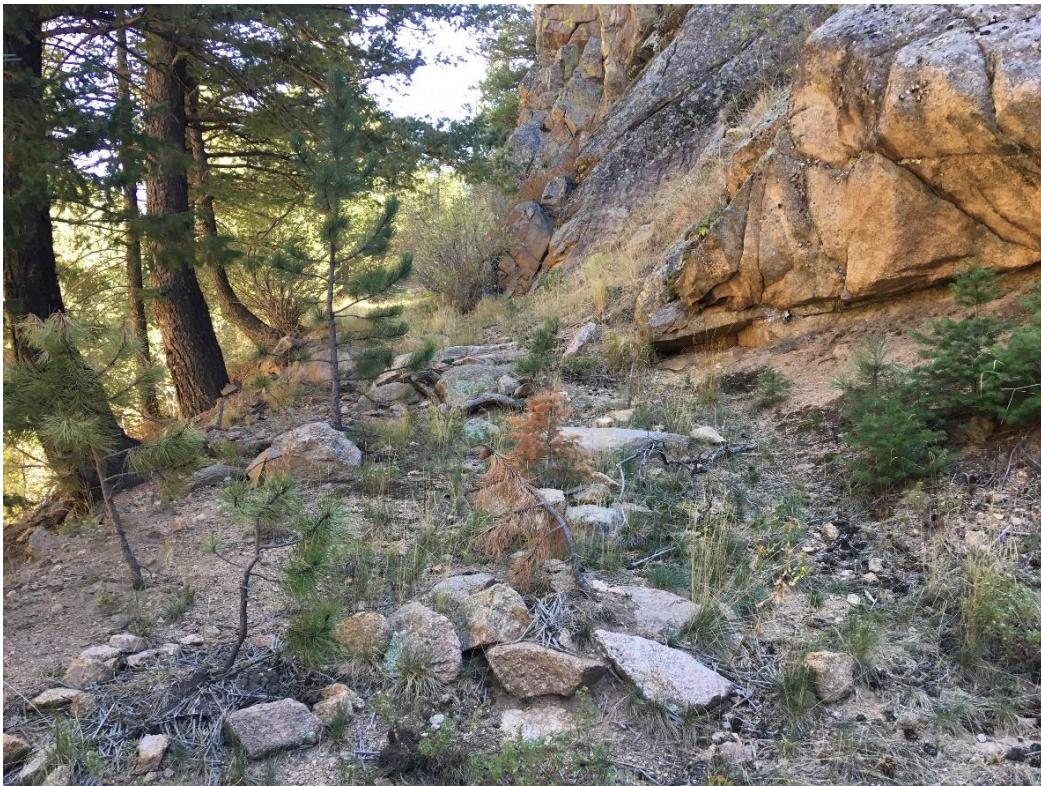
September 15, 2018. Note good growth of most ponderosa tree plantings, volunteer Douglas fir, and development of grass and forb cover. No evidence of vehicle traffic.

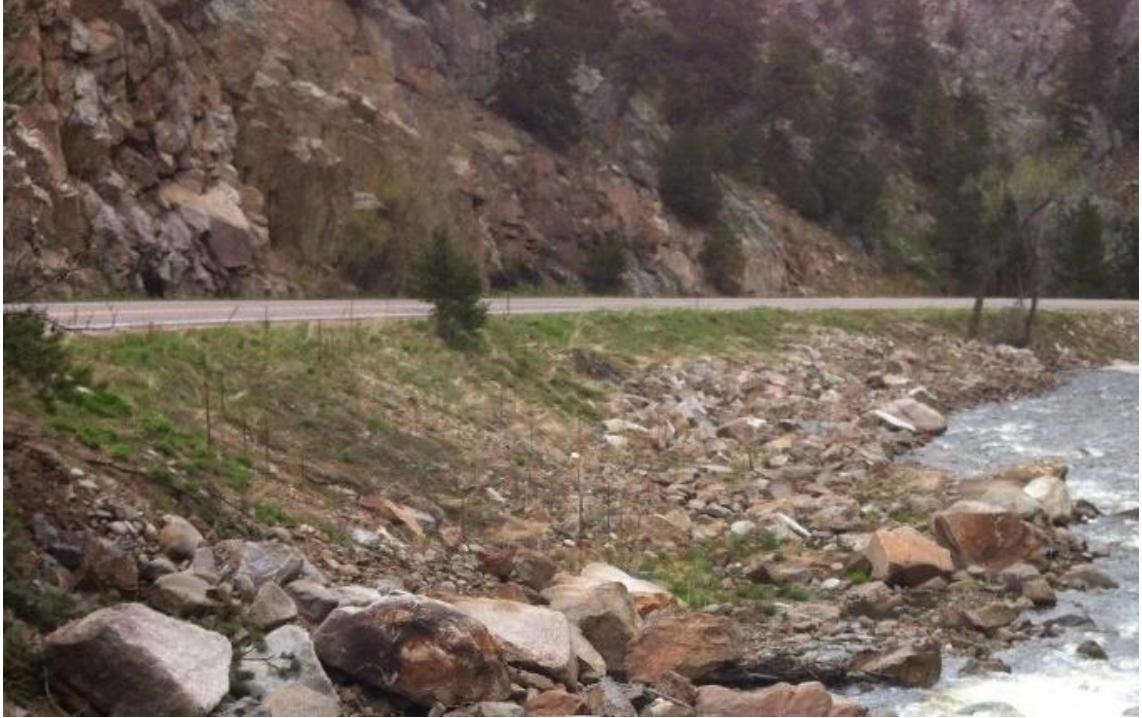
April 30, 2016. Note very little vegetation in low bank cobbles.

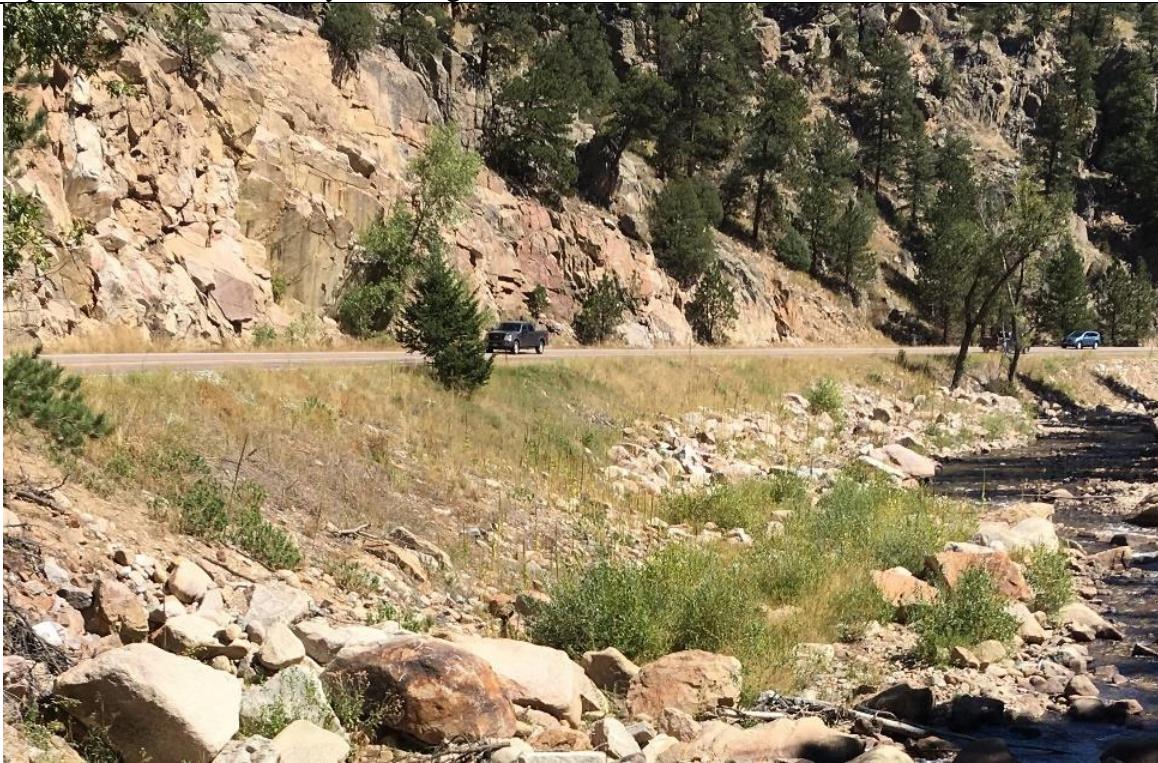
September 15, 2018. Note vigorous willow growth on low bank plus some pockets of volunteer wetland vegetation, fewer areas of bare ground on the road embankment.

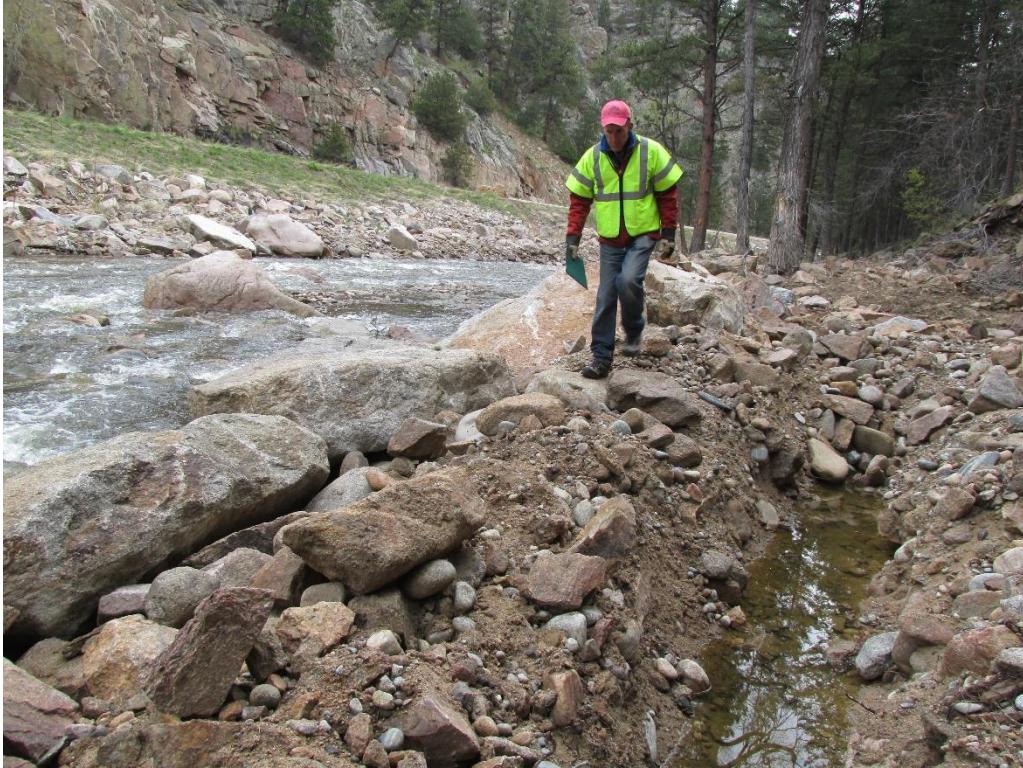
April 30, 2016, view down stream of willow trench post-construction. Note groundwater in trench bottom.

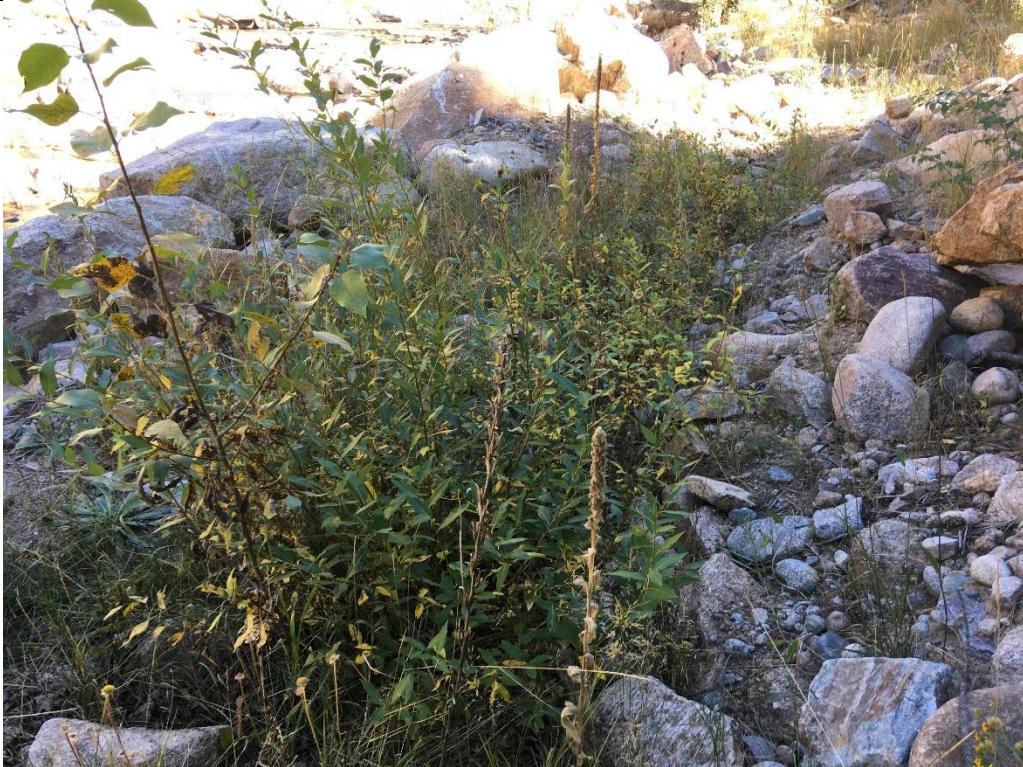
September 15, 2018, view down river of vigorous growth of planted willows and volunteer cottonwoods in trench.

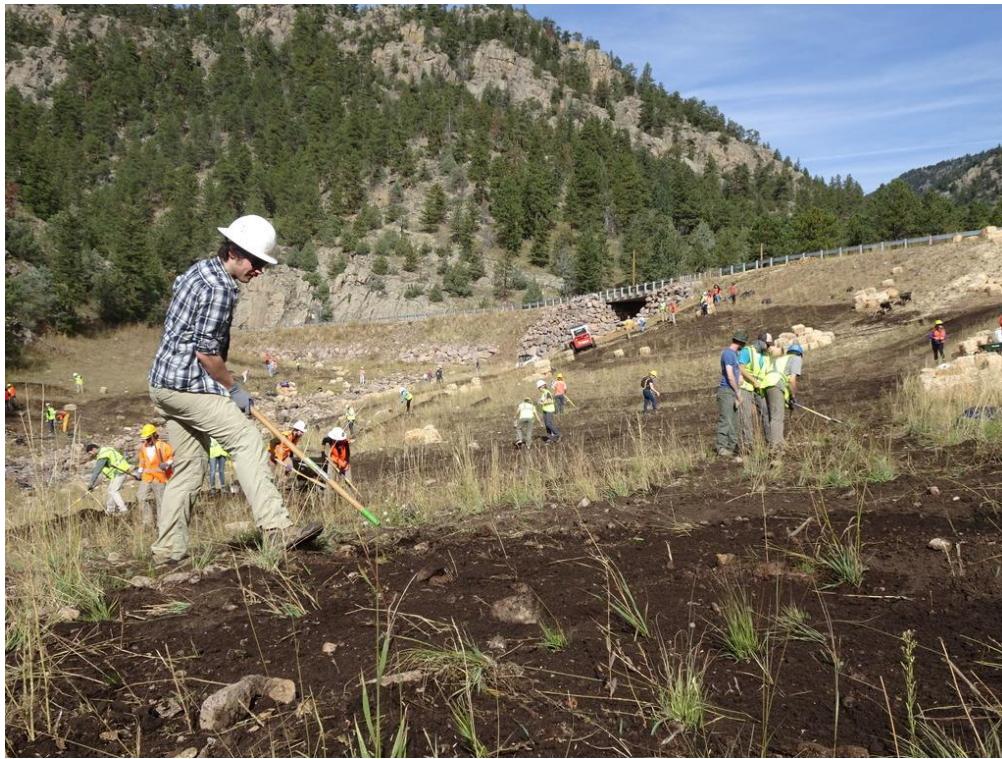
Restoration area on 9/30/2017: riparian zone up to highway, Big Elk Road in background. Note topsoil dressing on parts of the restoration. Erosion matting used on steep slope below road. Following spreading of topsoil, seeding, raking, and woodstraw applied.

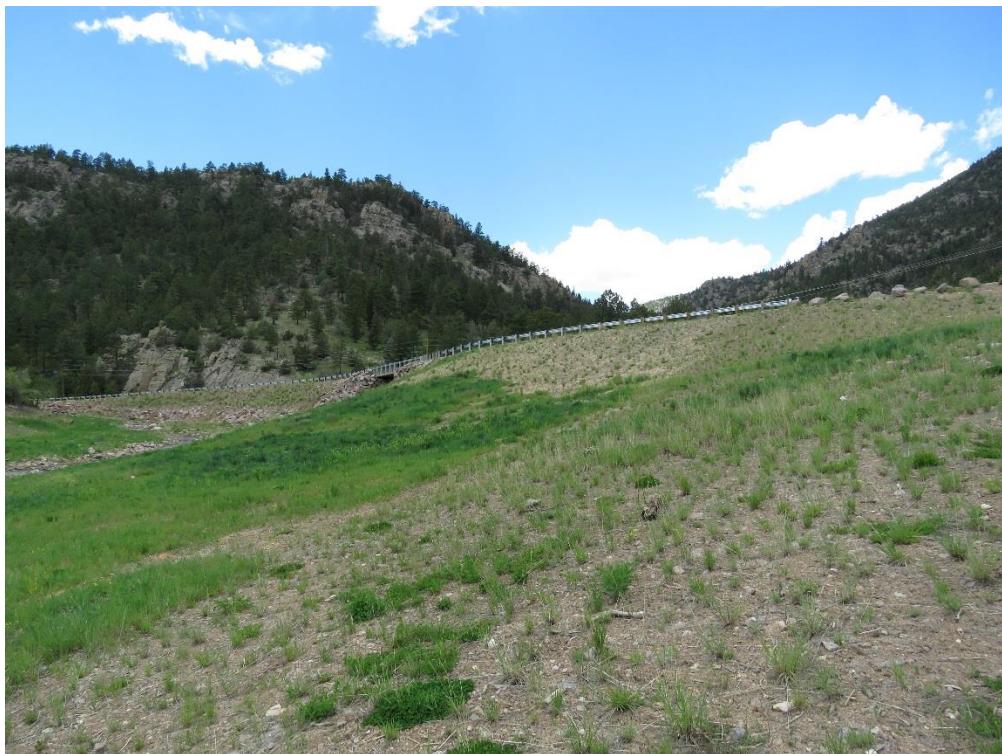
See photos. The top soil dressing clearly stimulated vegetation early on, and did result in greater production. It was unclear how this dressing affected weed abundance.

Spring of 2018, view to north with Big Elk road in background. More abundant vegetation on topsoil areas clearly visible.

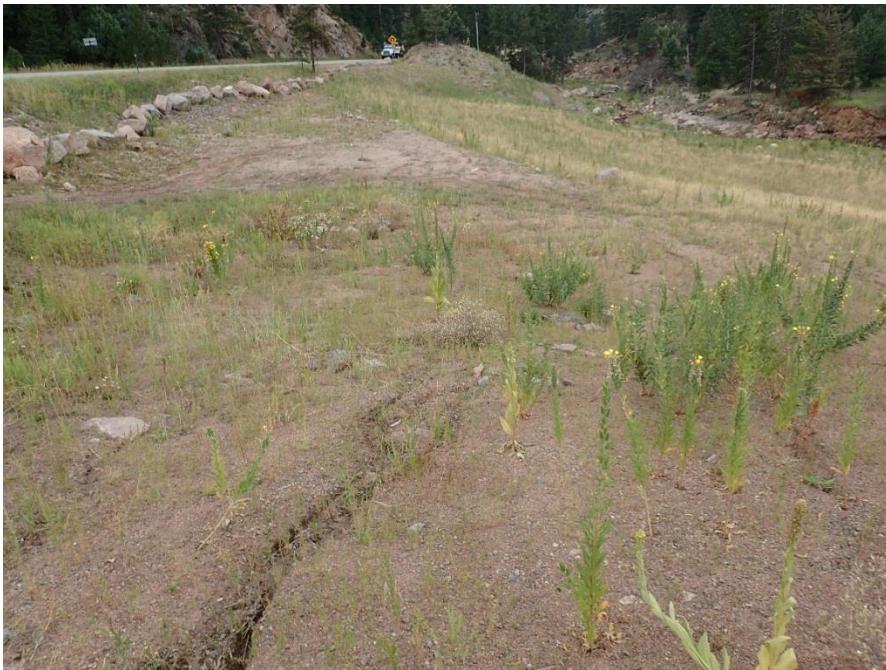
8/21/2018, view to south with US 36 in background. Foreground area NOT restored above site is eroding and weedy.

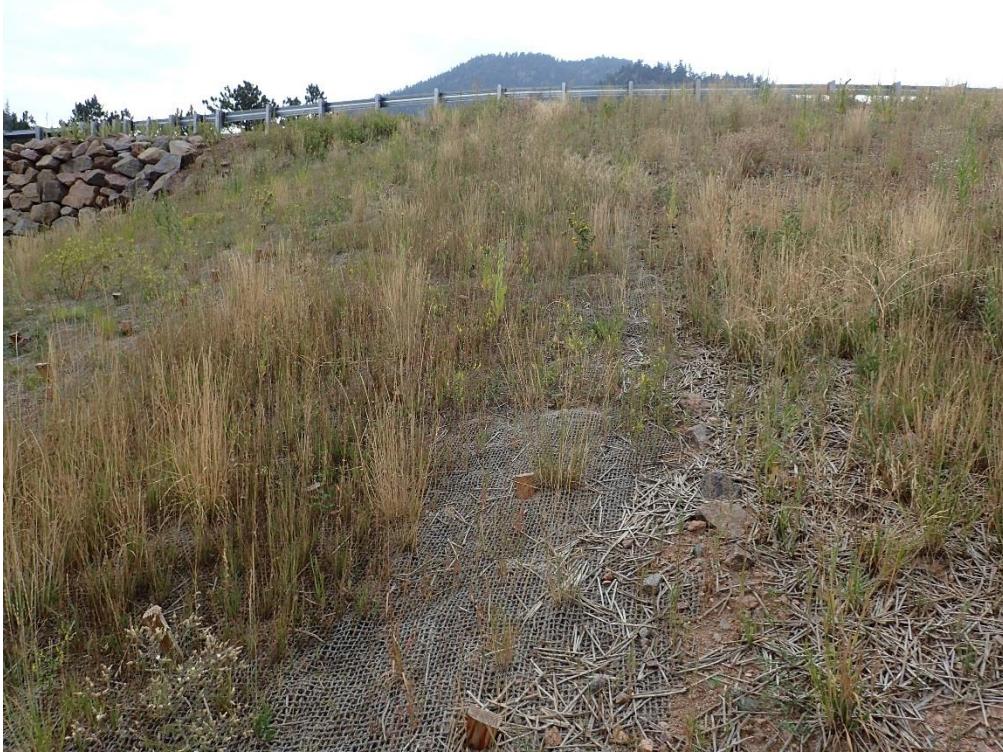
8/21/2018, view to north, Big Elk Road in background. Erosion matting on left, wood straw on right. Weeds in this picture include diffuse knapweed (which contain biocontrol -seed weevils but do not contain root weevils, which could be added), and tumble mustard, a common early successional disturbance species. The volunteer native forb, gumweed, (*Grindelia squarrosa*) also is in the background.

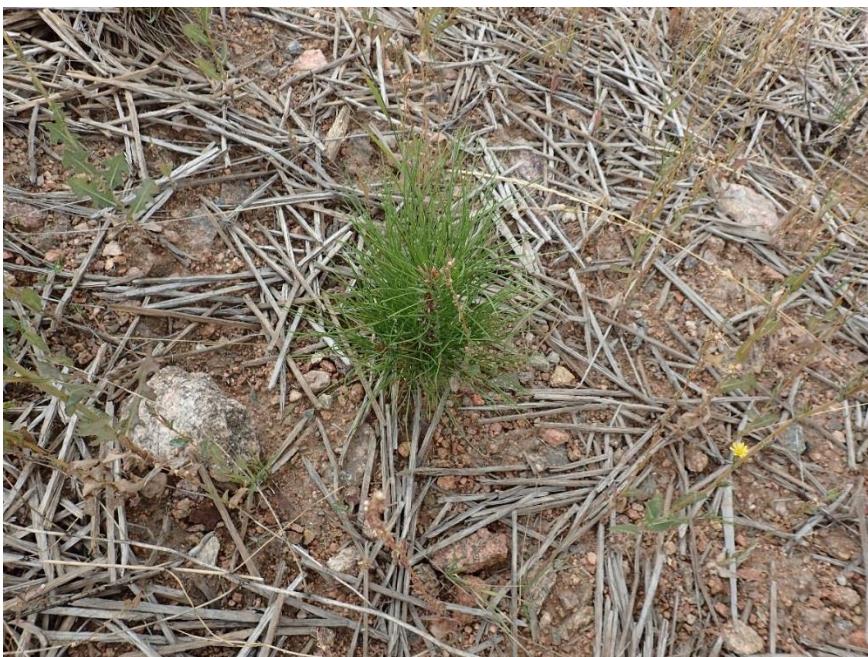
Ponderosa pine is among the volunteer species found on the site. Note presence of wood straw added the year before.

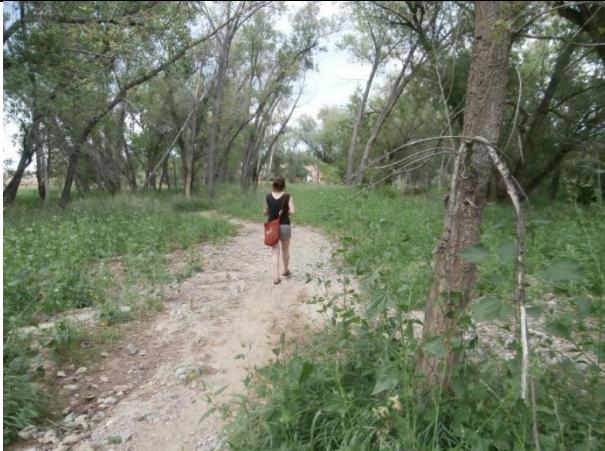
2014, view to north of trail through riparian area. Note dominance of lambsquarters.

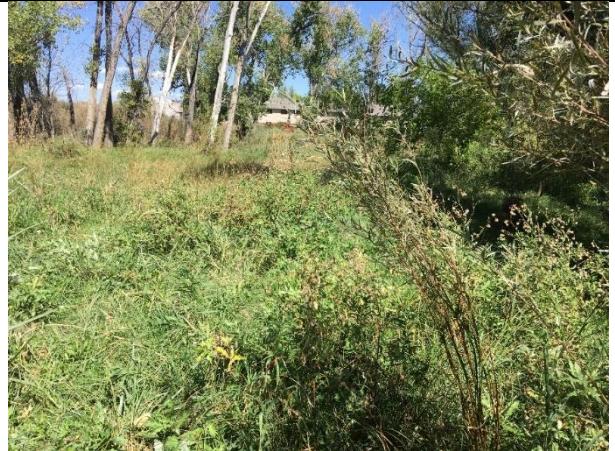
2014, Revegetated trail through riparian area, mostly volunteer species, few shrub and tree planting survivors. Note that trail is not longer visible.

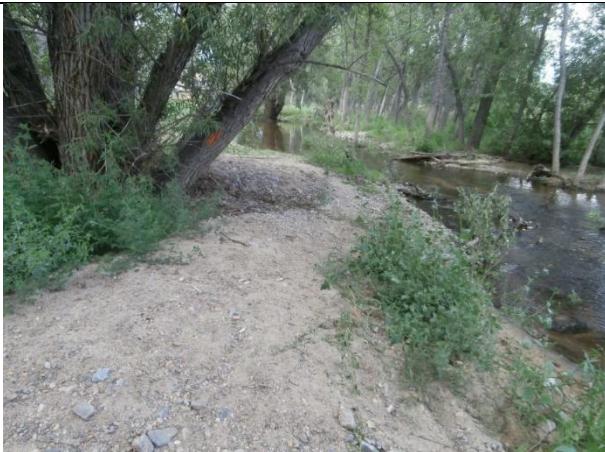
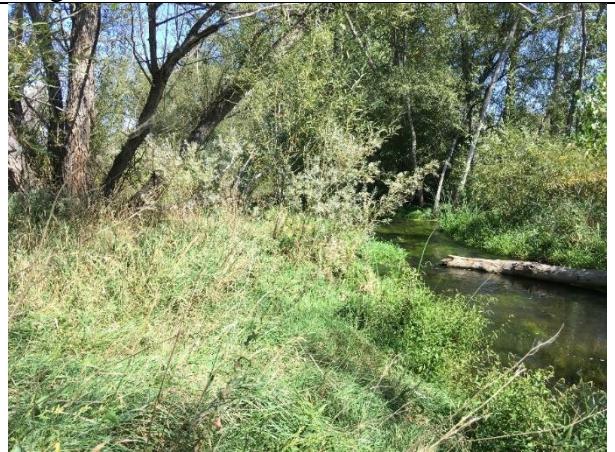
<p>2014, view downstream of typical stream bank. Note sediment deposit and very little bank vegetation</p>	<p>2018, Streambank with willow plantings on upper bank. Note abundant growth of volunteer species, mostly non-native.</p>

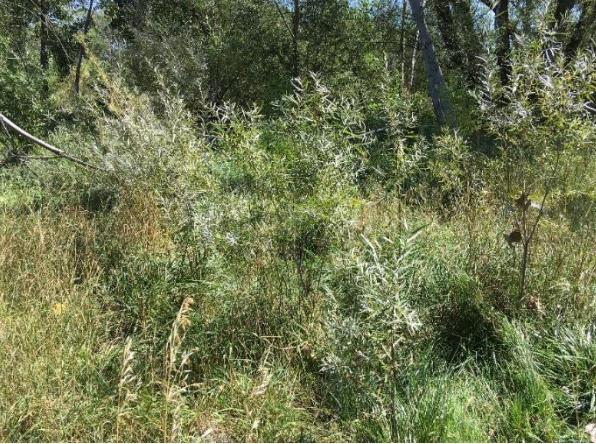
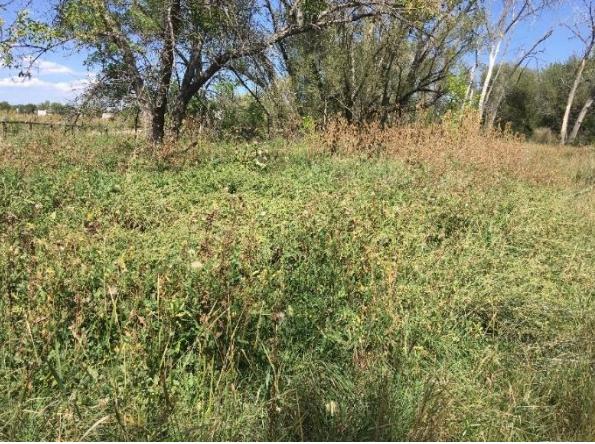
<p>2018, view to south of vigorous sandbar willow plantings in north side ditch.</p>	<p>2018, view to north of weedy upper riparian area with thistles, lambsquarters, teasel.</p>

Remove non-native trees such as Siberian elm, phased removal of crack willow.

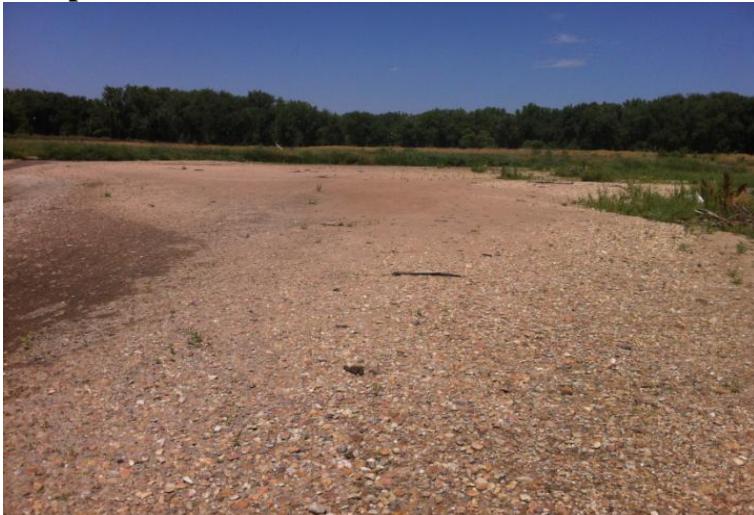
Sandbar in summer, 2016, view to north toward former channel. Herbaceous planting were installed on left side, cottonwood and willows planted in center.

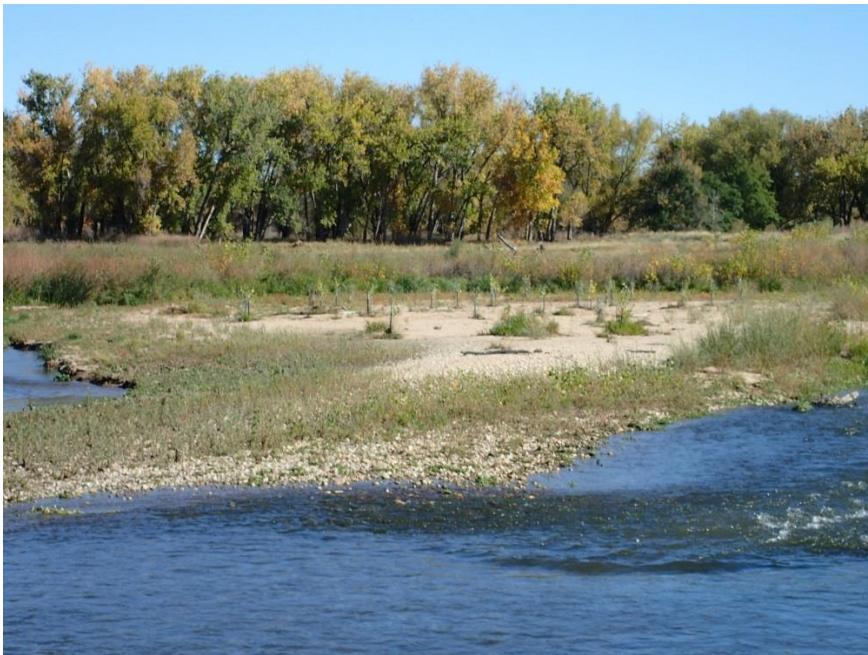
High water in spring, 2017 opened up what was believed to be a non-active channel and removed a large majority of the herbaceous plugs. Survivors at the furthest most eastern planting were observed. Non-dormant willow and cottonwood poles did not survive whereas all of the cottonwood and willow plantings appeared to have survived.

Sandbar in early Oct., 2017, view to north. Note active channel on left, with cottonwood and willow plantings visible in center

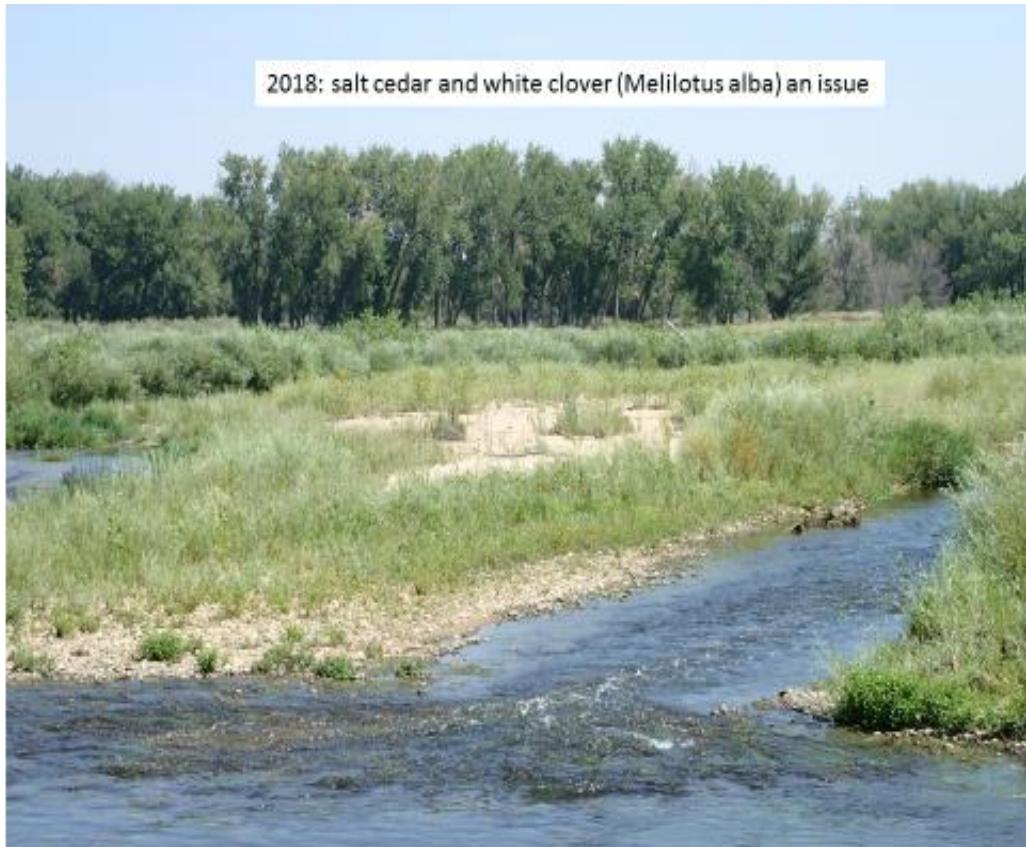
August 2018, view to north. Island plantings are doing well; we observed 100% survivorship of island cottonwoods and no mortality in willows from 2017 counts. Threats, however, are noted from invasive salt cedar (tamarisk). A subsequent tamarisk weeding event in 2018 removed these.

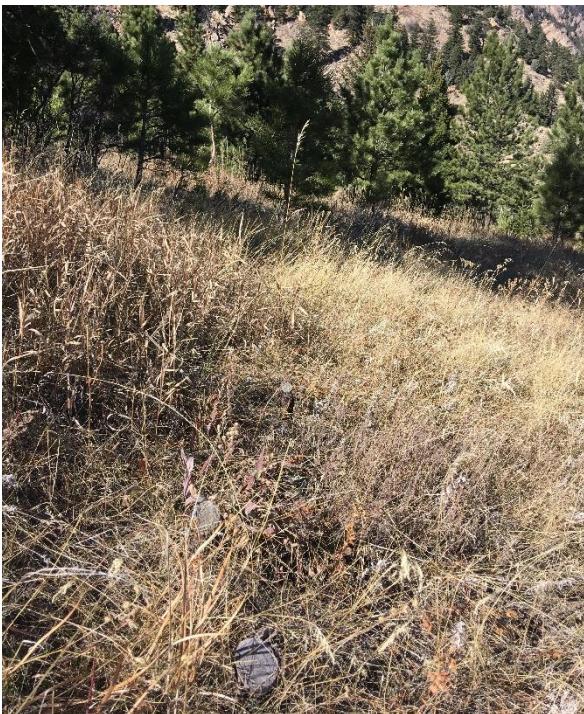
Close-up of dead cut stumps from the 2004 project.

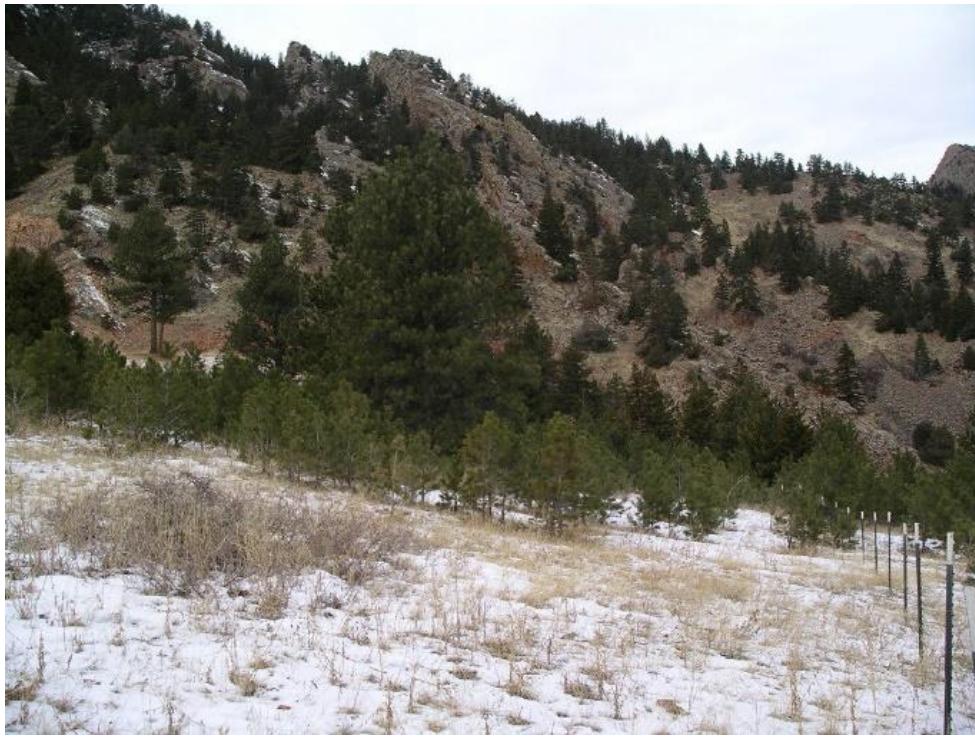
2004 Pre-Project. Note many dog-hair ponderosa pine.

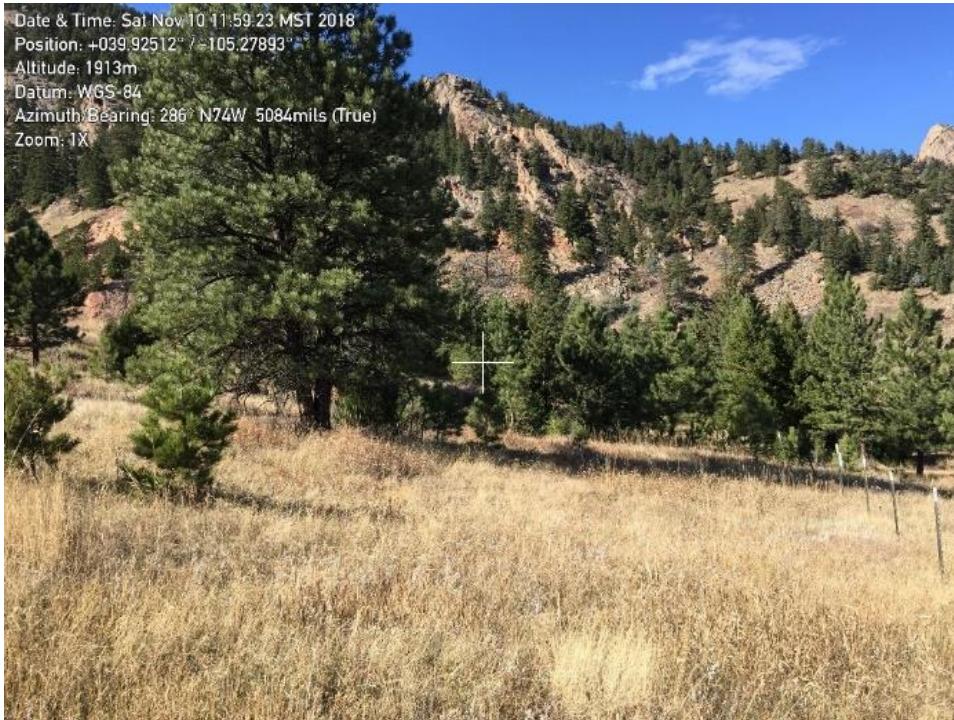
All photos, except for the comparison set, were taken during the November 8, 2018 monitoring. The photos show small ponderosa pines that sprouted following the 2004 tree thinning project. The relatively open savannahs would have become dense forests without the project.

2018 Monitoring. Note larger open areas and several small pine.

Corrective or Maintenance activities needed: Ponderosa pines that grew post project are now comparable in size to those cut in 2004. We recommend a follow-up thinning project within or prescribed burn in the next few years
