Monitoring WRV Projects – What We Learned During 2015  
September 28, 2015  
Laura Backus, Alan Carpenter, Todd Sanford

## **Background and Purpose**

## WRV QUICK MONITOR D R A F T

**Project Name:** Berthoud Pass Restoration

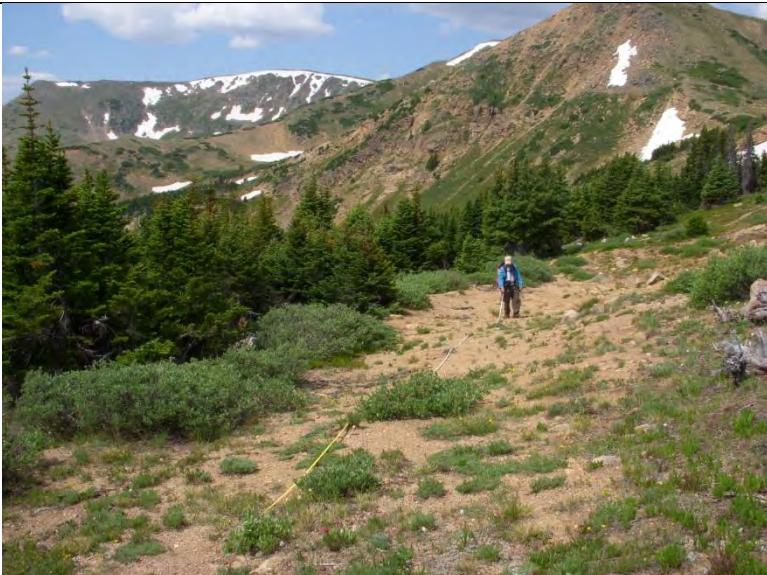
2008 pre-project

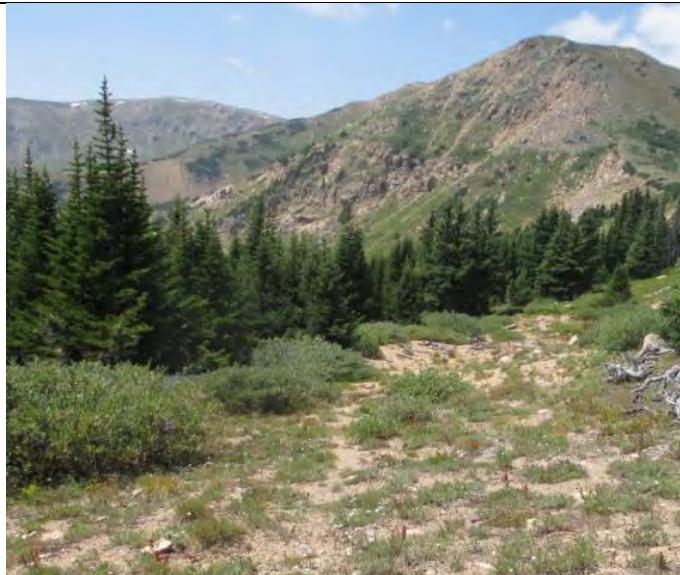
2015 monitoring. Note increase in vegetation cover.

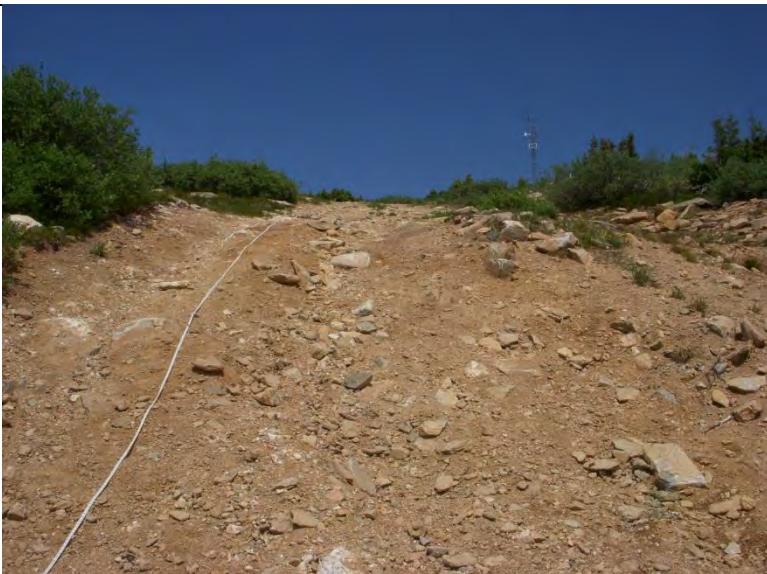
2008 pre-project

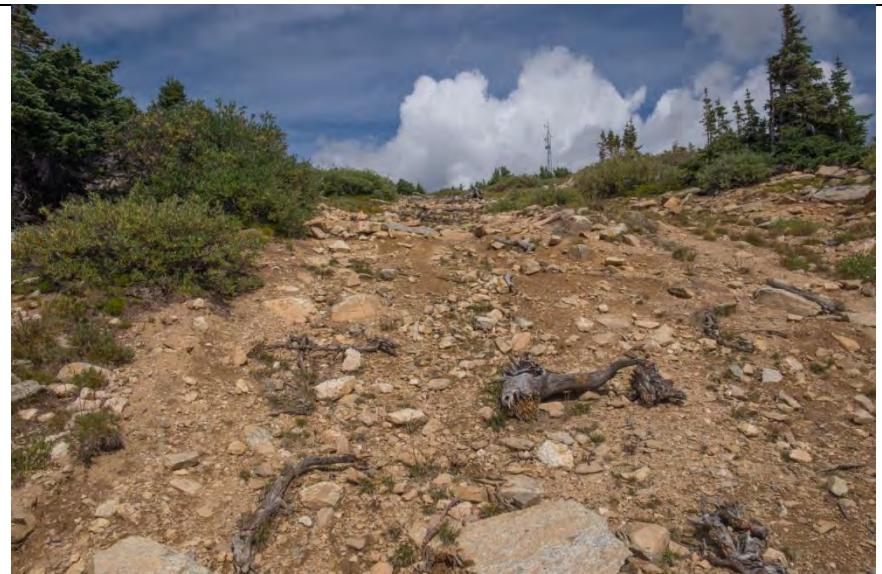
2015 monitoring. Note increase in vegetation cover, especially adjacent to woody debris and boulders.

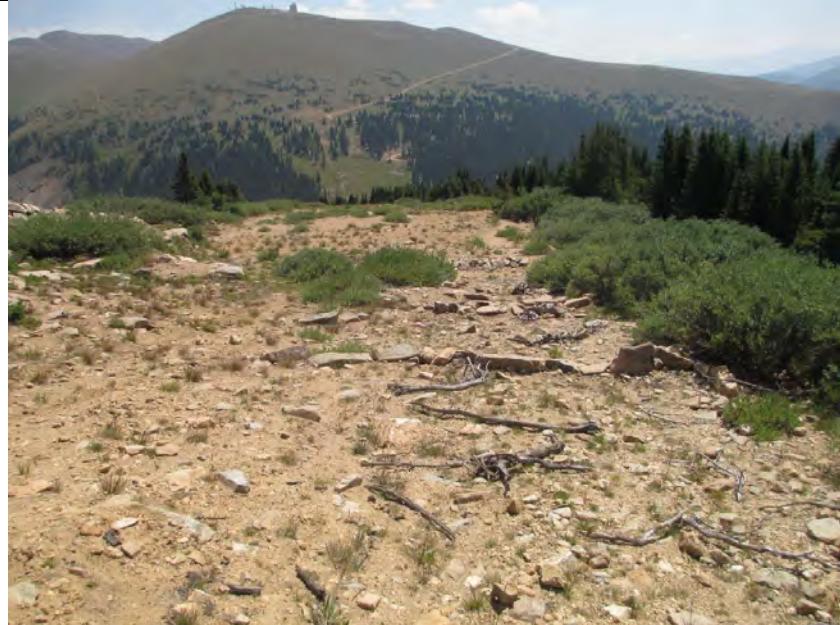
2015 monitoring, view to east (down slope).  
Note increase in number of small clumps of vegetation.

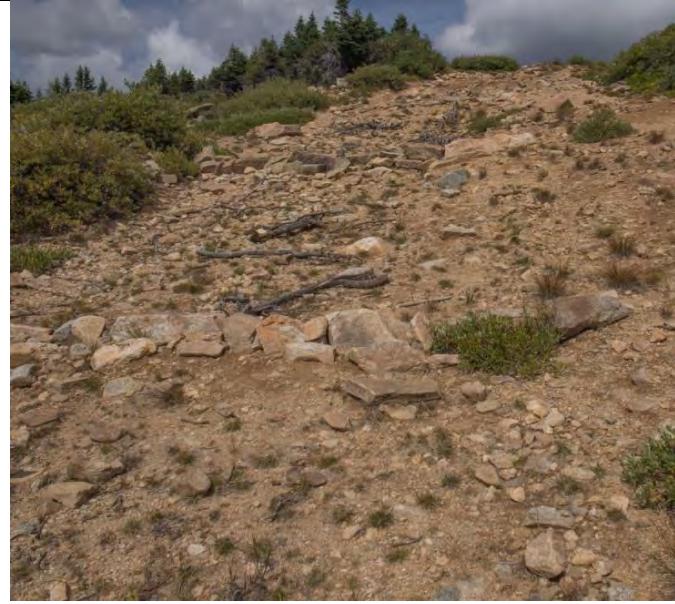
2015 monitoring, view to west (up slope).  
Note increase in grass clumps.

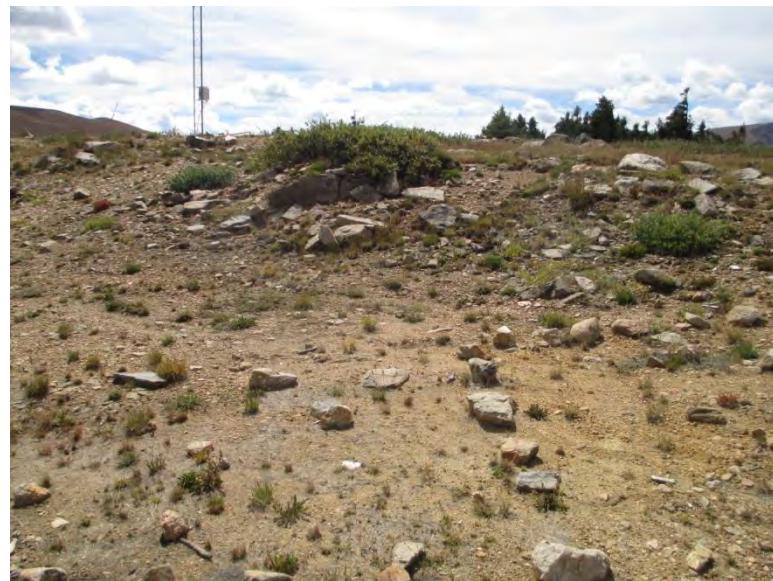
2015 monitoring, view to south. Note small increase in vegetation cover.

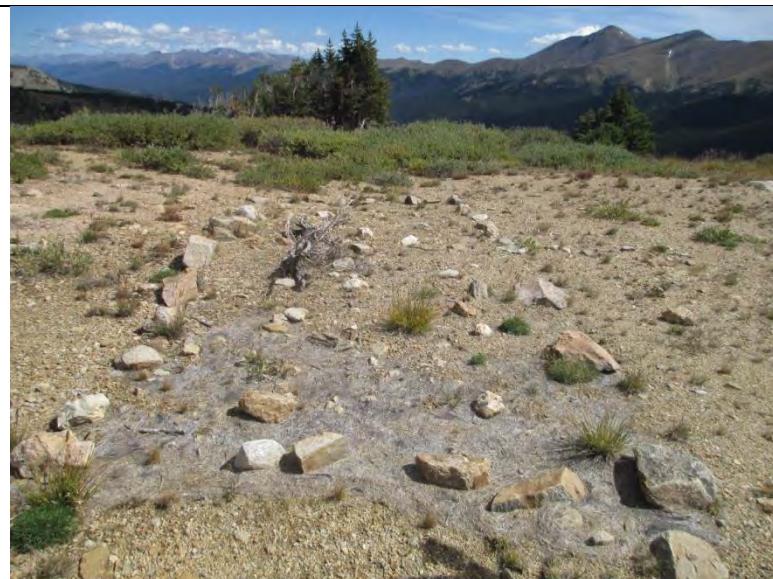
- In some areas, the erosion mats appeared to have inhibited plant development, especially of volunteers. In many areas of matting, the organic portion of the mat had not fully disintegrated and the synthetic portion was still visible. Only use fully biodegradable mats.

2015 monitoring, view to northwest. Experimental seeding site.  
Note that erosion control mat has not disintegrated.

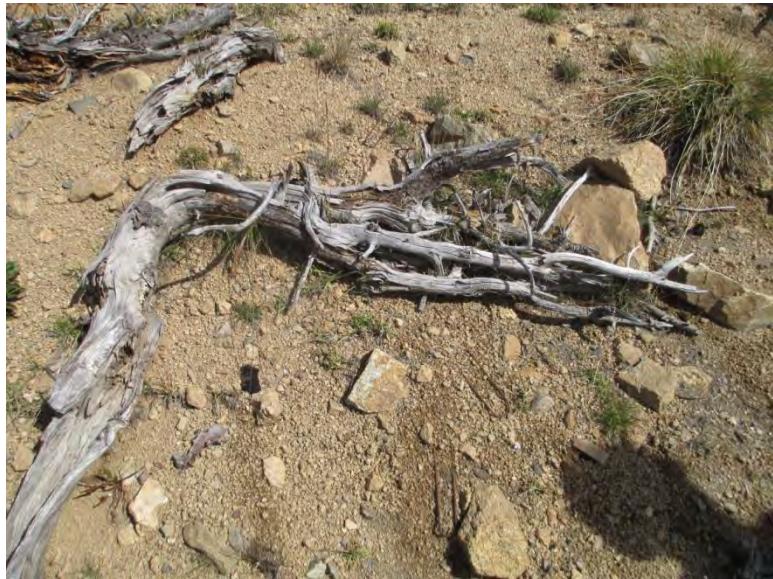
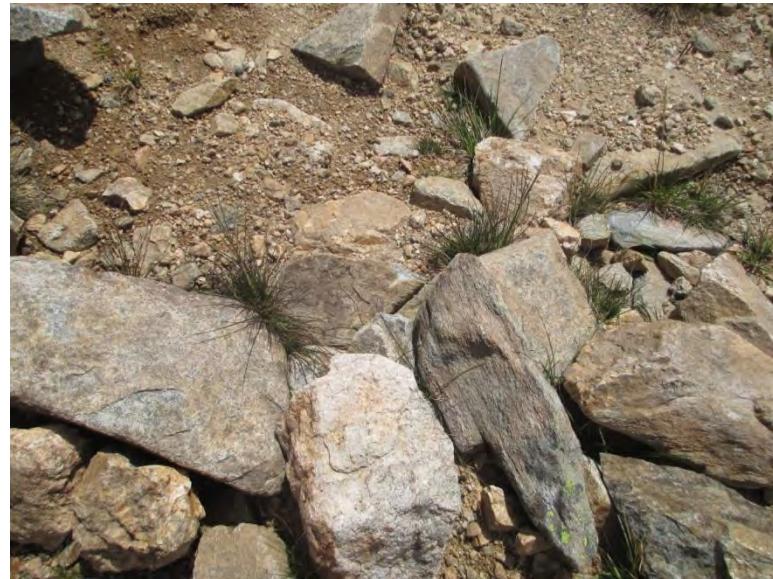
Woody debris and large boulders provide valuable micro-habitat for seeded and volunteer species.

- Very few transplants survived on steeper sections; in these areas, creation of favorable microhabitats with rocks, large woody debris, and planting depressions and grass seeding could be more effective. We also recommend concentrating seeding in these areas.

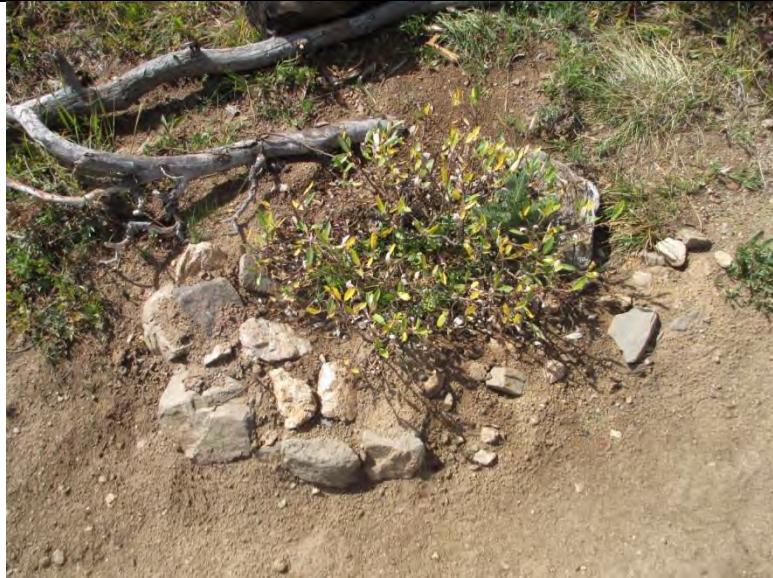
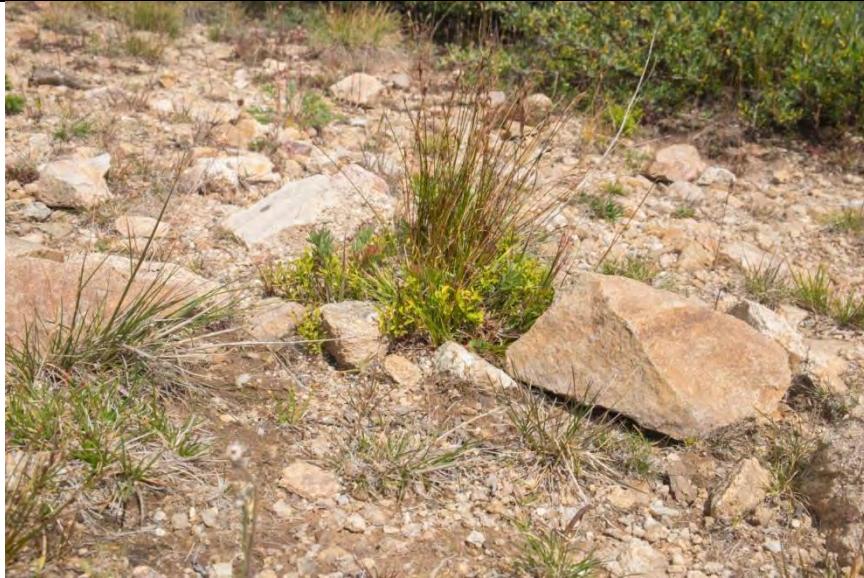
Planting depressions provide valuable habitat for transplants and volunteer species.

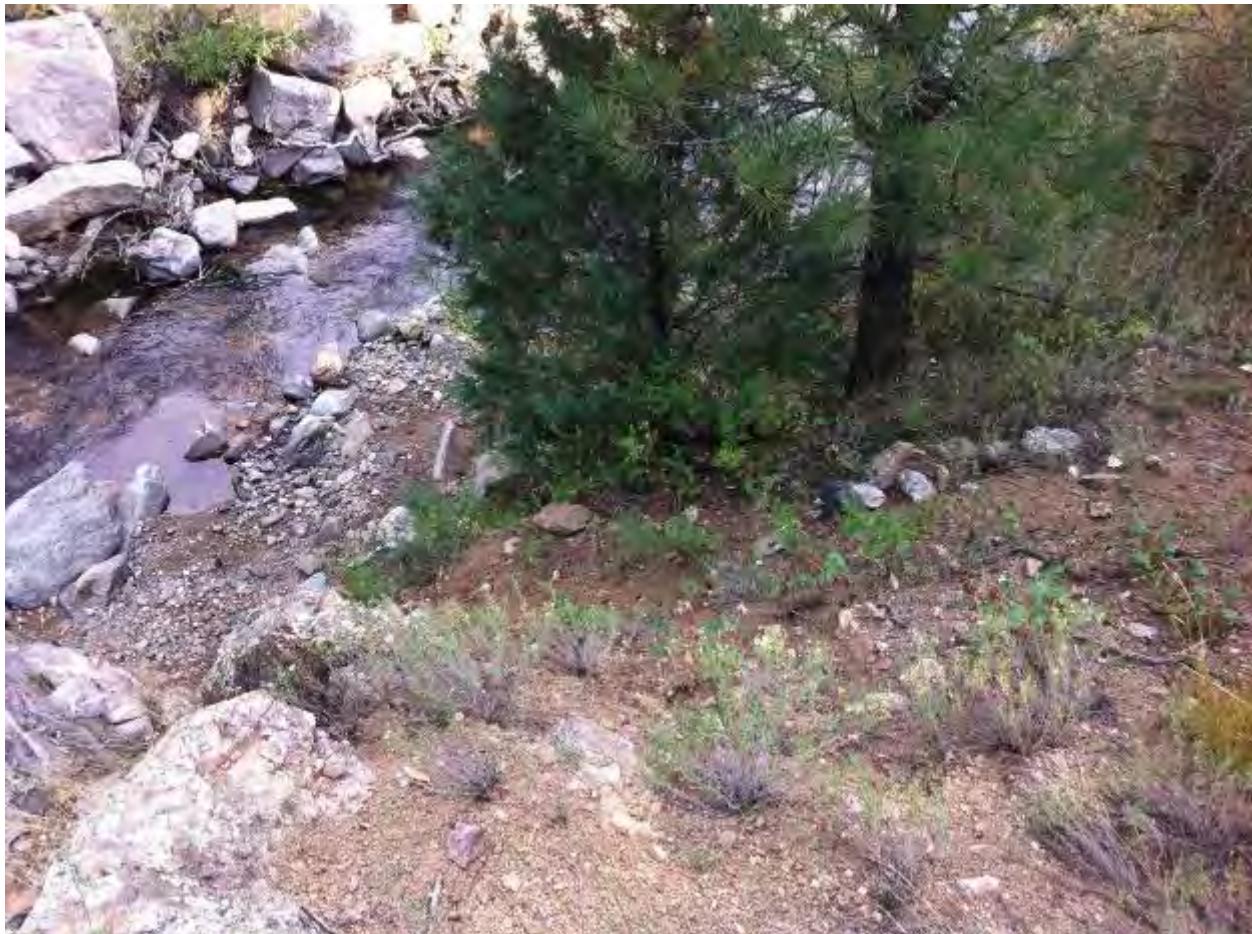
Section A at 4 mile canyon, very well obscured, and can't really tell where the trail used to go for the most part.

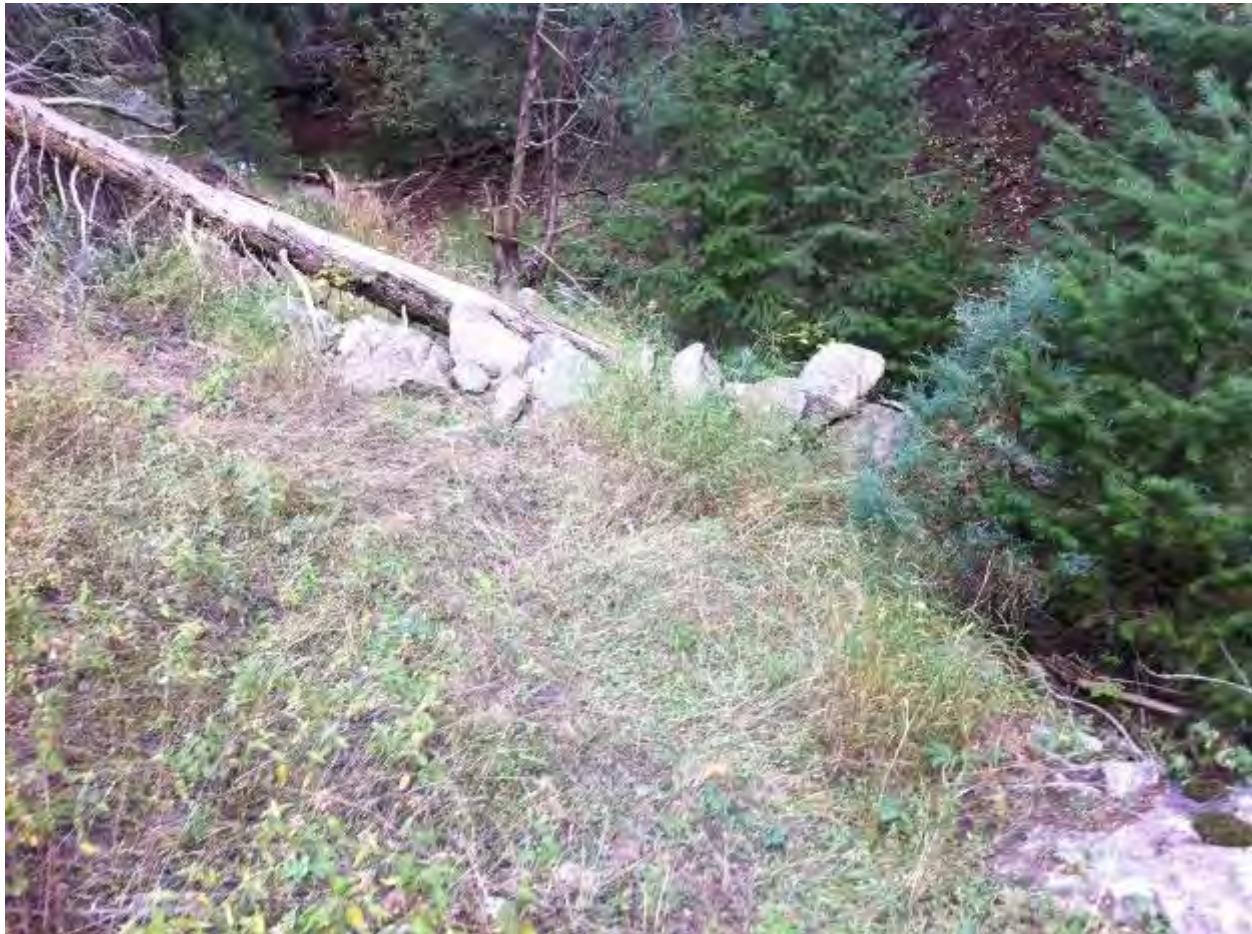
Section E, very nice water bar made with a combination rock and log, holding well, allowing vegetation to build up on the uphill side.

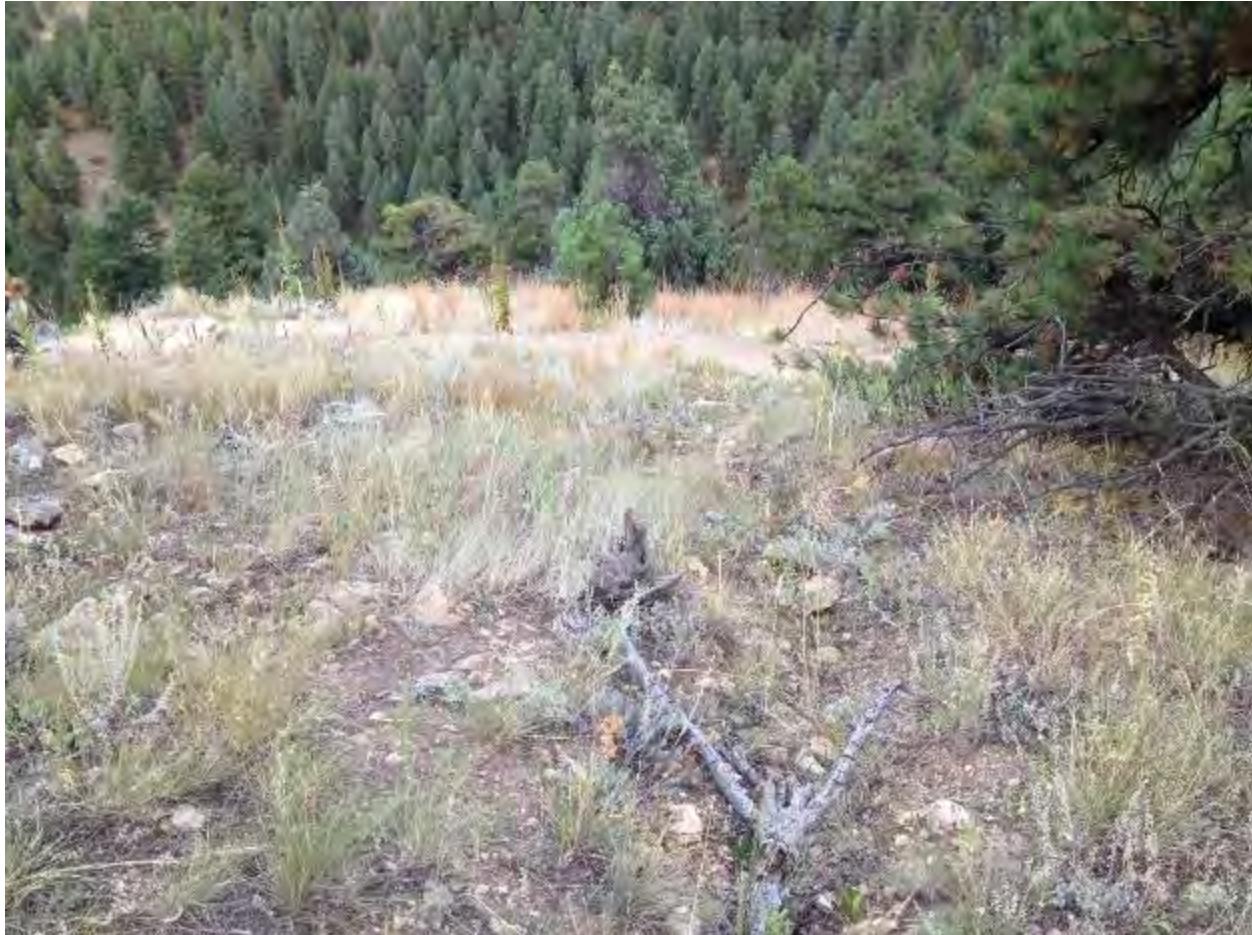
Section F, above (up hill and west of new trail) well obscured by woody debris and vegetation.

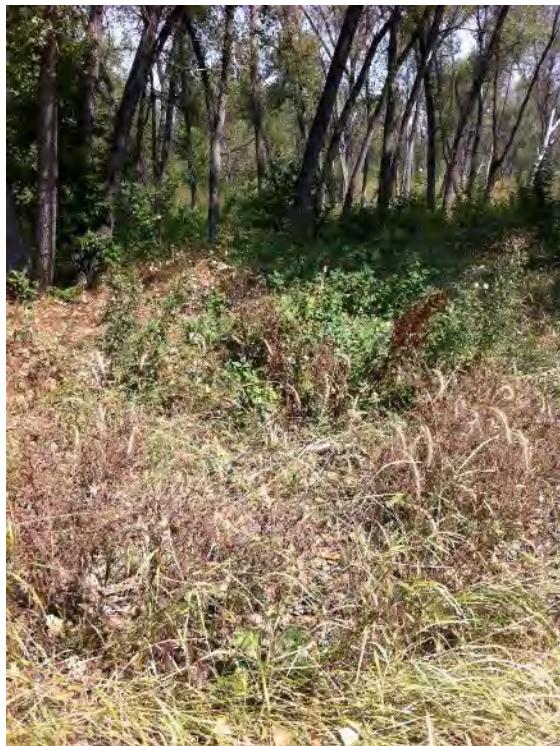
Area 5, surviving chokecherry shrubs 2015

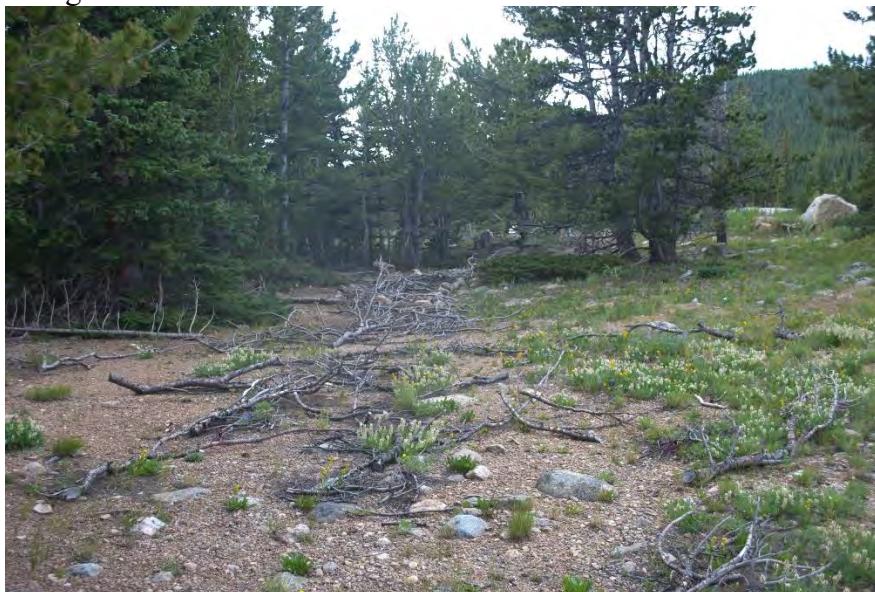
Looking south at a former social trail about 200 feet northeast of the bathroom, lots of branches, the trail was successfully closed, but revegetation is spotty

The social trails and camp sites should have been seeded if they weren't seeded. If they were seeded, the seeding was ineffective.

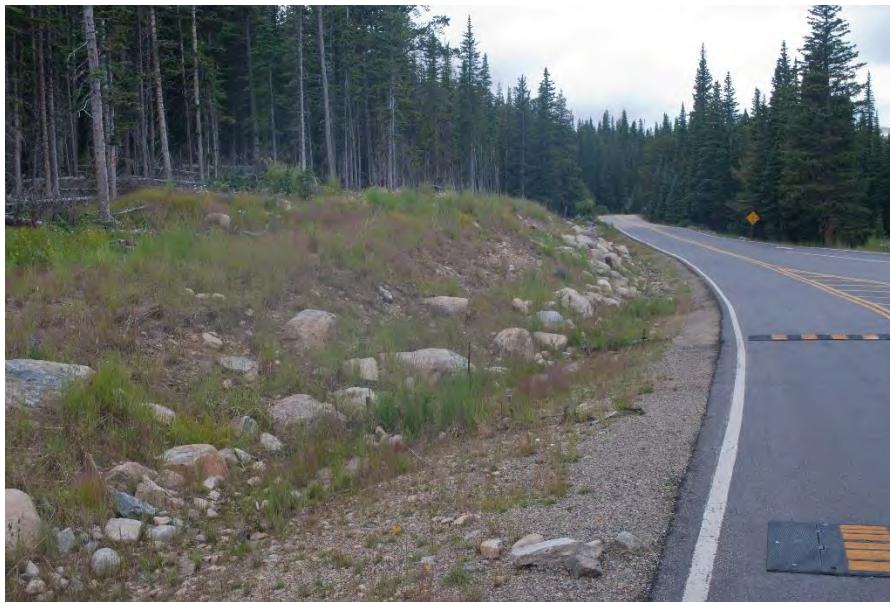
Vegetation cover on the steep slope was variable depending on the steepness of the slope. The top and bottom of the slope were generally well vegetated with seeded grasses and forbs. However, the steeper middle portion of the slope still had spots that were fairly bare of vegetation. The crew leader and section notes for this area called for erosion mat to be installed, but I did not find any evidence of erosion mat; rather observed old Wood Straw. It appears that Wood Straw was substituted for erosion mat in this work area. The Wood Straw was not effective on the steeper portions of the slope, where erosion mat should have been applied. The survival of the willow stakes installed in the drainage at the bottom of the slope appears to be satisfactory. The willows are still small, but looked to be healthy. I expect that the willows will increase greatly in size over the next few years. I observed minimal erosion along the bottom of the drainage at the bottom of the slope.

Looking west at the steep slope immediately south of the Brainard Portal entrance station, revegetation of the steep of the middle slope was spotty, Wood Straw was ineffective, erosion mat would have been a better choice

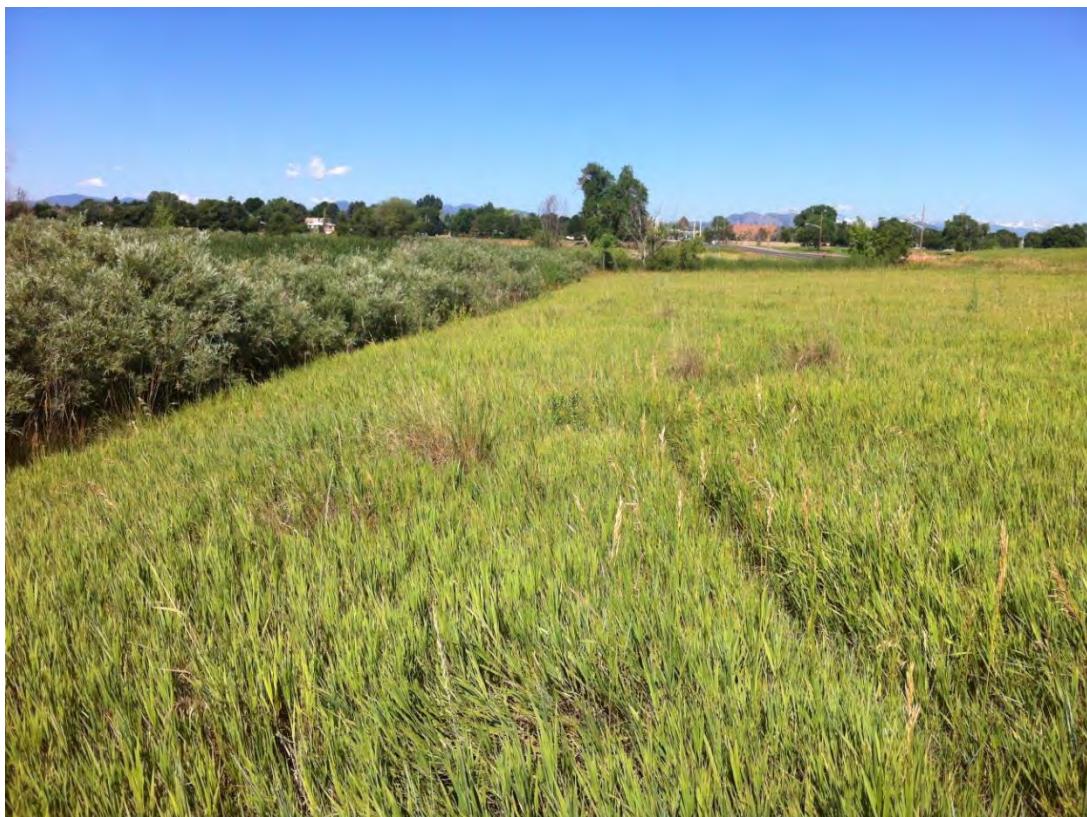
Photo1: Section 1 to West, no surviving cottonwoods

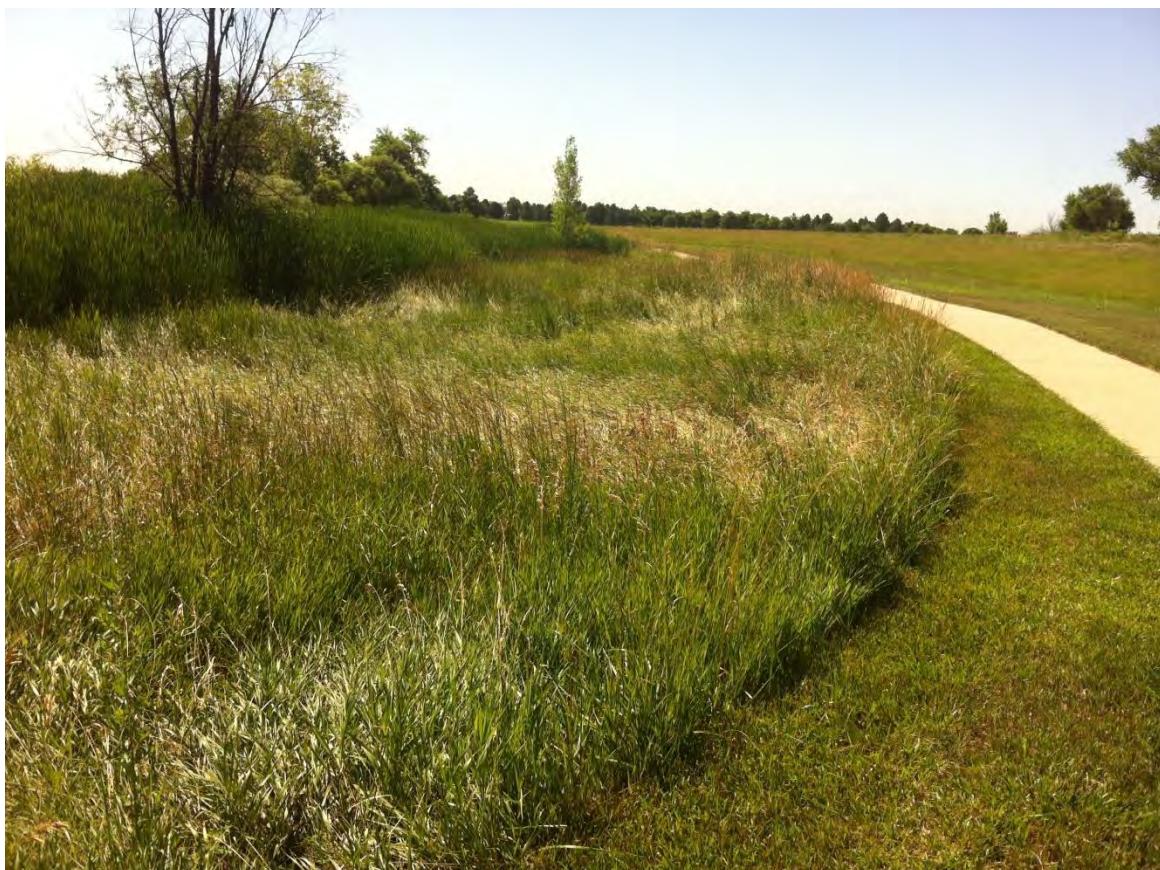
Photo 2: Sections 2-8 to SE, no cottonwood survivors evident

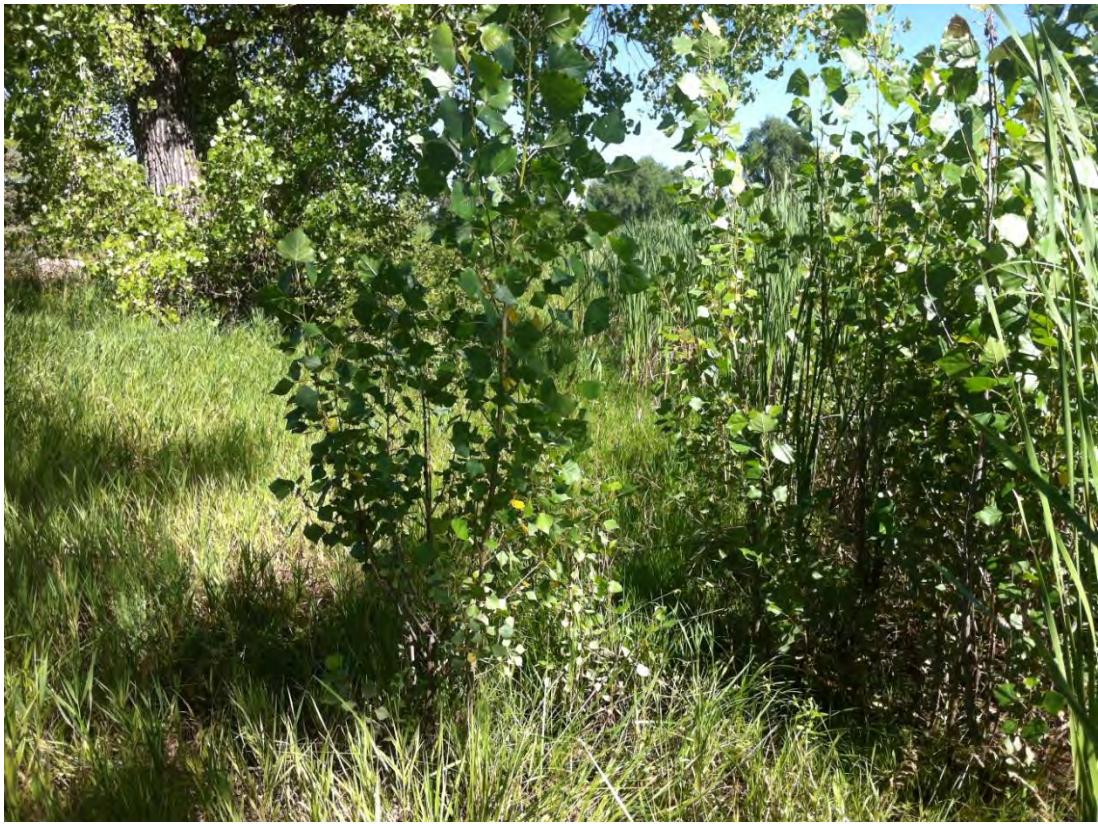
Photo 3: Sections 9-10 to NNW, cottonwood saplings, probably mostly volunteers

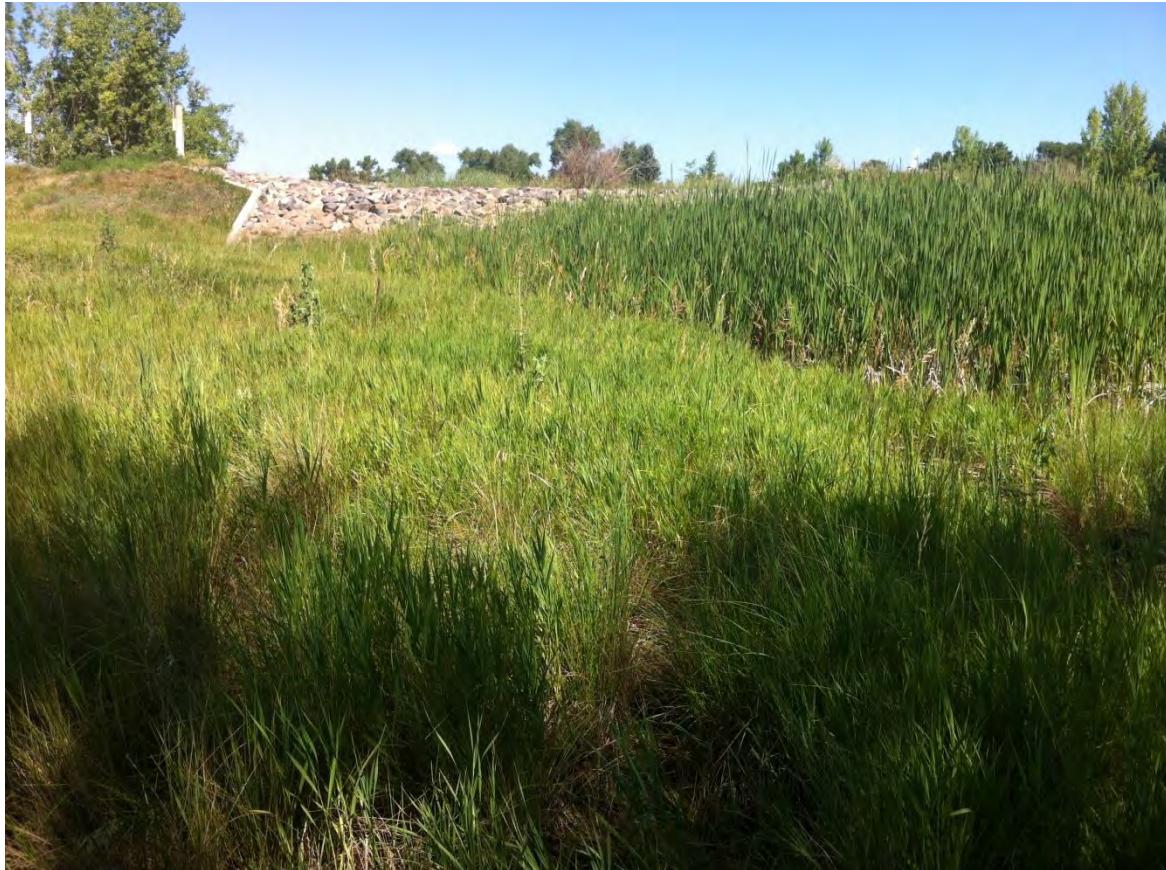
Photo 4: Sections 11-12 to NE, no cottonwood survivors in photo,  
1 survivor of this area not in photo.

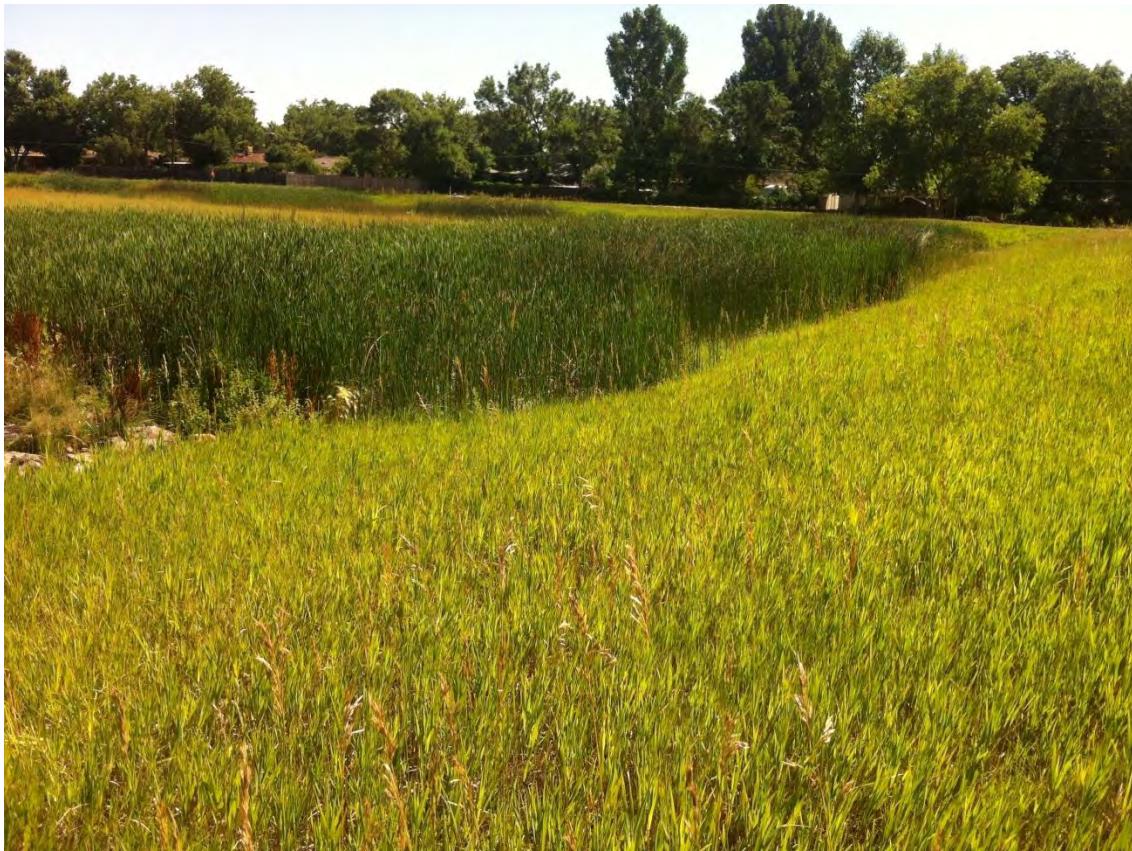
Photo 5: Sections 13-18 to ENE, no cottonwood survivors

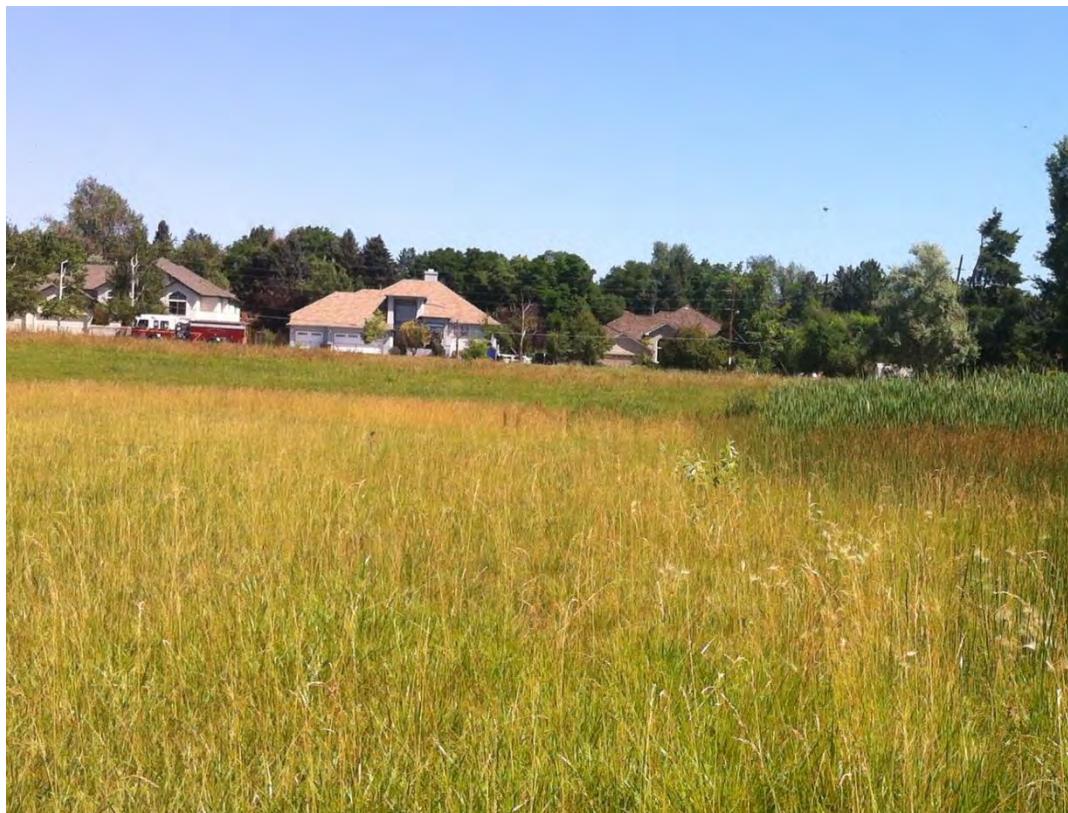
Photo 6: Peachleaf willow planting area. Note several surviving trees in photo right

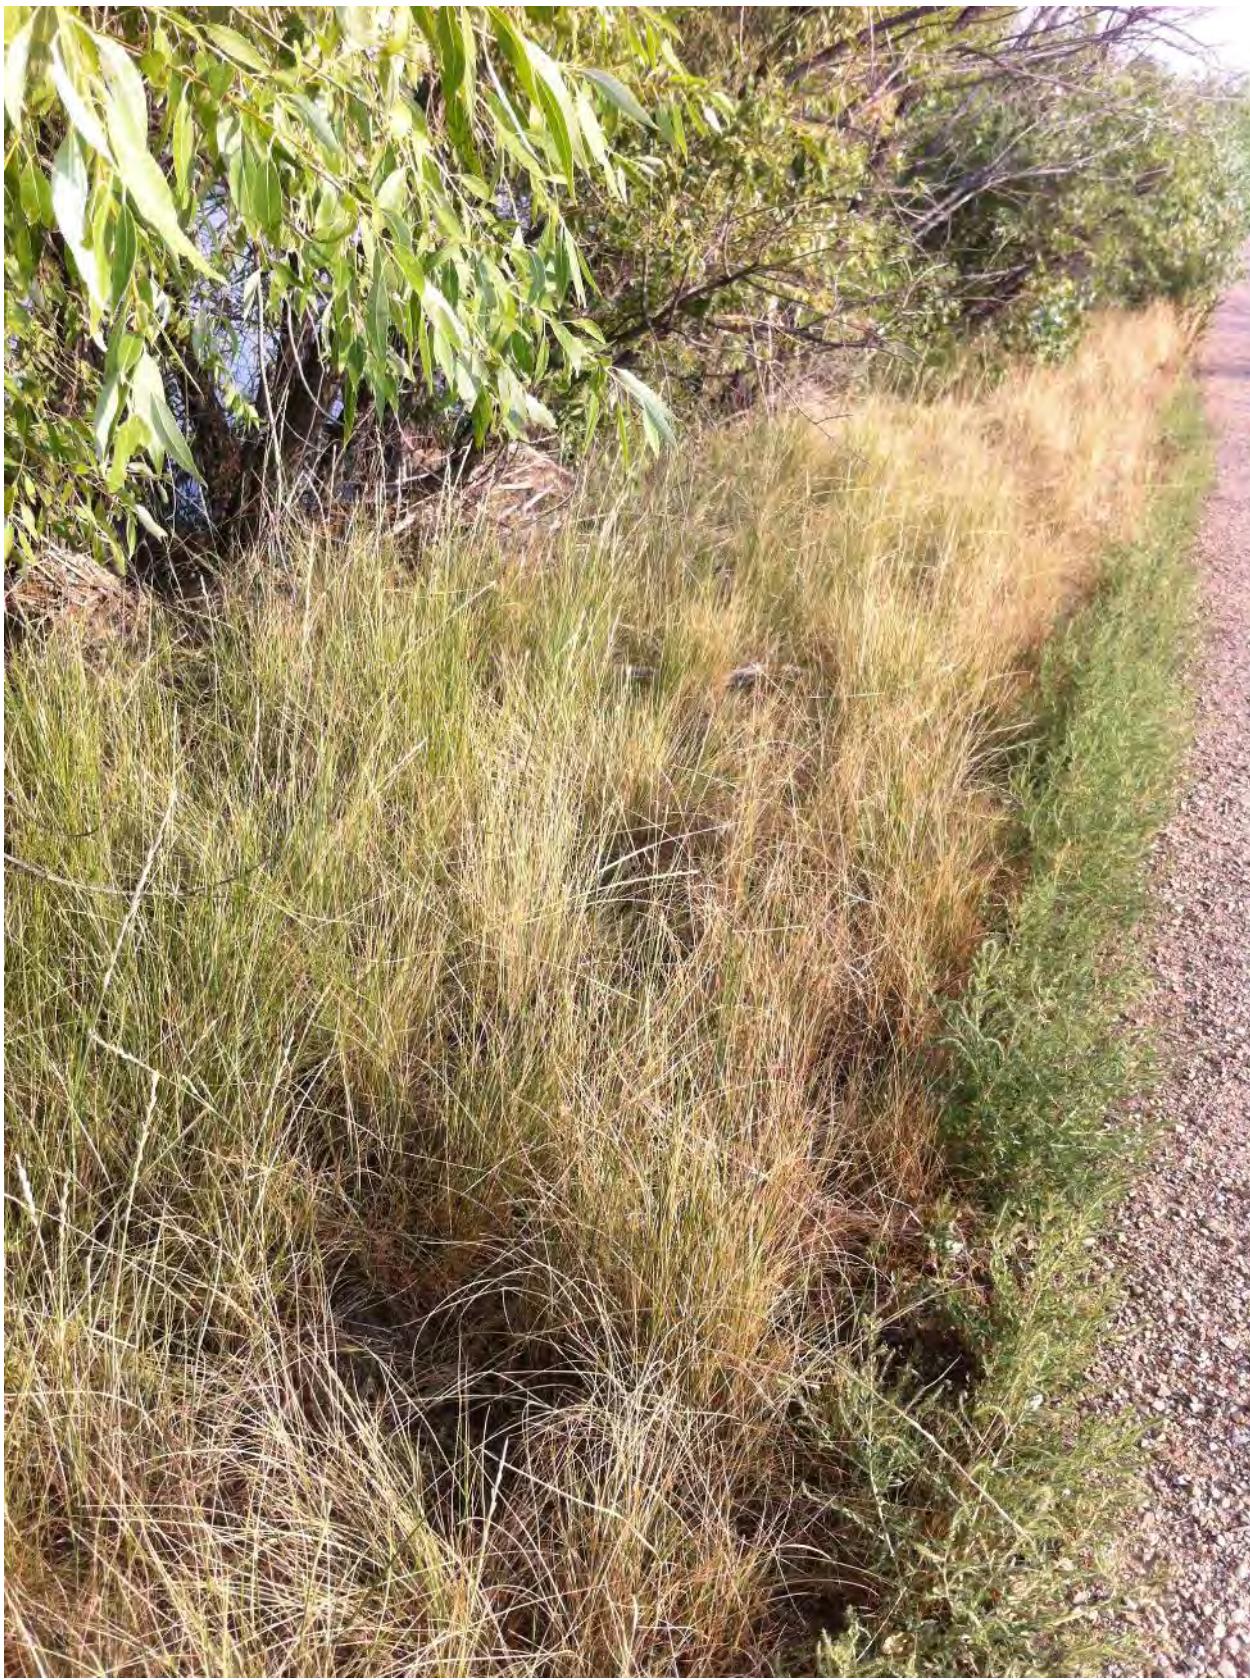
Thick native grass cover, east side, note Russian knapweed at trail edge

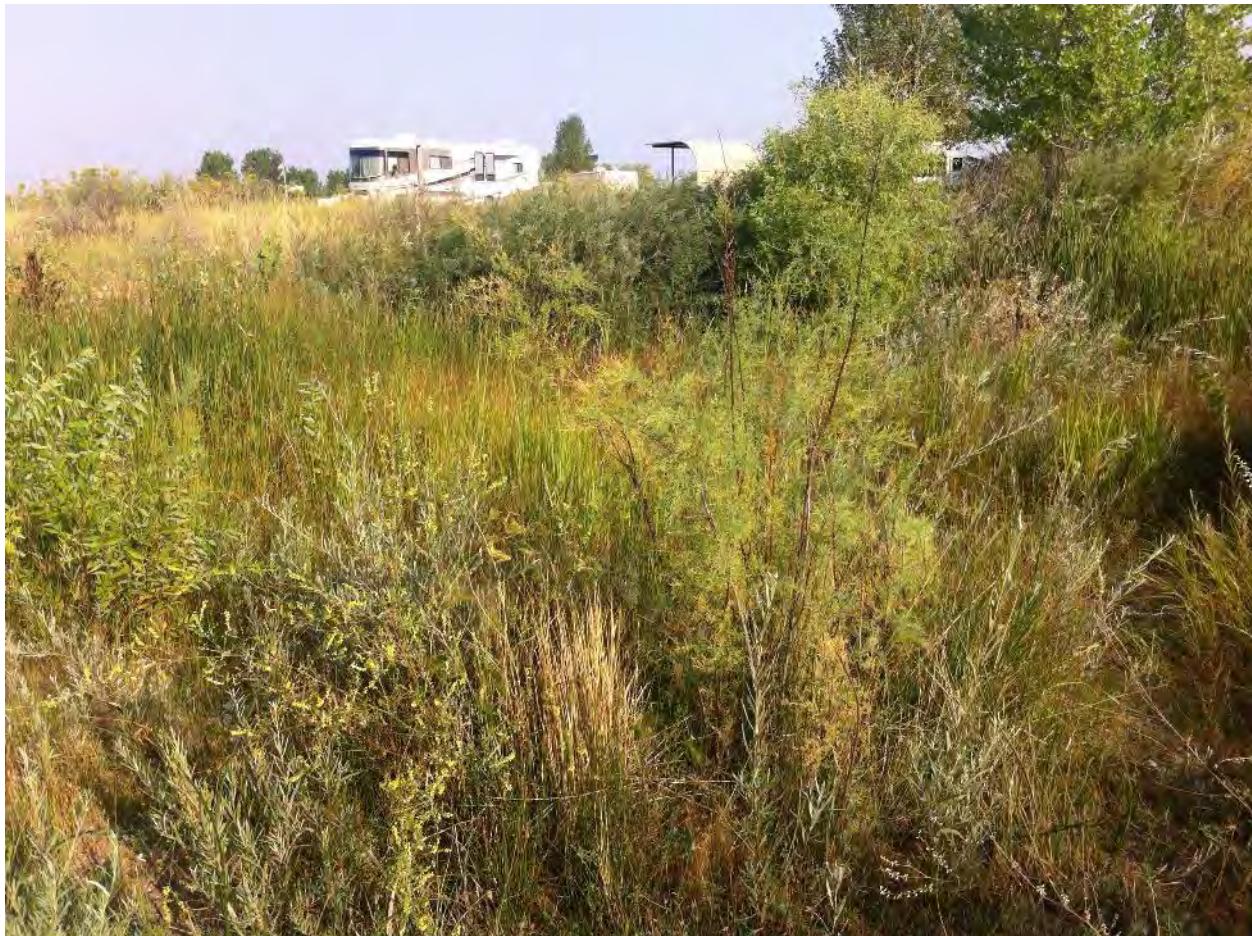
Tamarisk at fishing pier, SE corner

**Corrective or Maintenance activities needed:** Crack willow needs to be eradicated. I documented each plant location with GPS pts (about 8-10), tamarisk is also there, only about 3-4 plants, also GPS location documented. Cheatgrass and Russian knapweed occurs in small patches on the southwest side of the pond.

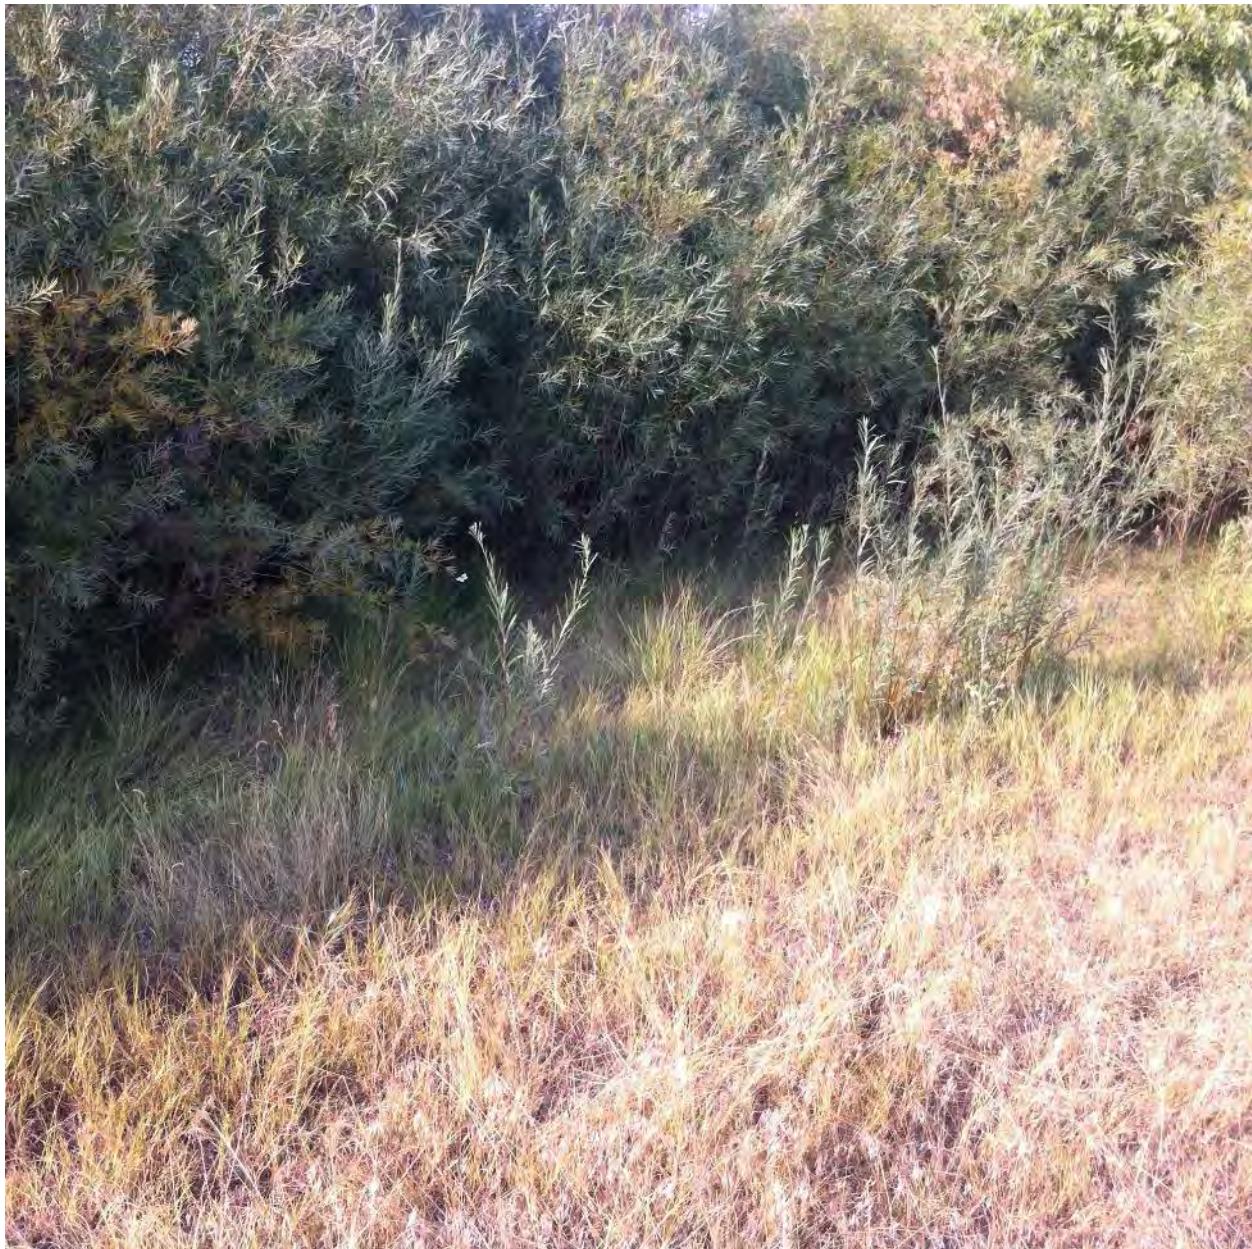
Dense native grass with some cheat grass

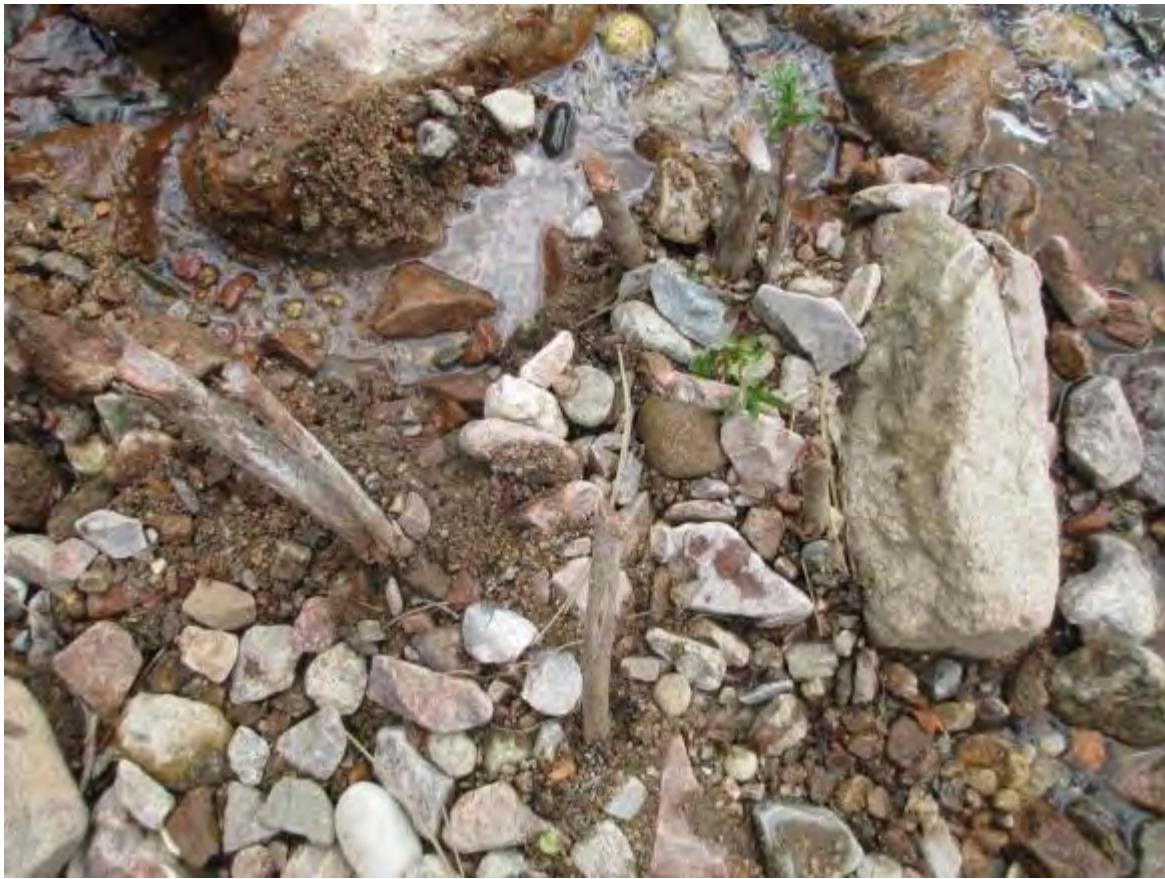
Minor growth of willows on the north bank near the Visitors' Center. Note that these stems are probably only out of the stream flows.

Install willow clumps at varying distances from the edge of water to be ready for unknown flow regimes during the first few growing seasons.
