Monitoring WRV Projects – What We Learned During 2015  
September 28, 2015  
Laura Backus, Alan Carpenter, Todd Sanford

## **Background and Purpose**

## WRV QUICK MONITOR D R A F T

**Project Name:** Berthoud Pass Restoration

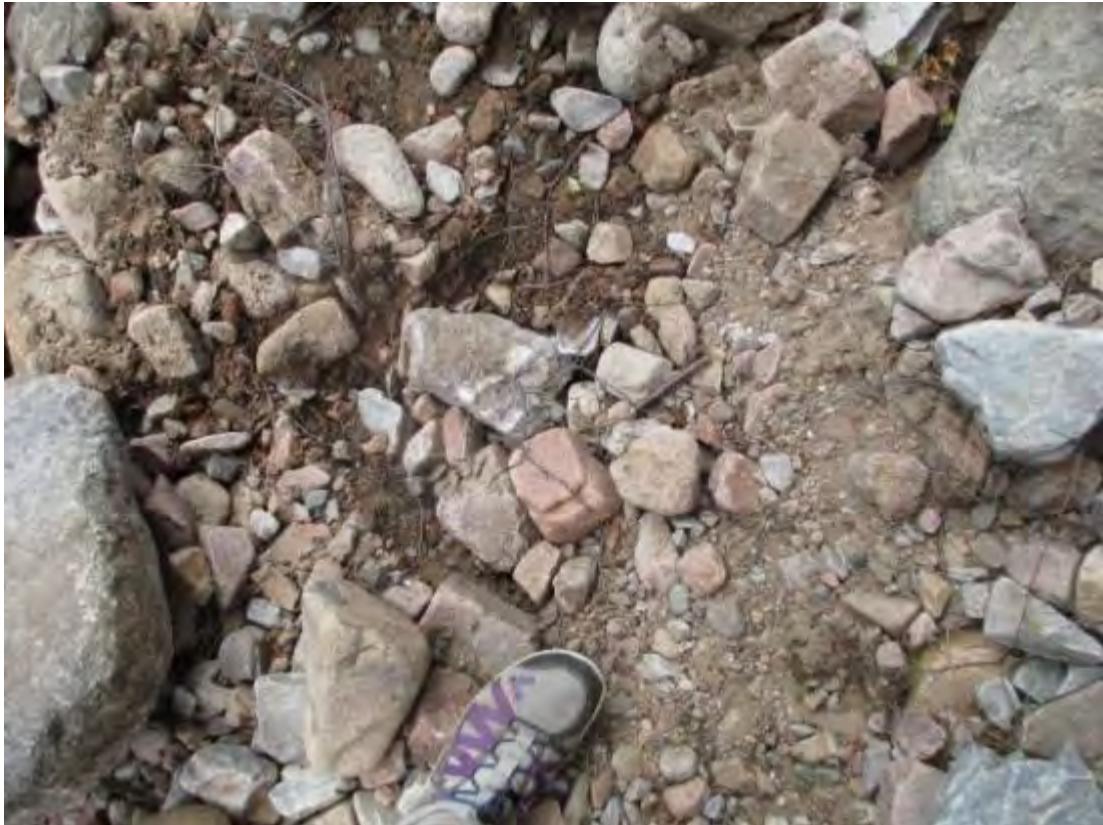
Only partially - many willow clumps were damaged or removed, probably by park visitors. Many of the remaining clumps are still in the high waters of the stream.

No willows left in this clump on the north bank near the Visitors' Center.

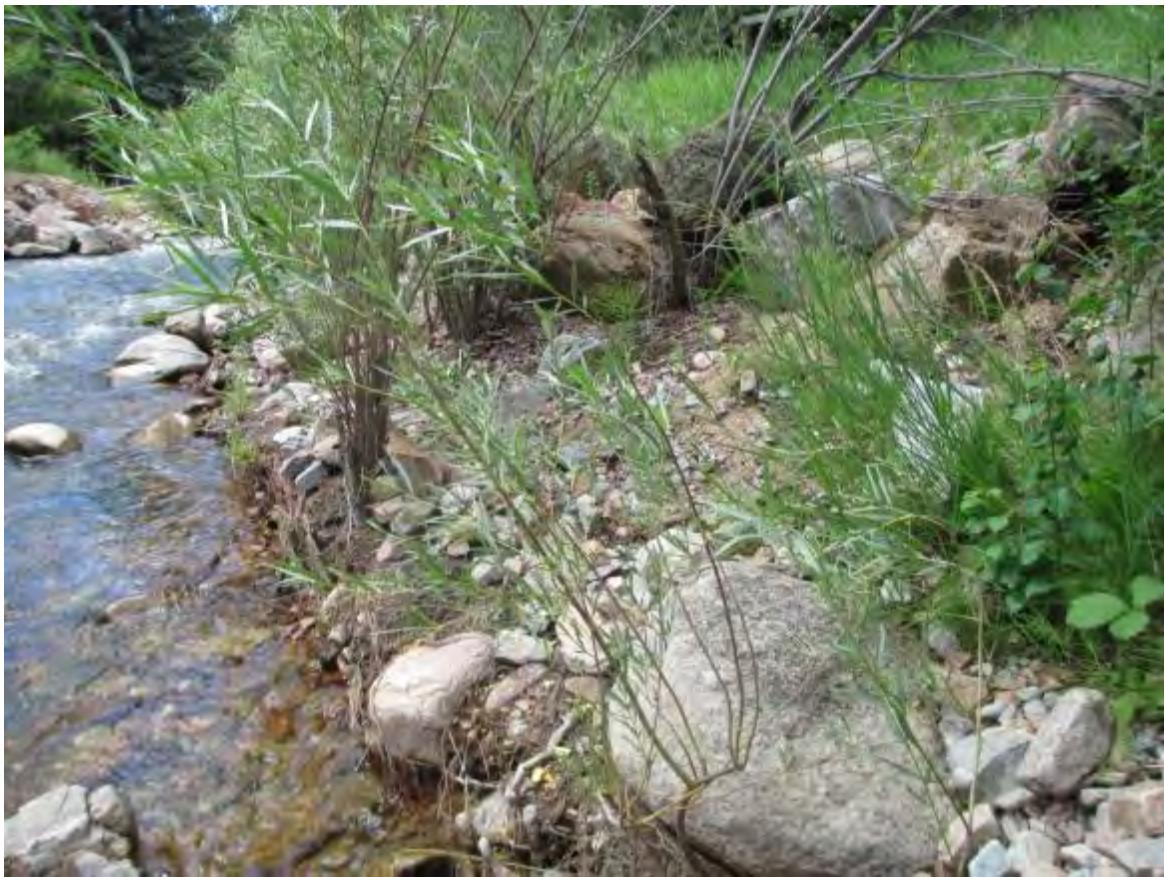
Willows resprouting from root stock.

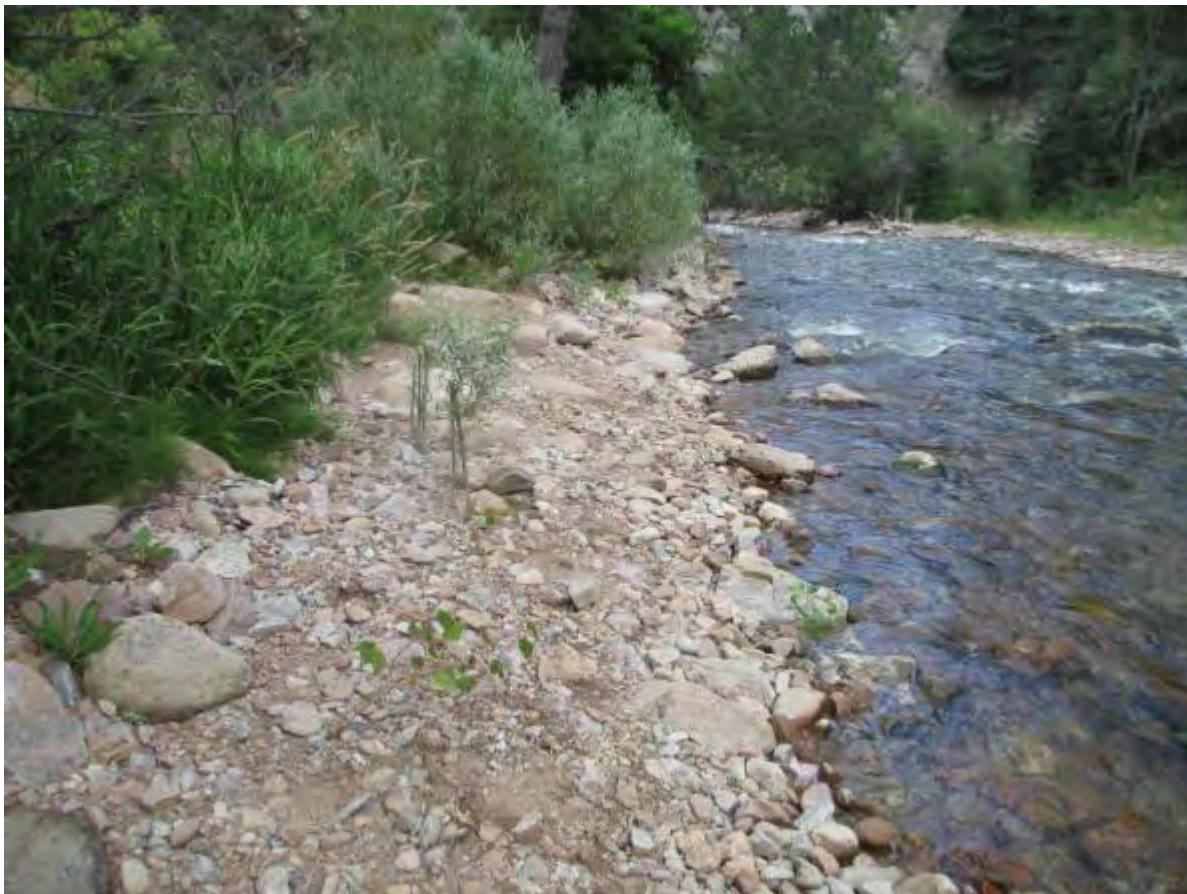
Willow plantings in areas of less visitor use show better survival.

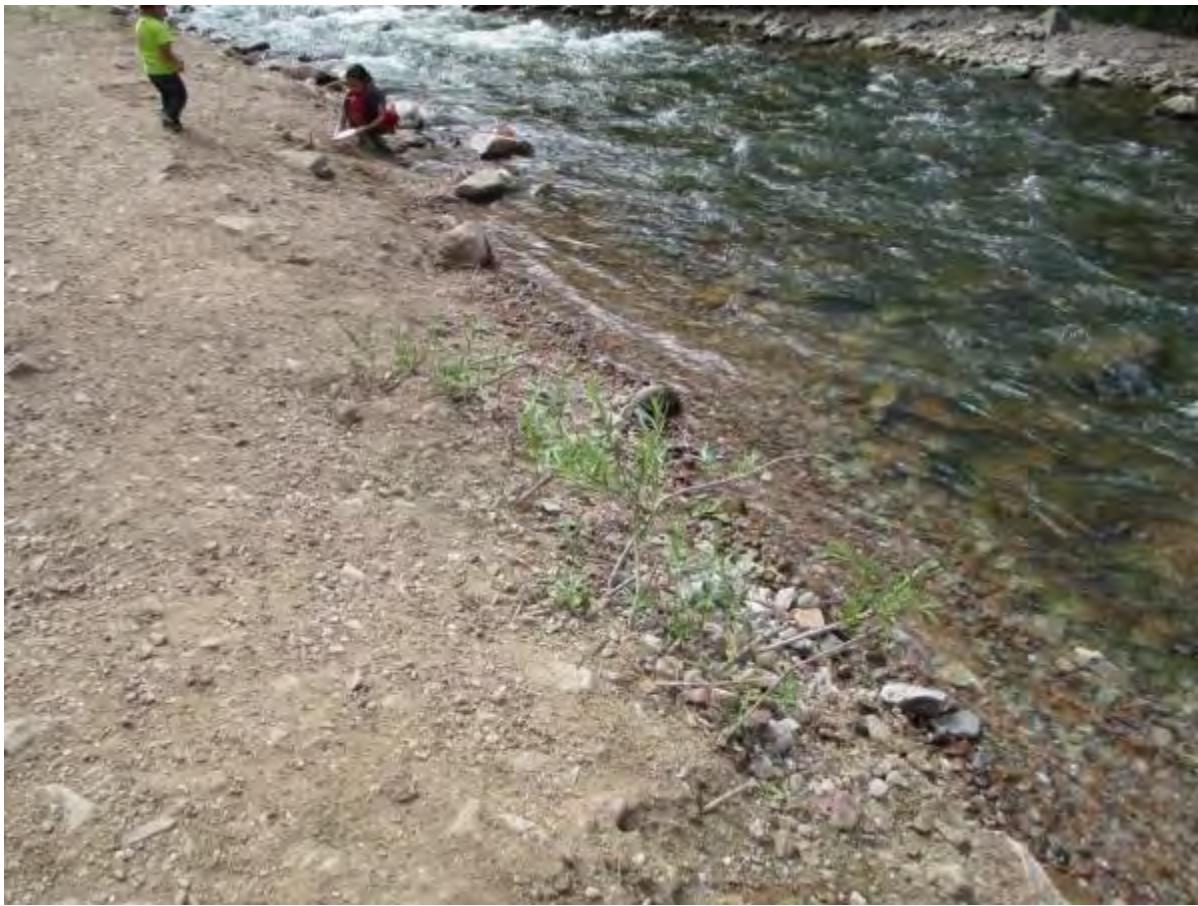
Surviving willow plantings on the less heavily used south bank.

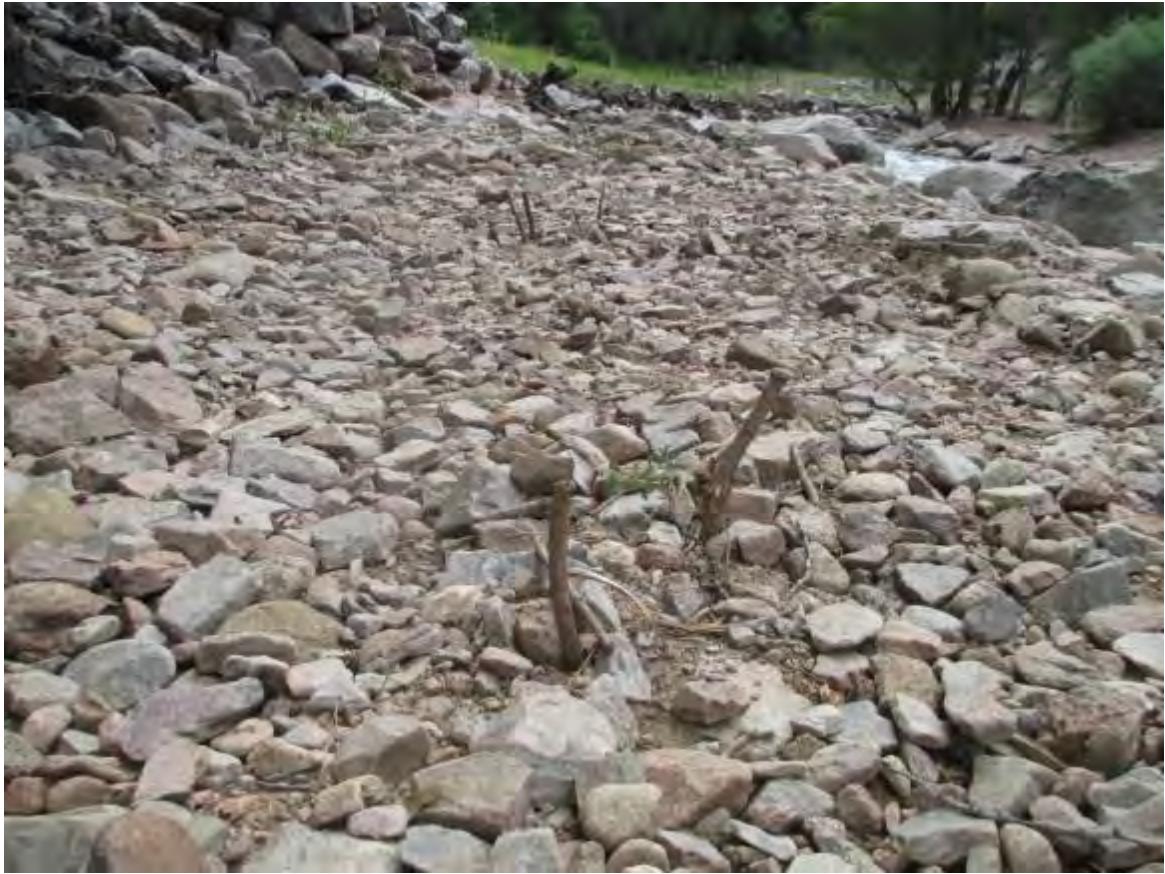
Willow plantings on the densely compacted south bank reconstruction area at the upstream end of the project area.

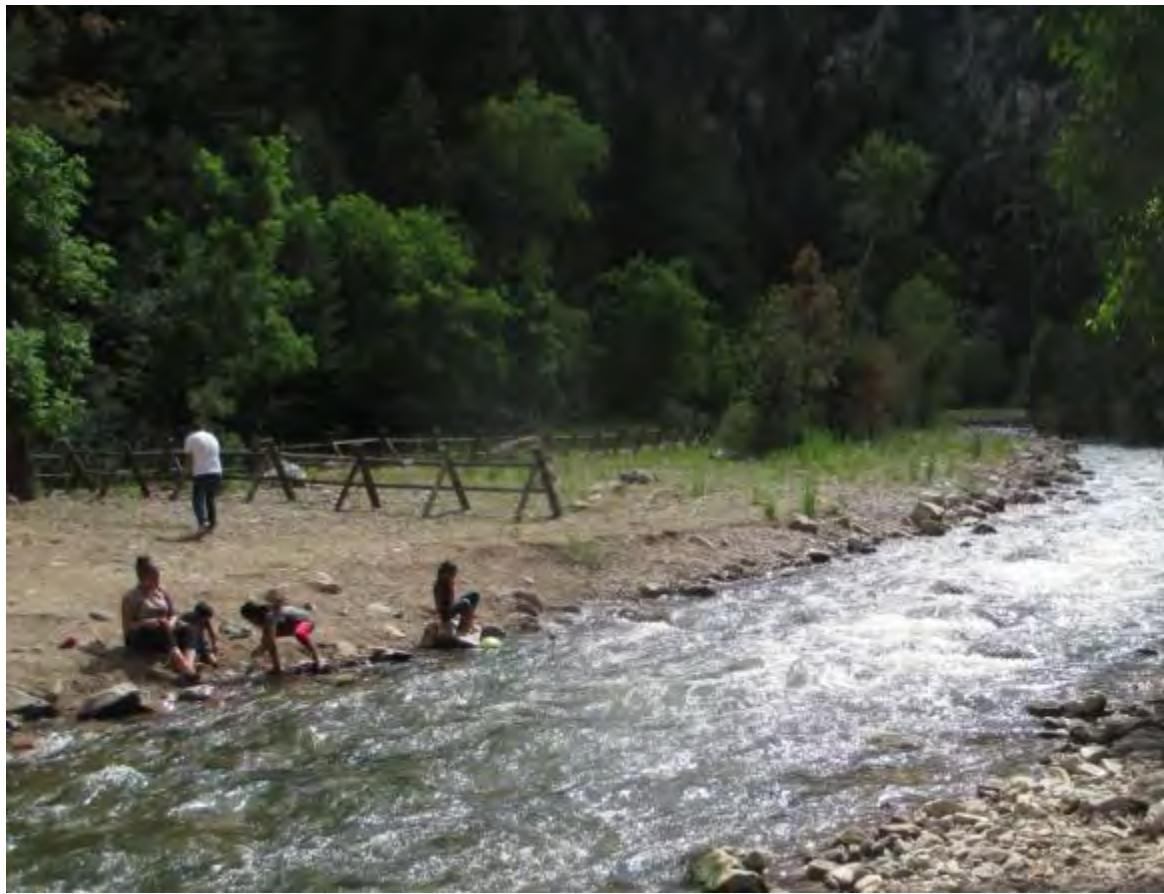
Very good survival of the Park's native tree and shrub plantings in fenced and labeled areas.

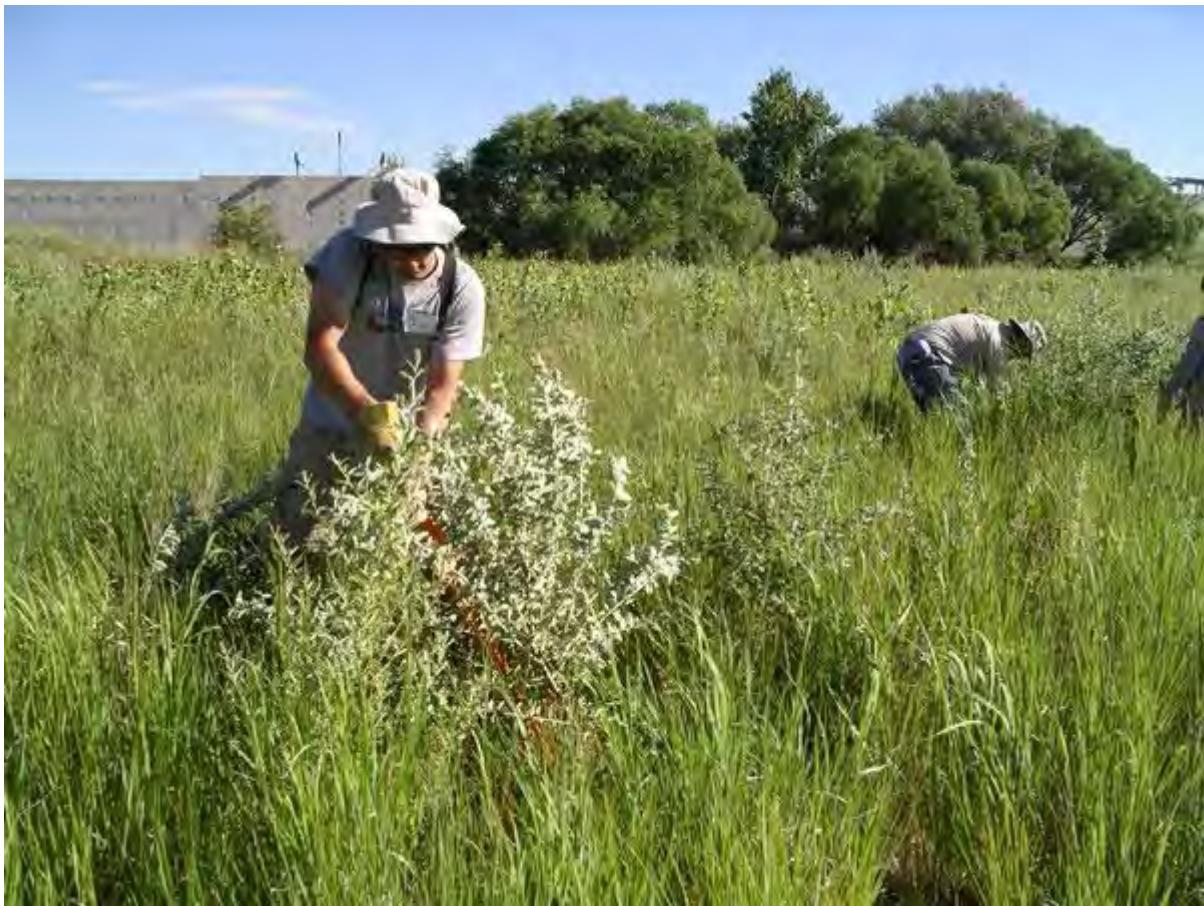
2005. WRV crew removes Russian-olive from the Left Hand Creek floodplain, view to north.
